SuperKEKB status

2025/09/29 B2GM
Ryuichi Ueki
on behalf of SuperKEKB

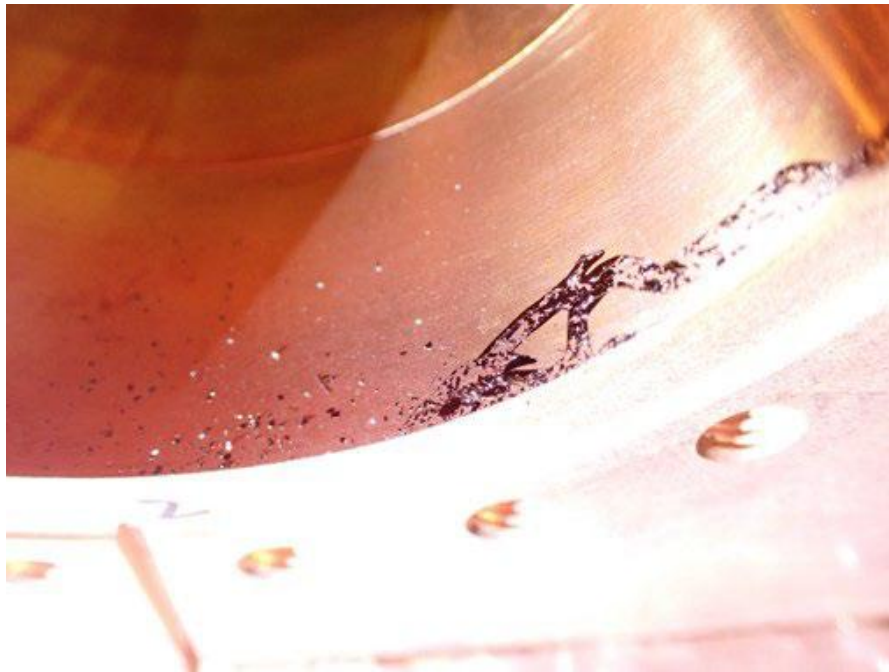
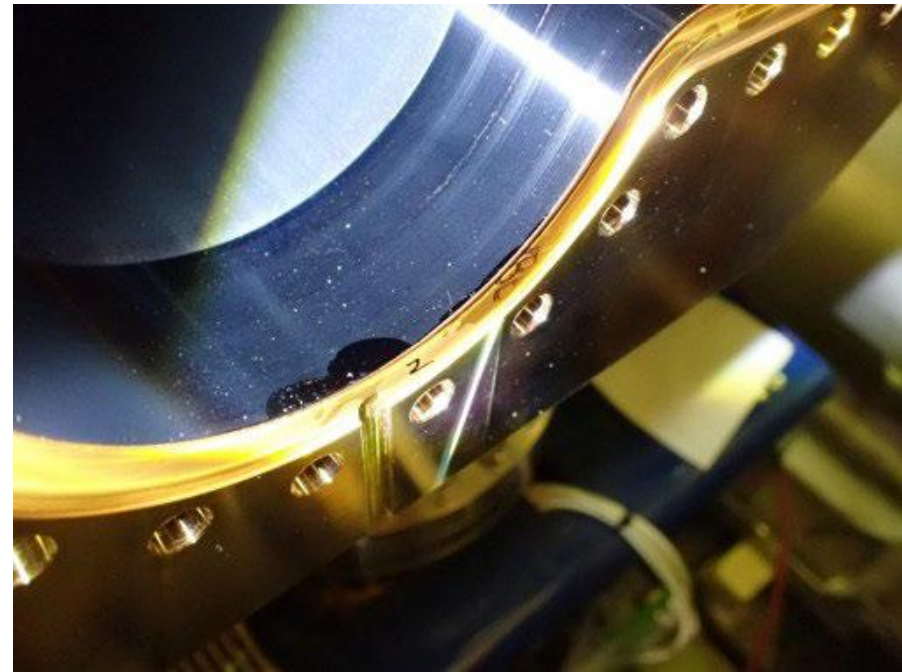
- Internal inspections have been completed, where
 - All MO-type flange connections where VACSEAL was likely used.
 - IR (HER, LER), LER wiggler sections (D04, D10, D11), others
 - Black stains were found on many flange connections and removed.

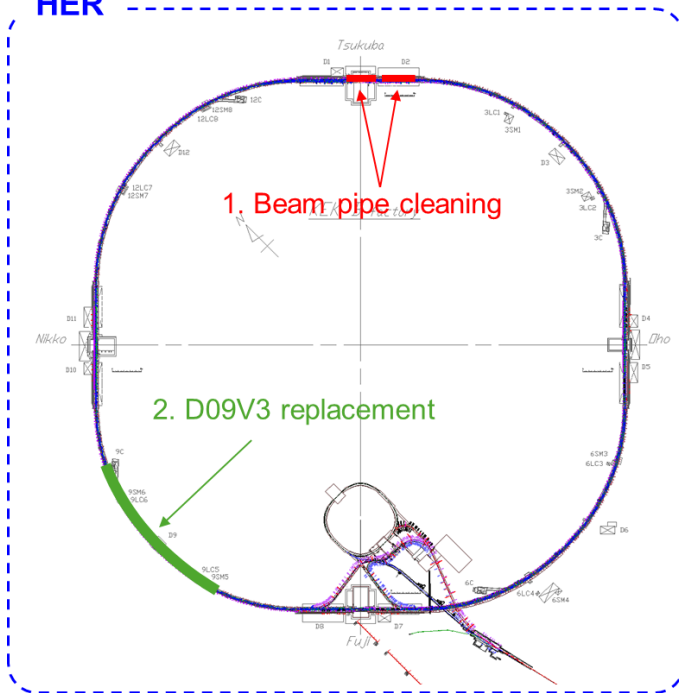
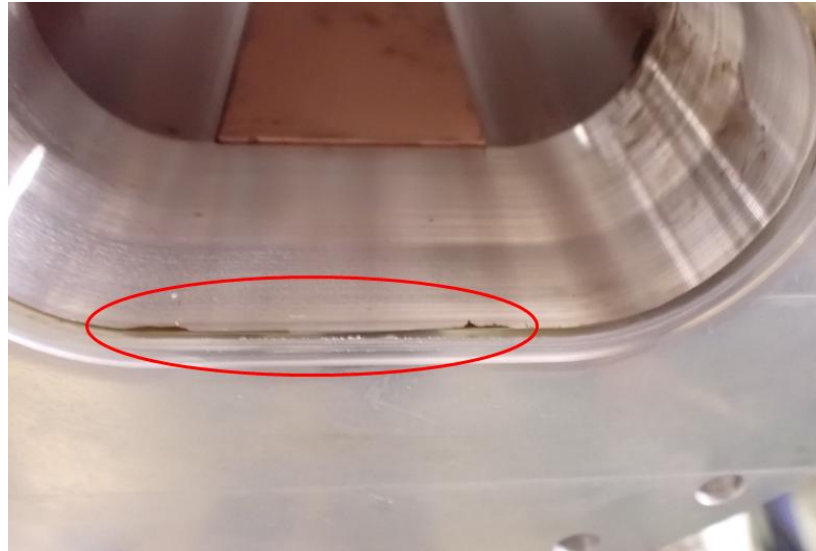
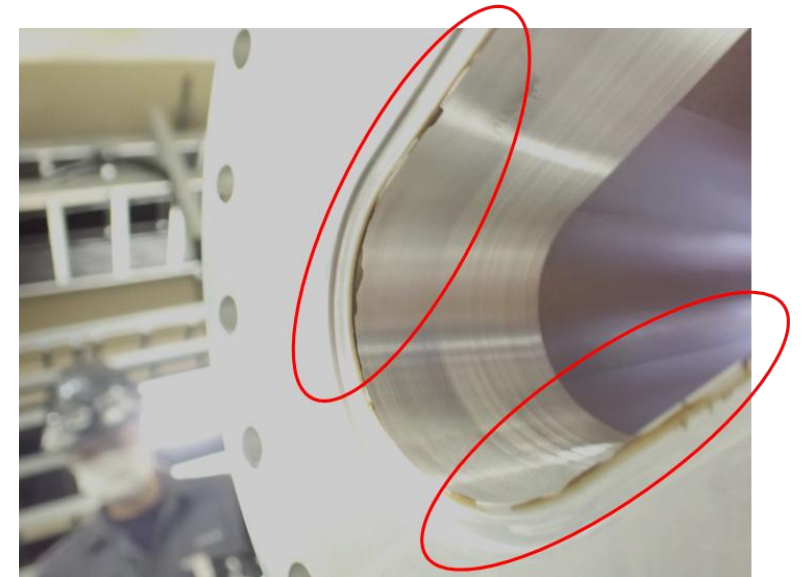
HELICOFLEX flange connection

- During D9V3 collimator replacement work
 - Black stains were found on HELICOFLEX flange connections.
 - VACSEAL had been used.
 - This is the first time such stains have been found on HELICOFLEX flange.
- Three HELICOFLEX flange connections will be inspected before operation.

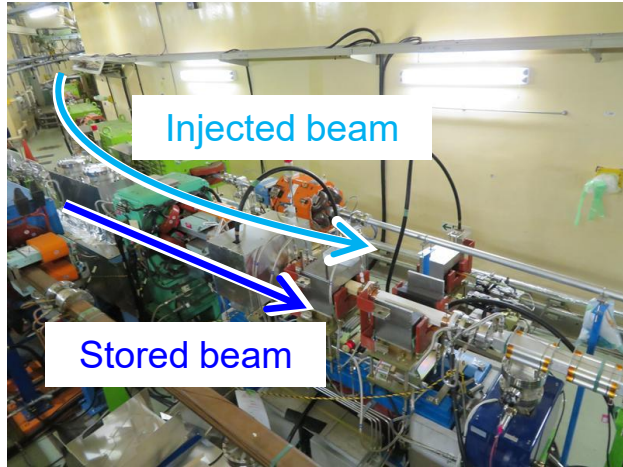
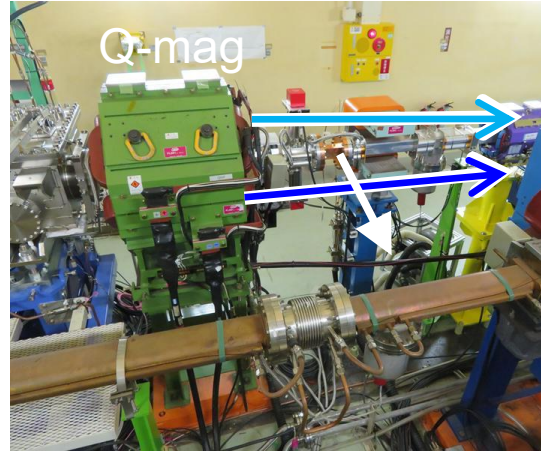
- LER beam pipe position survey was carried out.
- We found out beam pipes were tilted and deformed.

Improvement of physical aperture is expected.

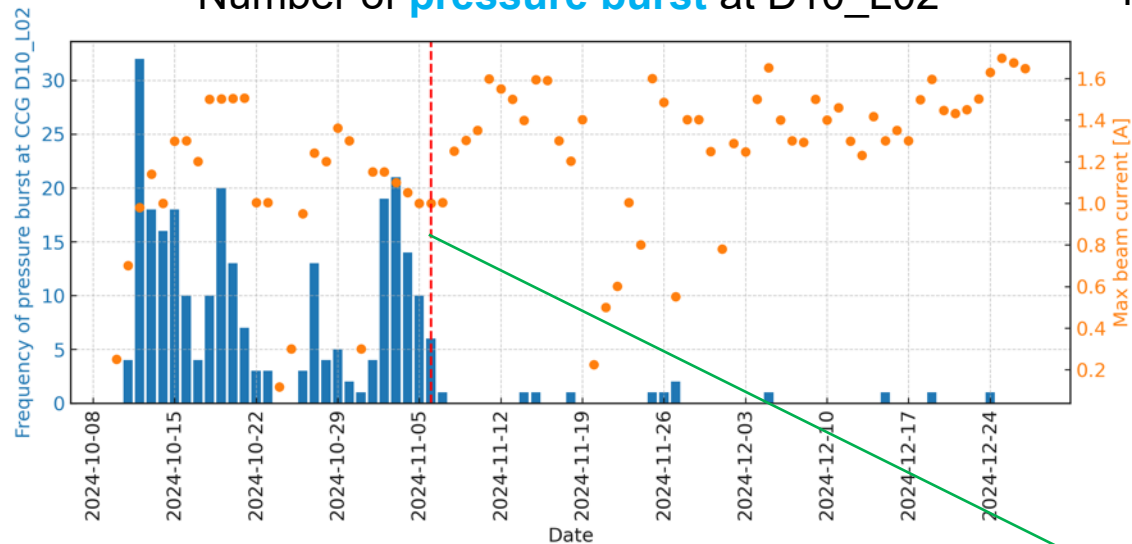
Number of **pressure burst** at D10_L02

- A bellows chamber near CCG D10_L02 was replaced, and VACSEAL was removed from the adjacent beam pipes on Nov. 6 during the 2024c run, using the same cleaning method.
- After this work, the number of pressure bursts in the area has been significantly reduced.

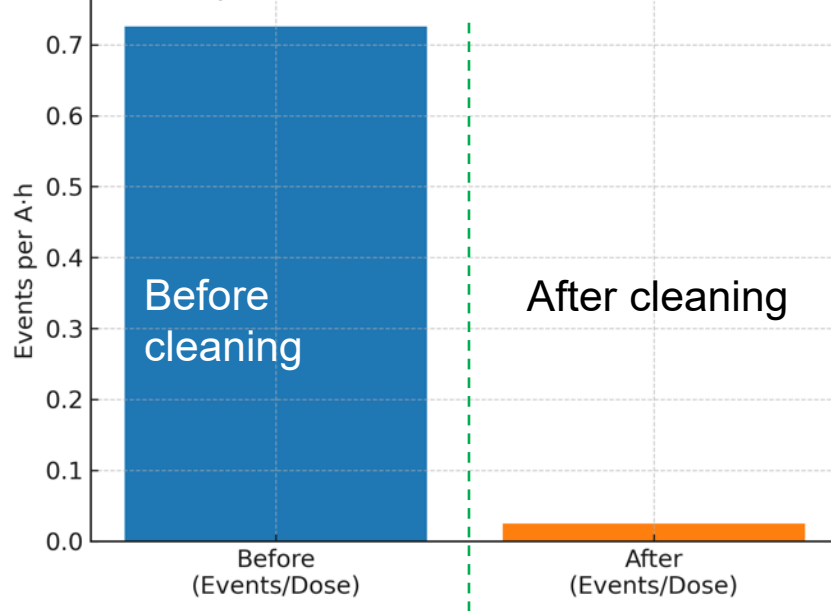
Frequency of **pressure burst per 1 Ah** at CCG D10_L02

- A bellows chamber near CCG D10_L02 was replaced, and VACSEAL was removed from the adjacent beam pipes on Nov. 6 during the 2024c run, using the same cleaning method.
- After this work, the number of pressure bursts in the area has been significantly reduced.

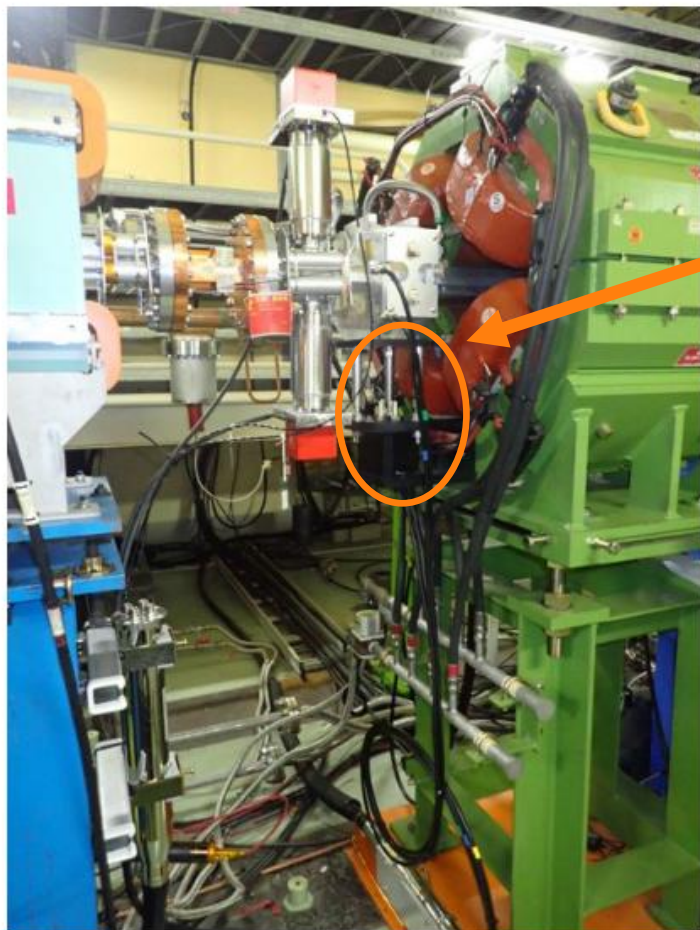
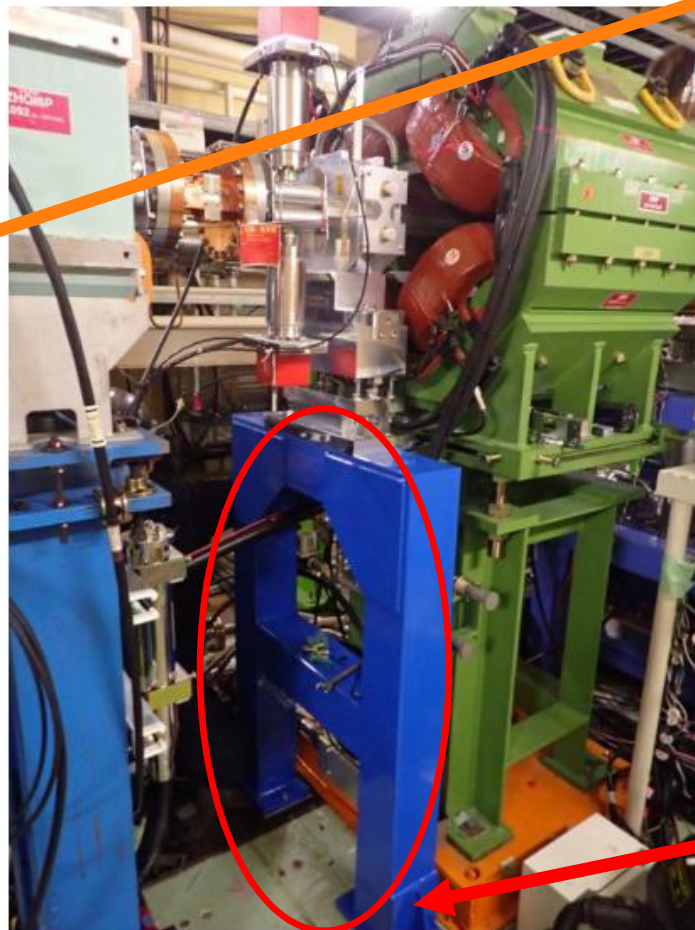
QI6PのBPMサポートは
他の場所とは違いひ弱な構造

リング外側に、QI6PのBPM
サポートが傾いていた

このサポートを緩めるとリング内側に
動きオフセットが緩まると思ったが、
逆でリング外側により動いた

サポートを強化するためと、アライメント調整
ができるように、独立のサポートに
変更した

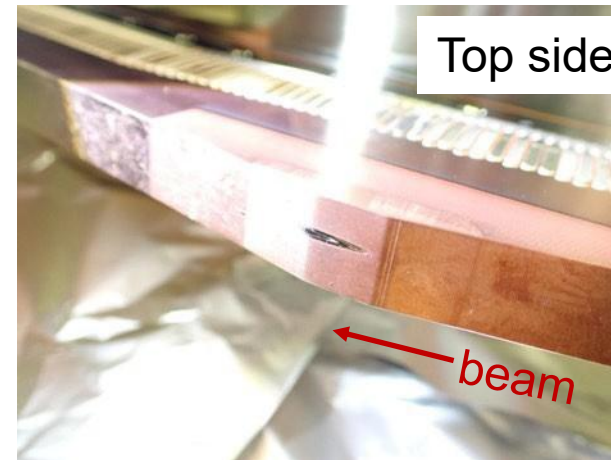
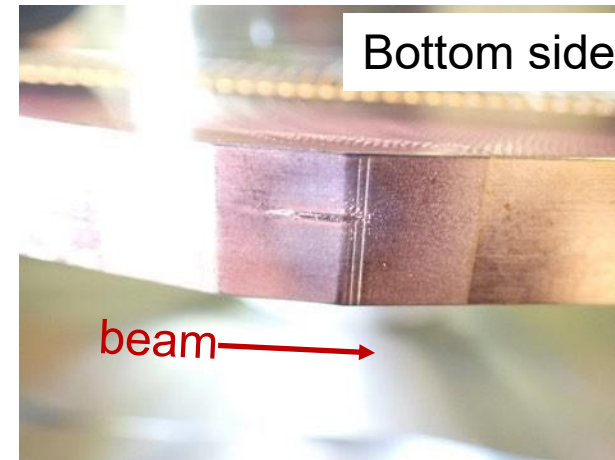
Damaged jaws removed from D02V1 (Ta, 10 mm)

- Damaged jaws in D02V1 and D05V1 were replaced with new ones.
- The top jaw removed from D05V1 was replaced, although its flat area at the tip appeared undamaged and still usable.
- We installed a Ti jaw on the top side of D05V1 to test its durability and evaluate its background reduction performance.

- D02V1: Ta, 10 mm (both side)
- D05V1: Ti, 10 mm (top side)
Ta, 10 mm (bottom side)
