# SuperKEKB status

BPAC Review in summer 2025

30th June 2025

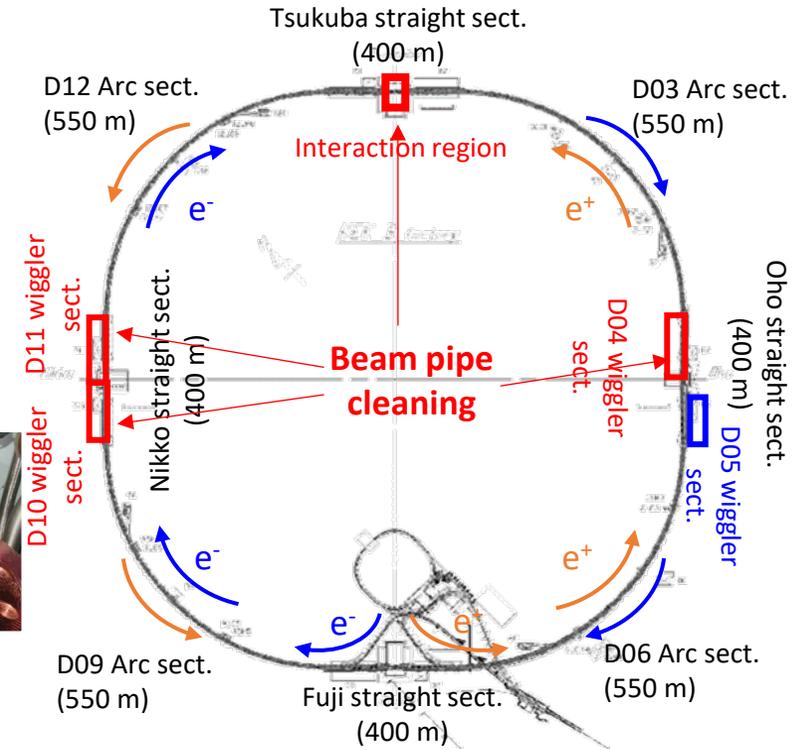
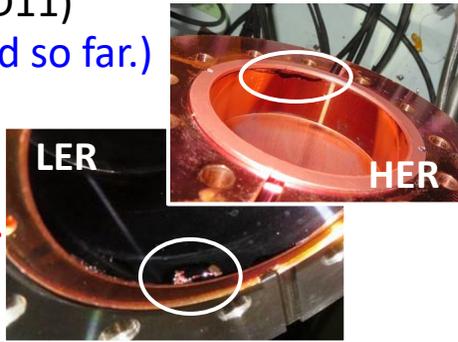
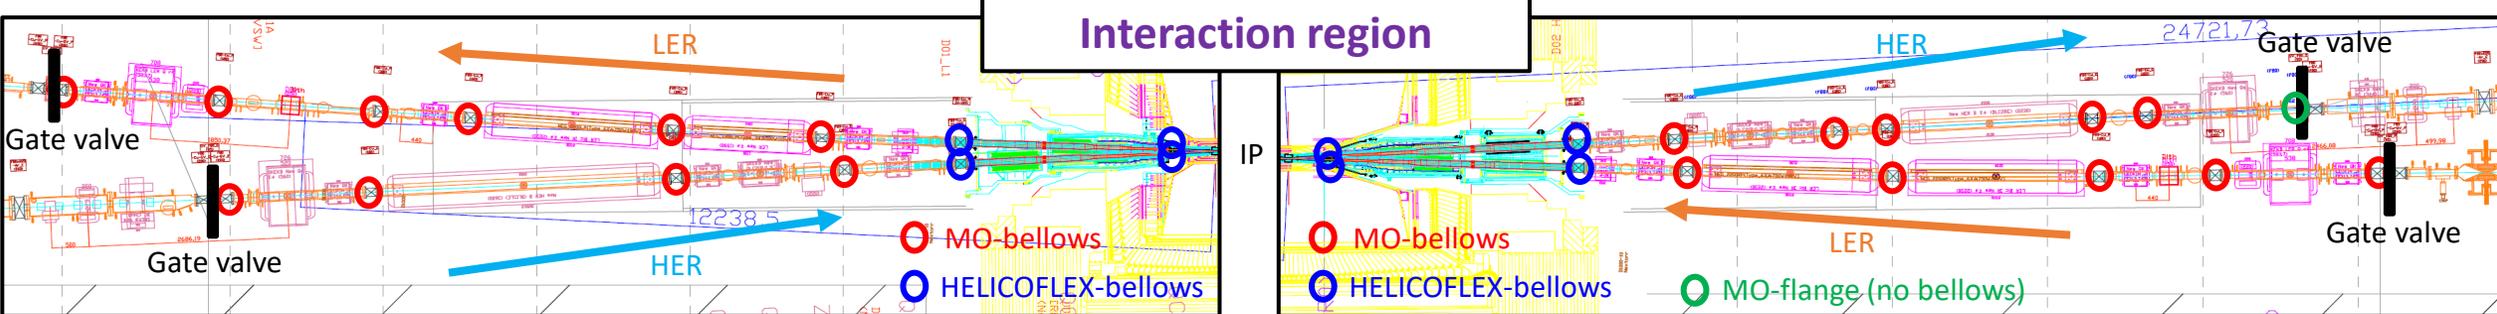
- Black stains are thought to be consist of liquid-type vacuum sealant (VACSEAL).
  - VACSEAL can enter the beam pipe via the MO-flange.
    - Strong SR irradiation turned VACSEAL into black stains?
  - Some black stains are flaky and easily turn to dusts.
- Black stain removal are being conducted.
  - At **MO-flange connections** most-likely with VACSEAL.
    - It is impossible to identify all MO-flanges with VACSEAL due to lack of records.
  - In sections where many pressure burst was observed with SBLs.
    - ⇒ At interaction region (IR), LER wiggler sections (D04, D10, D11)  
 Not at HELICOFLEX-flange (No black stains have been found so far.)
- IR : **All MO-flange connections were cleaned.**
  - 41 MO-flange connections were opened.
  - **Black stains were found in many MO-flanges and removed.**
  - 16 HELICOFLEX flange connections left uncleaned.

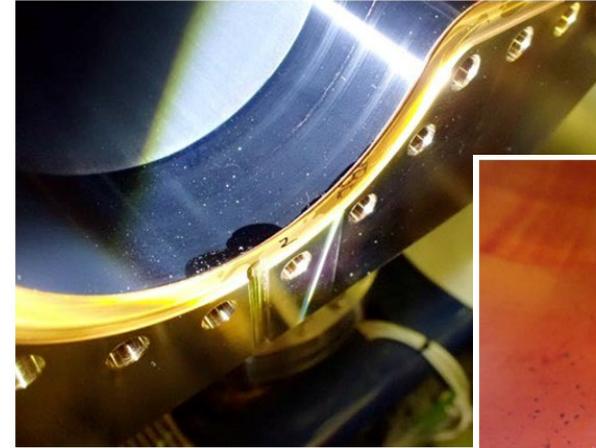
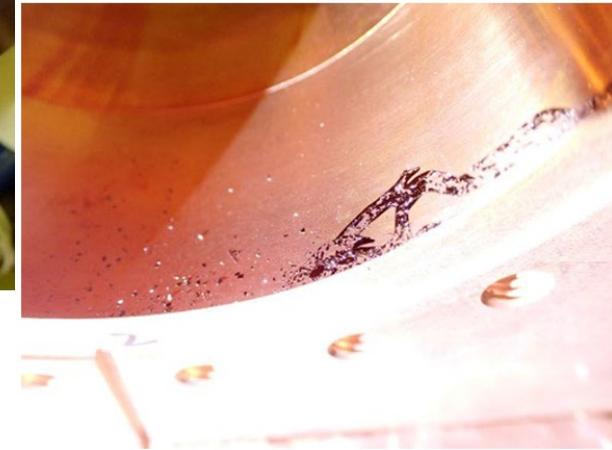
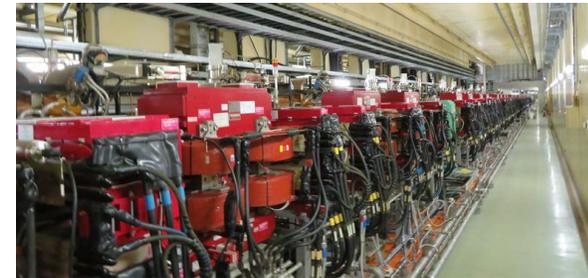
- LER wiggler sections
  - Many pressure bursts accompanied with SBL events
  - Strong SR irradiation especially downstream wiggler section.
    - Vacuum leaks occurred more frequently than other sections
  - Many MO-flanges most-likely with VACSEAL
- LER D04&D10 : All MO-flange connections were cleaned.
  - D04 : 52 MO-flange connections (26 bellows chambers)
  - D10 : 54 MO-flange connections (27 bellows chambers)
  - Many black stains were found and removed.
- LER D11 : Ongoing (will be completed by mid-July)
  - 44 MO-flange connections (22 bellows chambers)
- And more
  - Some MO-flanges with VACSEAL applied to stop vacuum leaks

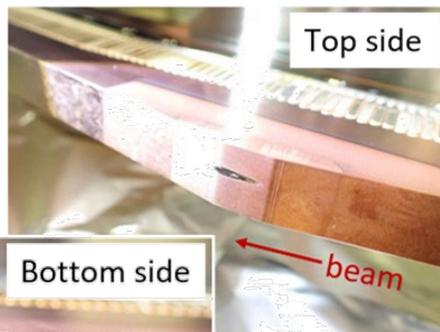
Damaged jaws (D02V1, Ta, 10 mm)

- D02V1 and D05V1 were replaced with new ones.
- D05V1 (NLC) top jaw material was changed to Ti.
  - Top side : Ta (4 mm) -> **Ti (10 mm)**
  - Bottom side : Ta (4 mm) -> Ta (10 mm)
- Durability and background reduction performance of **Ti jaw** will be tested in coming beam operation.

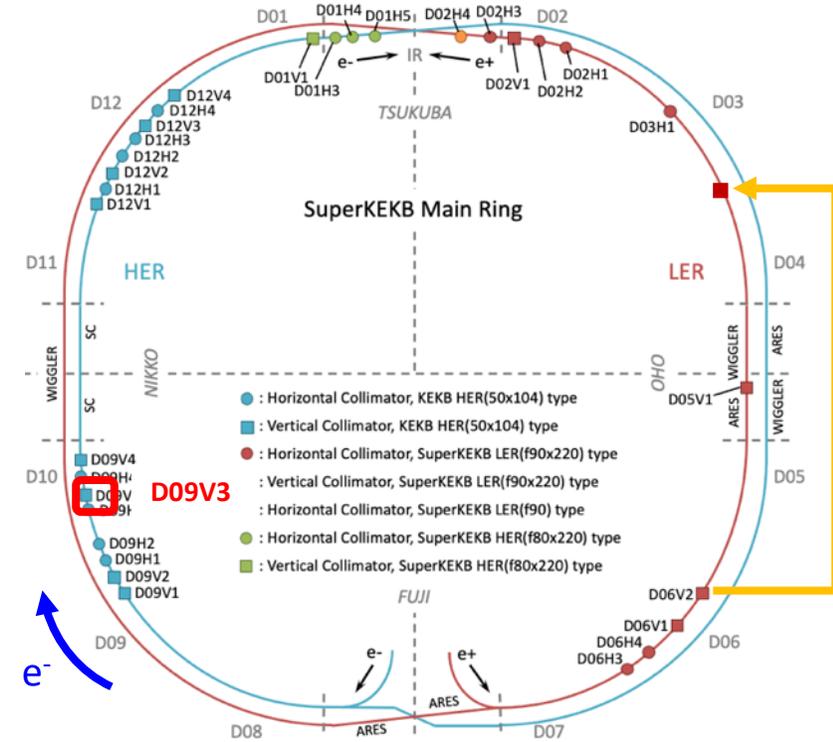
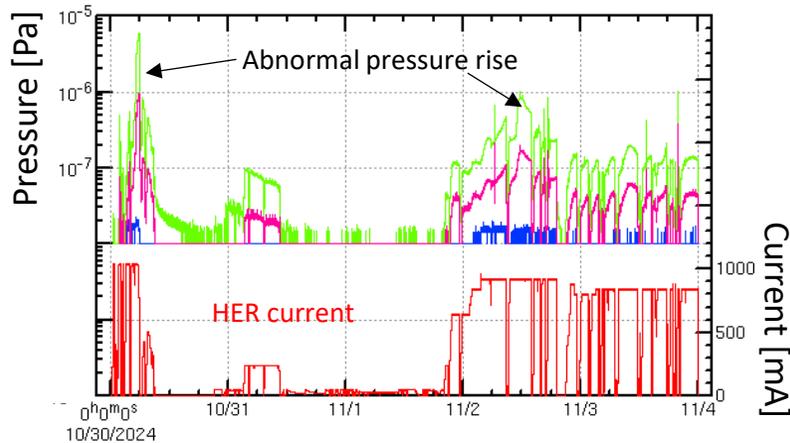
- Abnormal pressure rise was observed near D09V3 in 2024c run.
  - Pressure increased even if the beam current is constant.
  - Pressure depended on bunch current and collimator gap.
- Collimator jaw may be heated by HOMs generated by itself.
  - Or discharge may occur around collimator jaw.
  - The cause of the abnormal pressure rise is still unclear.
- D09V3 collimator will be replaced with water-cooled one.
  - New collimator is expected to be delivered by the end of October and installed in early November.

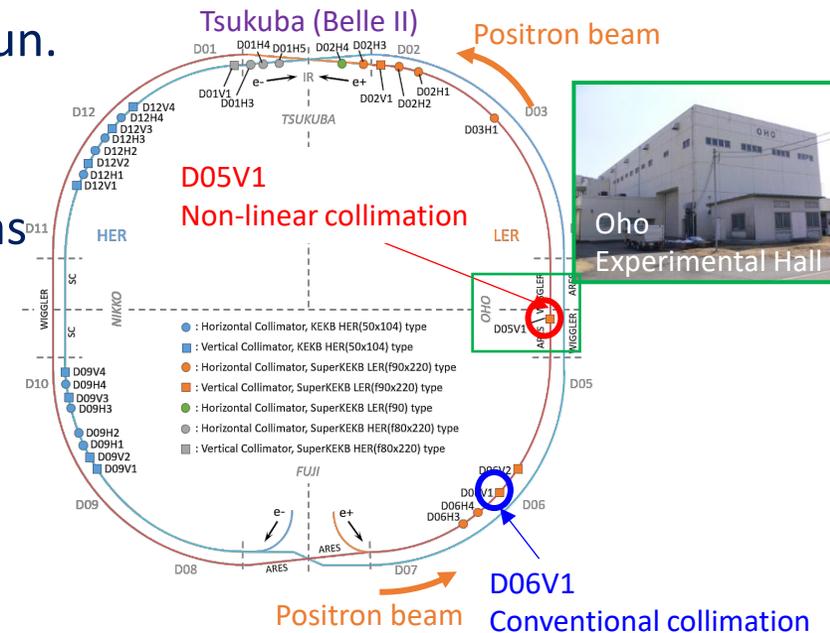
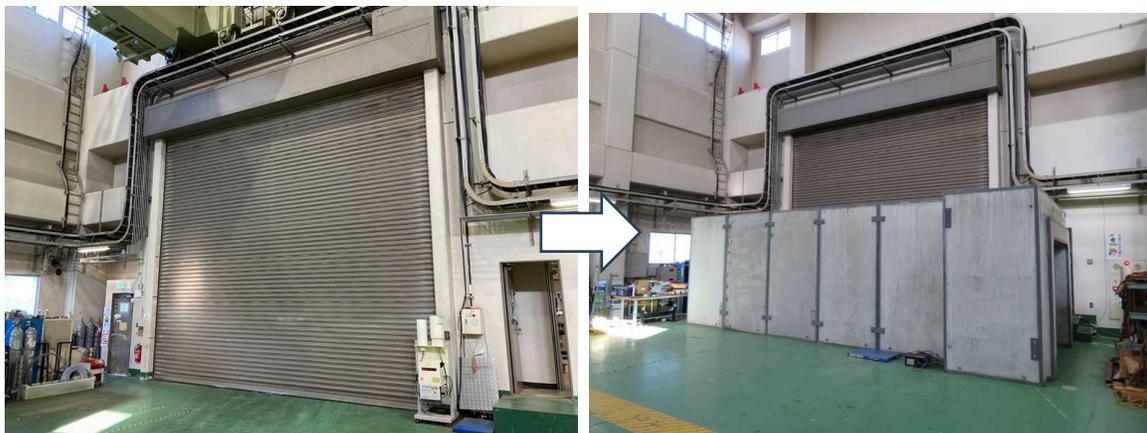
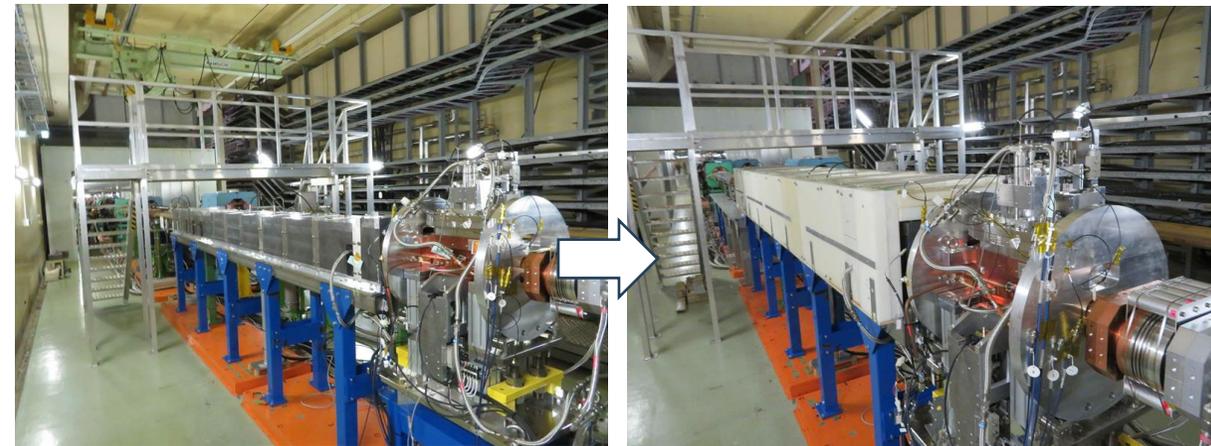
Countermeasures during 2024c run.

- LER current was limited by high radiation level at Oho Exp. Hall in 2024c run.
  - Radiation level in the Oho Experimental Hall increased as closing the D05V1 collimator gap.
- Radiation shielding was reinforced during 2024c run. (11/26-27), but it was not enough.
  - Polyethylene blocks were added on the existing lead shields in the tunnel.
  - Concrete shields were installed at Oho Experimental Hall to reduce the radiation levels outside.
- For full-scale use of the D05V1 collimator, it is required to reinforce radiation shielding and expand the radiation control area.
