OPERATION STATUS OF SSRF POWER SUPPLIES AND INTERLOCKS FOR TOP-UP OPERATION

Abstract

Digital switching mode magnet power supplies are used in SSRF which have been operating since 2008. Summary of the operation and maintenance of these power supplies will be shared over here. The availability of the power supplies is increased steadily over the past 4 years. And the power supplies interlocks for the SSRF top-up operation will be also introduced in this paper.

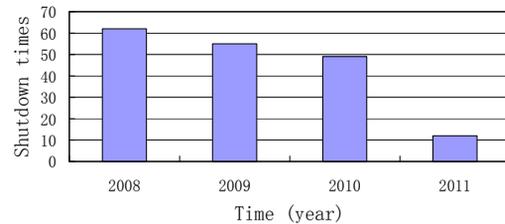
Figure 1: Power supplies shutdown times

From 2008, we began to statistics the MTBF of all the power supplies and try to get better. The MTBF increases 11% every year from 2008 to 2010. Less than 20 shutdown times is expected in 2011, Figure 1.

Power supplies shutdown times decreased 11% every year from 2008 to 2010.

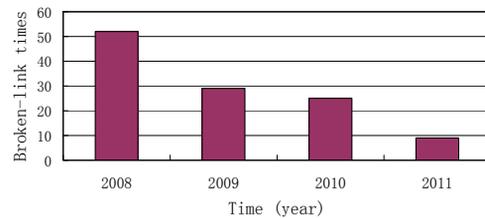
Figure 2: Communication broken-link times

For the communication broken-link problem, figure 2, it is very difficult to find the real reason for the problem for it is just happened on imported cards and there are several tens broken-link over about 300 power supplies a year. According to the operation experience, temperature, dust and hardware may be the three main causes of broken-link.

On the other hand, the VME system is not a negligent factor. Sometimes VME was needed to reboot, sometimes the fiber should be re-plugged to re-link the digital cards.

Communication broken-link times stepped down notably in 2009 for the dust on the DSP was cleaned and some defective DSP cards were replaced.

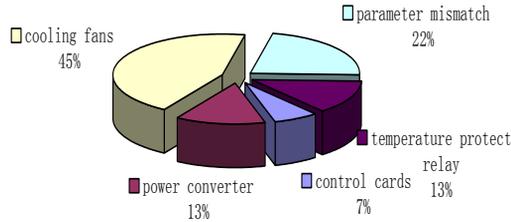
Figure 4: Pie for middle power supplies shutdown reasons

After about a year continuous running, cooling fans often caused power supplies shutdown, figure 3. When the pulse type fan was running normally, which should generate a pulse signal every turn, but the pulse often triggered the interlock circuit mistakenly. The power supply could be run again by reset, but which may be triggered mistakenly again. All fan interlock signals were masked for several months until new plug and play fans module

were used. The power shutdown times were reduced effectively since that time, figure 4.

The second main reason was the parameter mismatch, for the real mean of every parameter of the imported cards was not understood clearly at first. All the cards parameters were updated and the problem was solved.

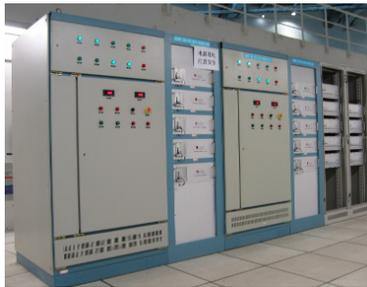
Figure 5: Storage ring Q power supplies for one station

There are 40 dc buses and 200 converters to power the storage ring quadrupole magnets. All these power supplies ran with imported digital cards until May, 2011. All the power supplies were distributed in 20 stations along the technical corridor, figure 5. For each station, there are 10 chopper type magnet power supplies fed by 2 DC bus sources.

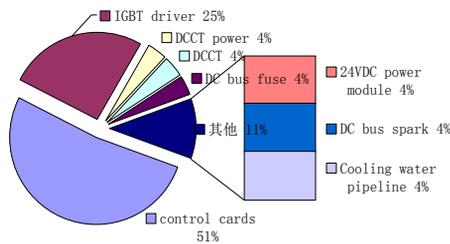
Figure 6: Pie for Q power supplies shutdown reasons

Figure 6, control cards contributed the most shutdown times and it would be talk about later. The IGBT driver EXB841 was the second main reason to make the power shutdown. A restorability resistor fuse was installed on the IGBT driver card. The resistor stood nearby the EXB841 chip, after continuous operating at the rated current for long time, the chip was heated up by the resistor and caused the chip disorderly. When the power supply box was opened, all the components were cooling and could operate normally. It took us long time to find the reason. All the 200 power supplies were fixed at Jun. 2009. Some other factors were found also, such as DCCT,

+24V DC power and etc, these happened occasionally for all the power supplies.

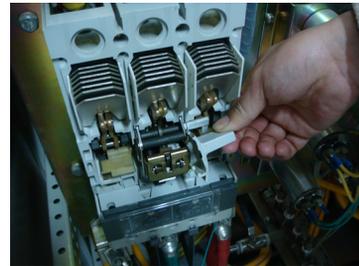
Figure 8: The contactor handle was broken

The contactor handle of storage ring dipole magnet power supply was broken 3 times, figure 8. It was incredible but happened. Any reasonable explain were not gotten from the contactor company until now. Absorb capacitor must be replaced for the colour of capacitor getting dark every year, some even have a fracture on it, figure 9. All of 120 capacitors should be replaced every year and this did not cause shutdown until now.

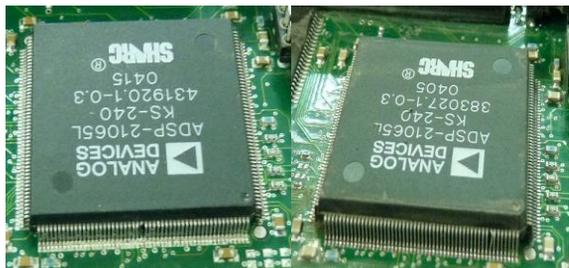
Figure 10: Some pins of the DSP contacted each other.

Communication broken-link is a second main problem for SSRF power supply system. Both the VME control system and the cards should be responsible for broken-link. Most of time, cards can be reset to re-link again. The optical fiber should be re-plugged sometime. Cards should be replaced only when reset cards and VME invalidly. 10 DSP and 10 ADC were fixed and returned by Diamond light source and some cards are being fixed now.

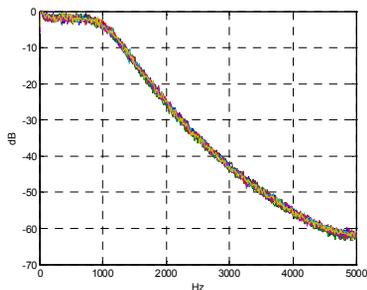
Figure 11: The fast orbit steer power supplies reached 1kHz bandwidth with home-made digital cards.

The new home-made cards were used on the fast orbit steer power supplies which bandwidth got 1kHz.
