Operational Disasters at ISIS Every Picture tells a story!

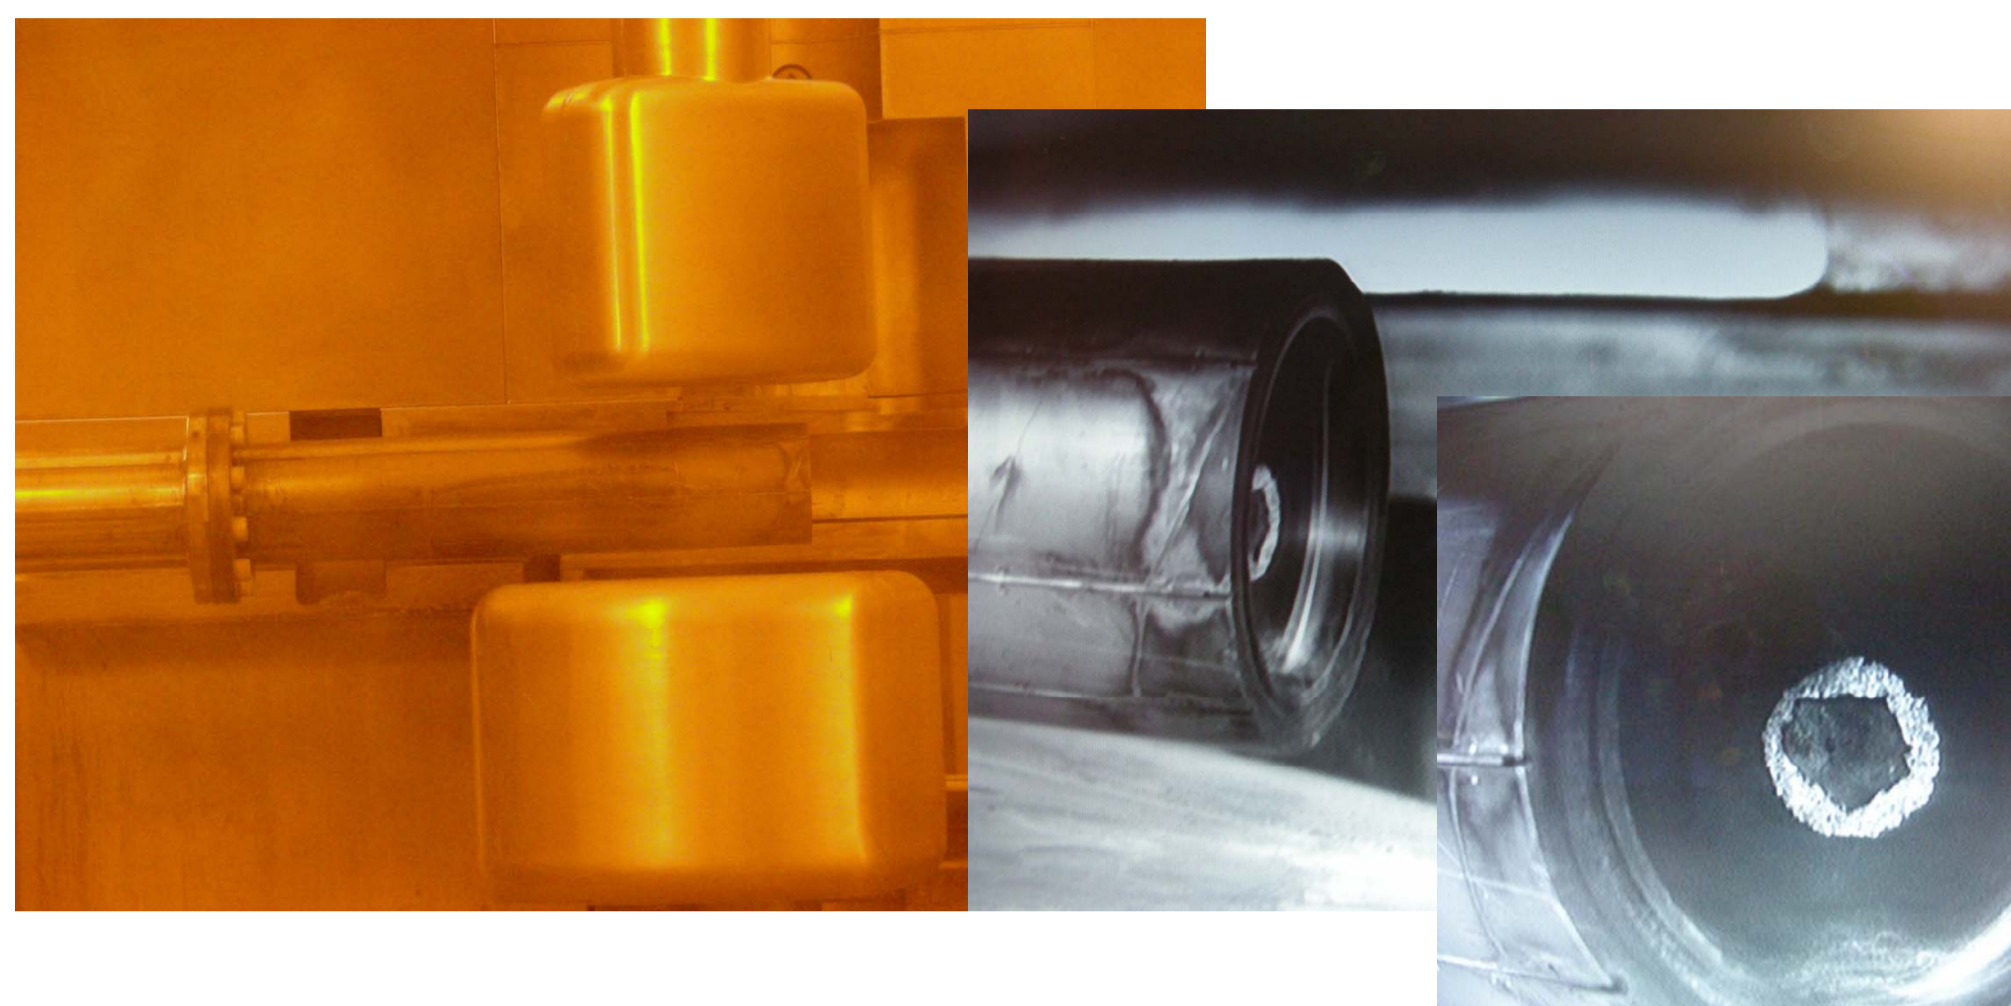
Target 2 catastrophic failure in Jan 2010. Tantalum cladding corrosion resulted in replacing the target. June 2010 saw similar effect occurring. Void Vessel atmosphere moist. Temperature modelling error made - possible 800°C not 200°C on front face! Redesign, manufacture & test program over 8 months. New design has water cooled front face.

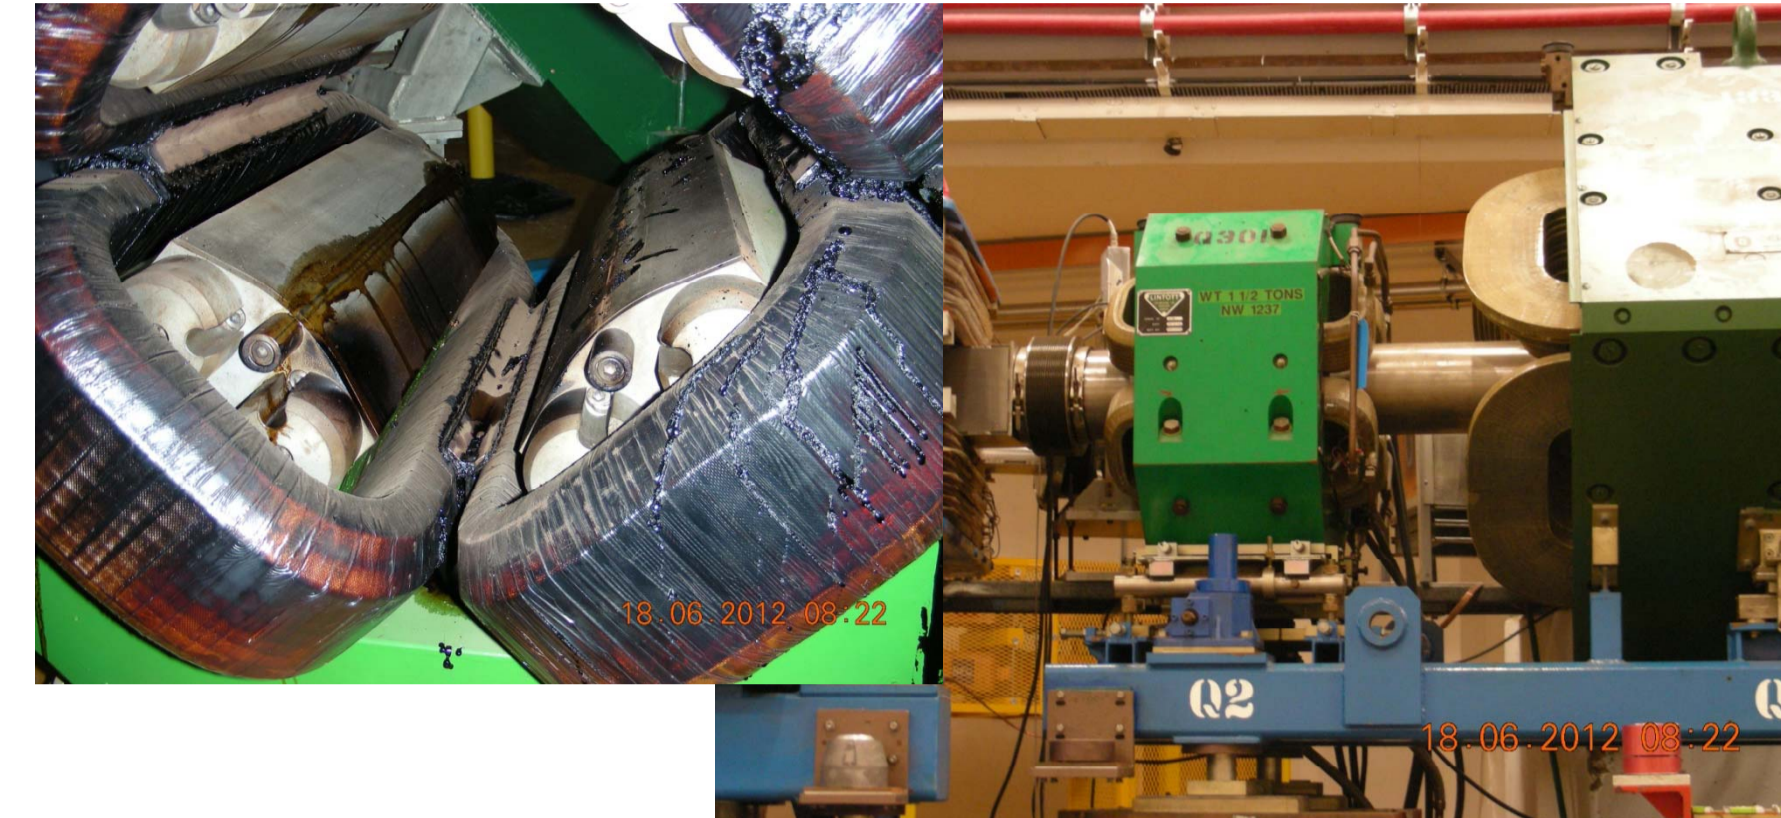
June, 2012 power was lost to Sub Station 22. Area out of bounds for ISIS staff. Power supply restored in approximately 5 hours but 'knock on' effect significant. EQ2 power supply controller failed to danger and continued to power magnet (5kW)! Overheating and smoke resulted. 8 CO₂ extinguishers used. Local Fire Service arrived but 'radiation' environment!!!

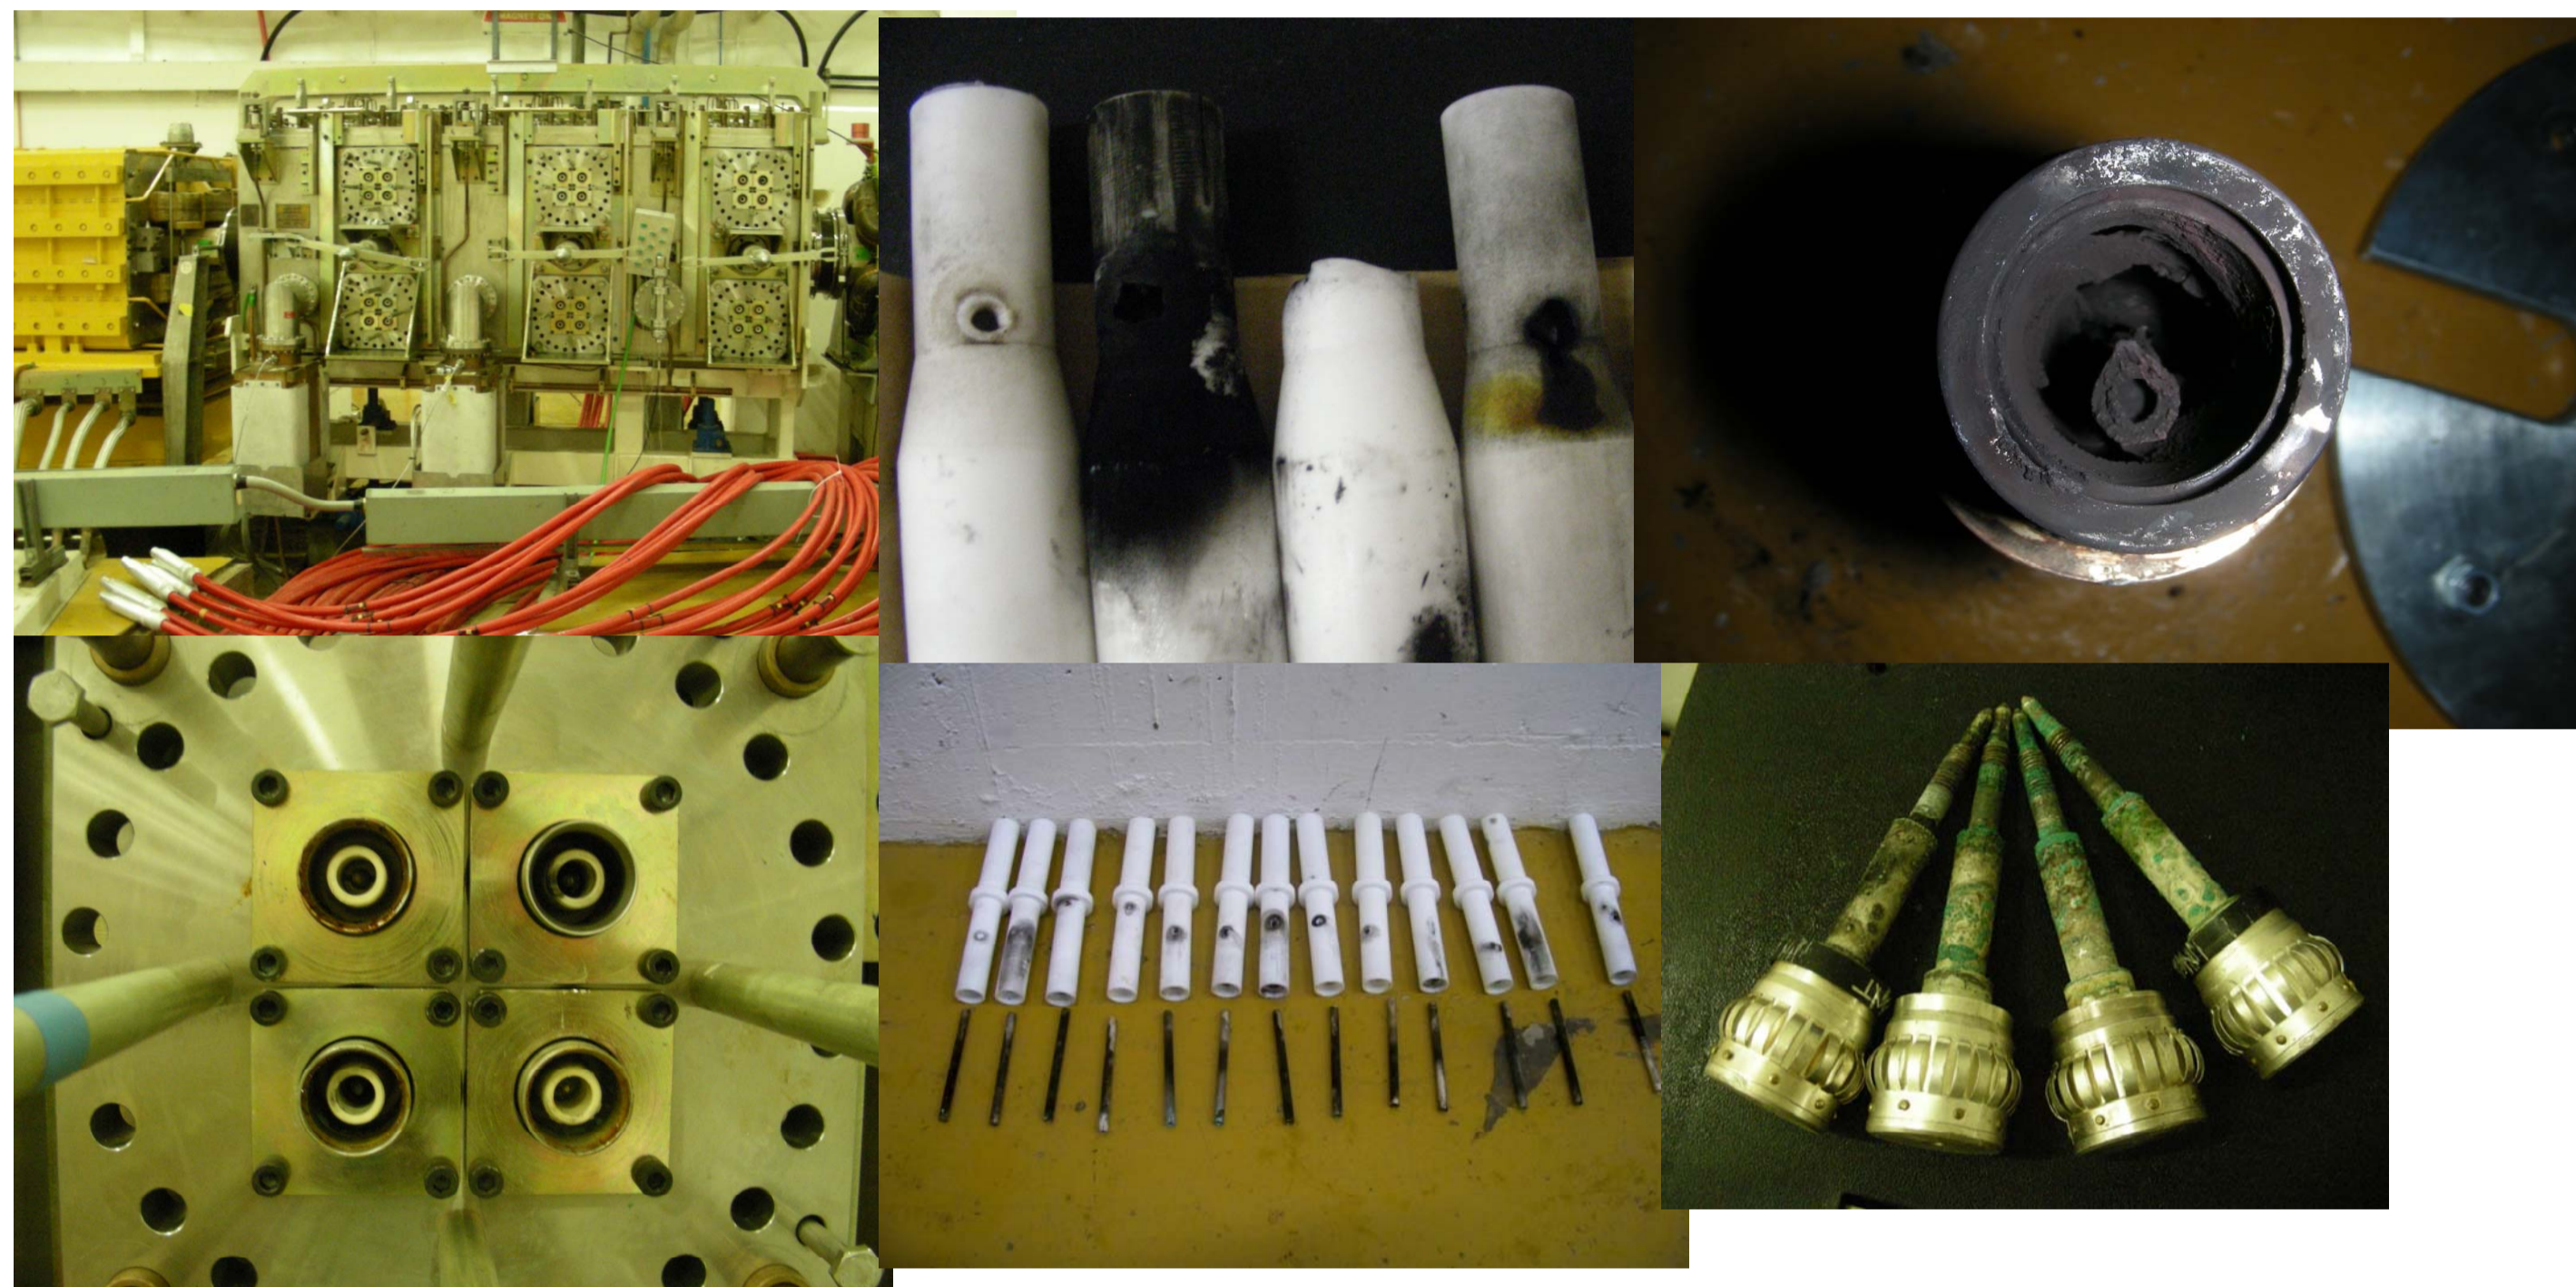
Kicker magnet connector failures - Kicker cables upgraded and connectors redesigned by contractors. New features included sharp edges, thin material and unspecified PTFE grade. Although PTFE not ideal for radiation areas had been successfully used for many years. Lost time due to random failure incurred and radiation doses to personnel during cycles. Occasional synchrotron vacuum loss when ceramic connectors overheated (~24 hour recovery time). Embarked on a regime of scheduled inspections mid-cycle. Tried Peek material but same problem. Many months taken to remedy the issue. New 'rounded' design, thicker material, 'moulded' rather than 'turned' virgin PTFE.

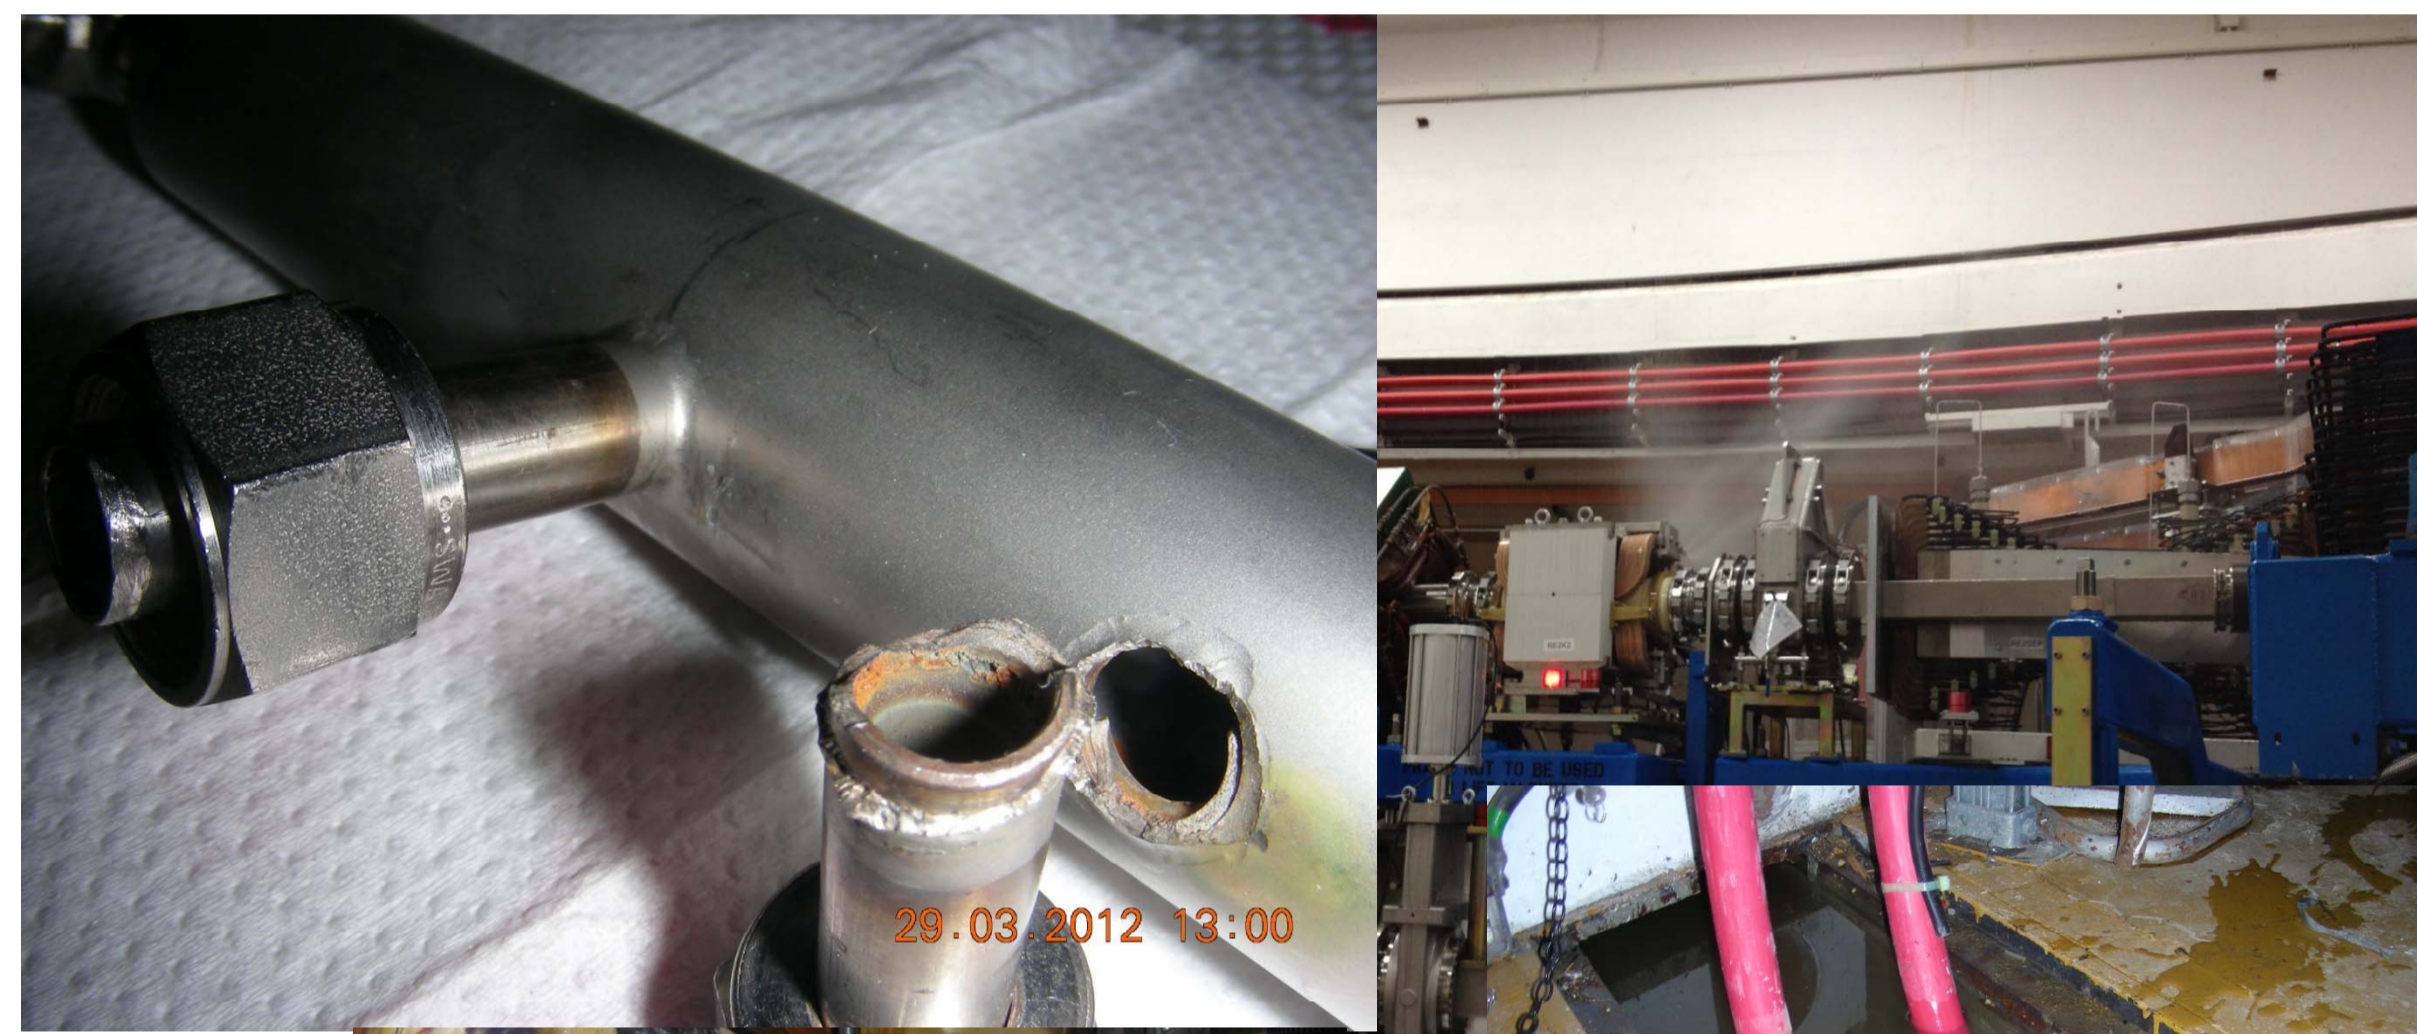
E2K2 Kicker manifold failure - this magnet operates at 10Hz and the vibration caused the weld to fracture. A significant amount of water was lost. Water penetrated the insulation of Dipole 3 and brought about the premature failure of the magnet windings. The cycle was terminated 5 hours early. 4 weeks to change the dipole.

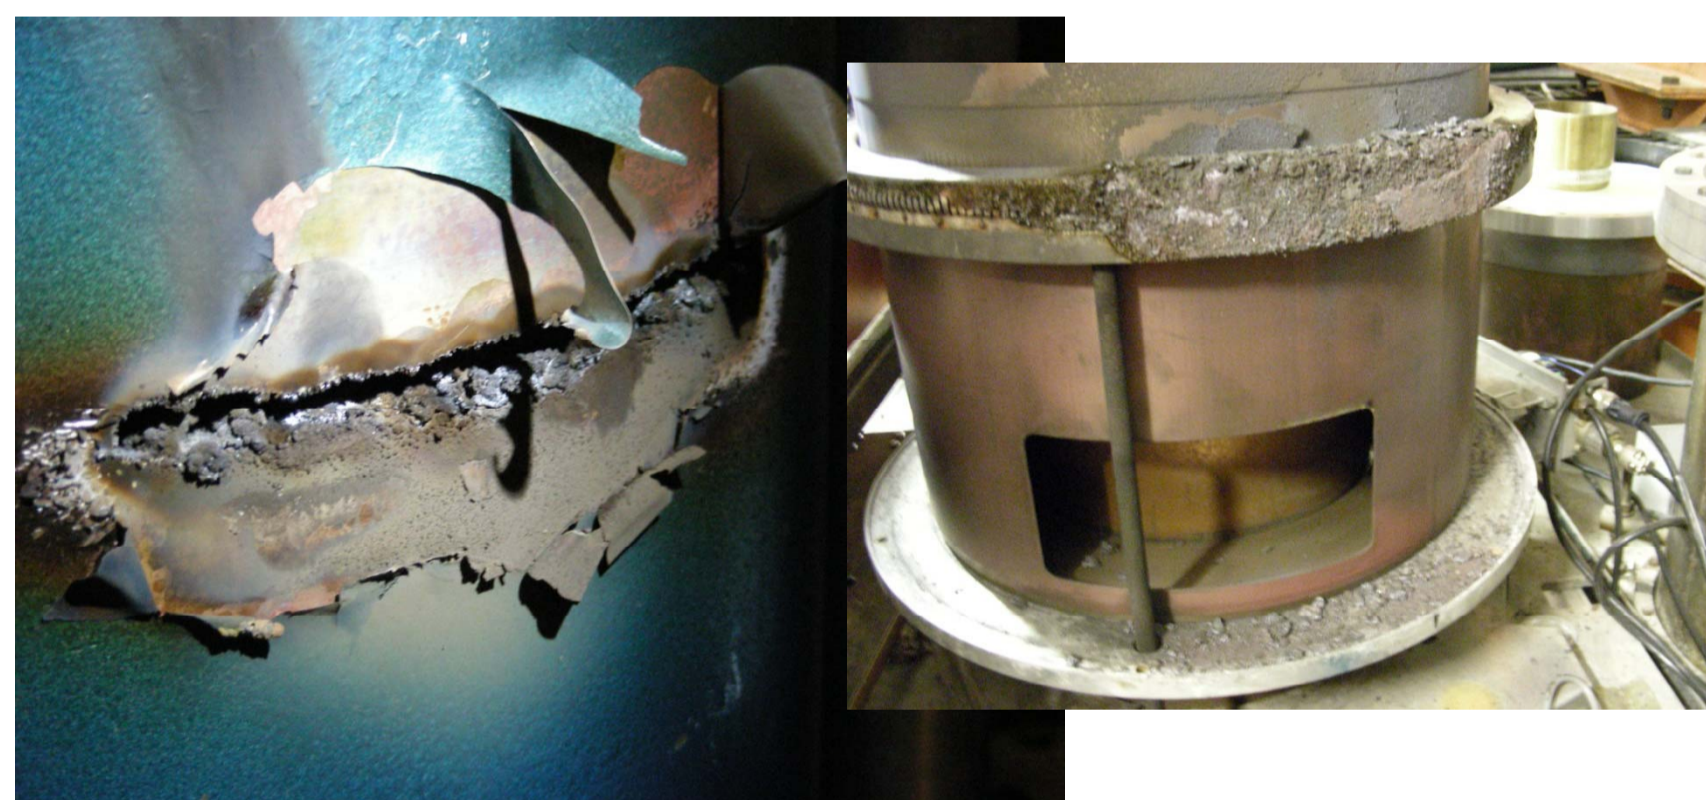
Linac Tank 4 TH116 coaxial circuit - 2MW pulsed RF amplifier, 202.5MHz. The anode tuning ring finger strip, after many years service, failed. Intense sparking occurred and 'cut' the brass outer casing. ISIS was down for approximately one week.

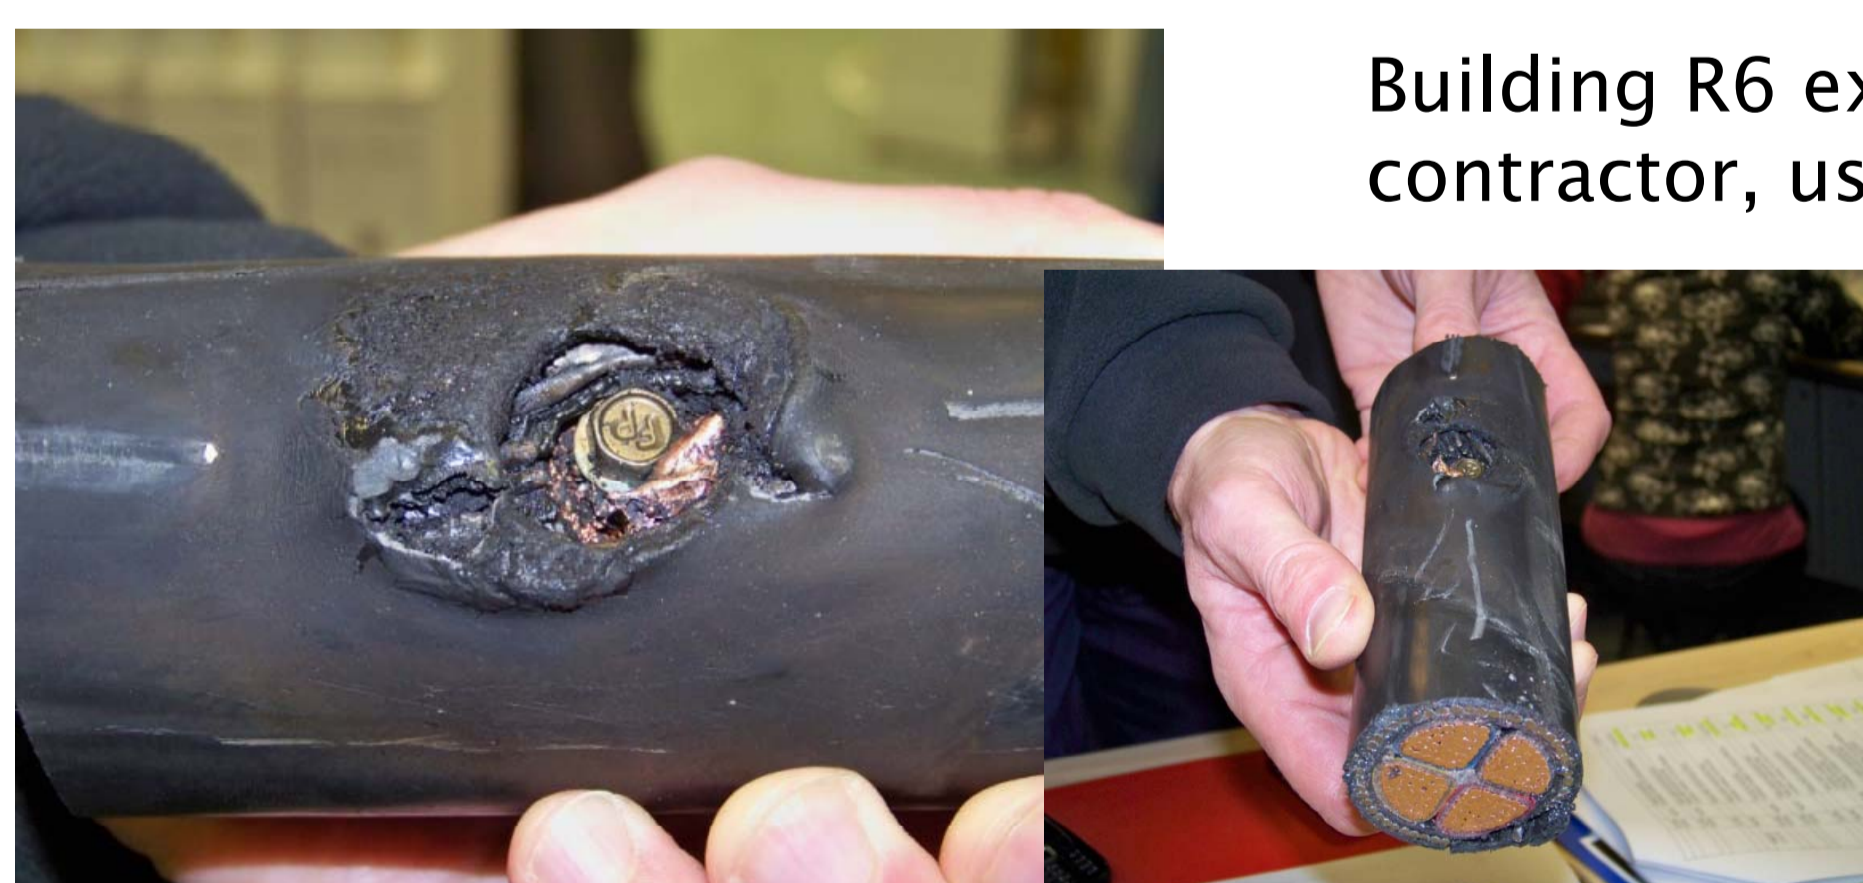
Building R6 external re-cladding - a contractor, using a battery operated drill, successfully drilled a hole for inserting a rivet. He even managed to get the rivet in but was shocked by the result!! No one was badly hurt and it took 4 hours to become operational.

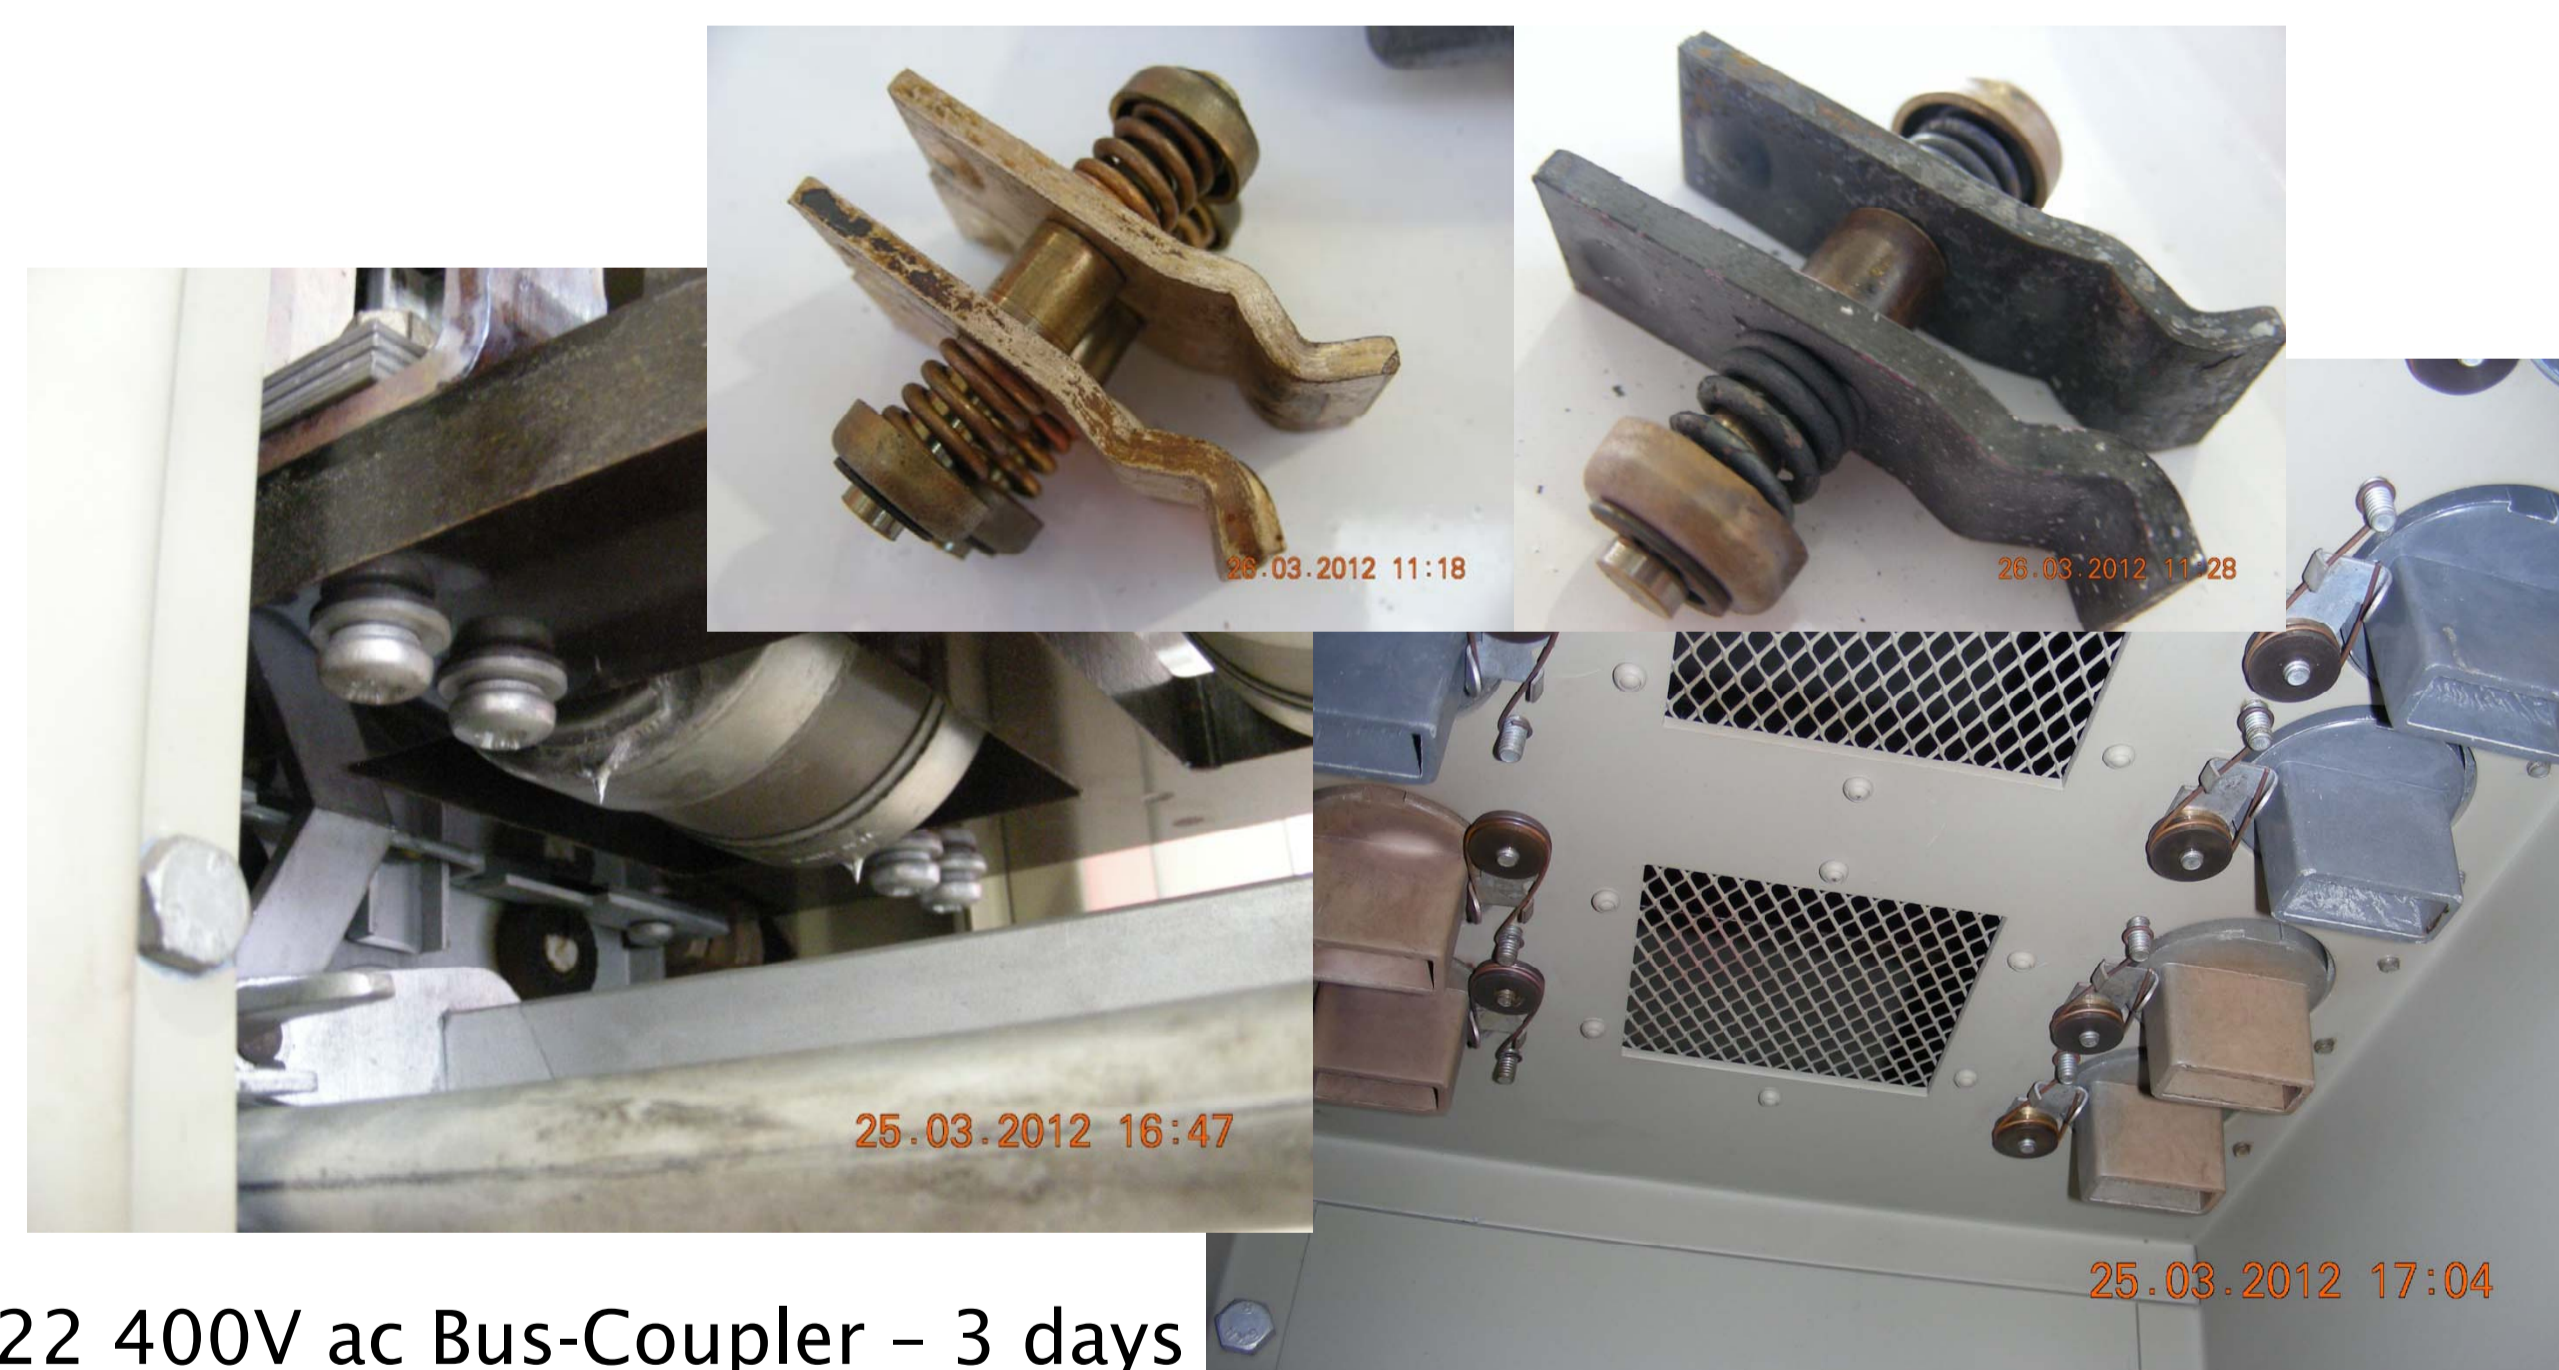
SUB 22 400V ac Bus-Coupler - 3 days lost. No spares! Redundancy is arranged by the operation of the bus coupler. Unfortunately the unit had not been serviced for some time as it was scheduled to be replaced. Problem due to weak springs on the fuse carrier receptacle.

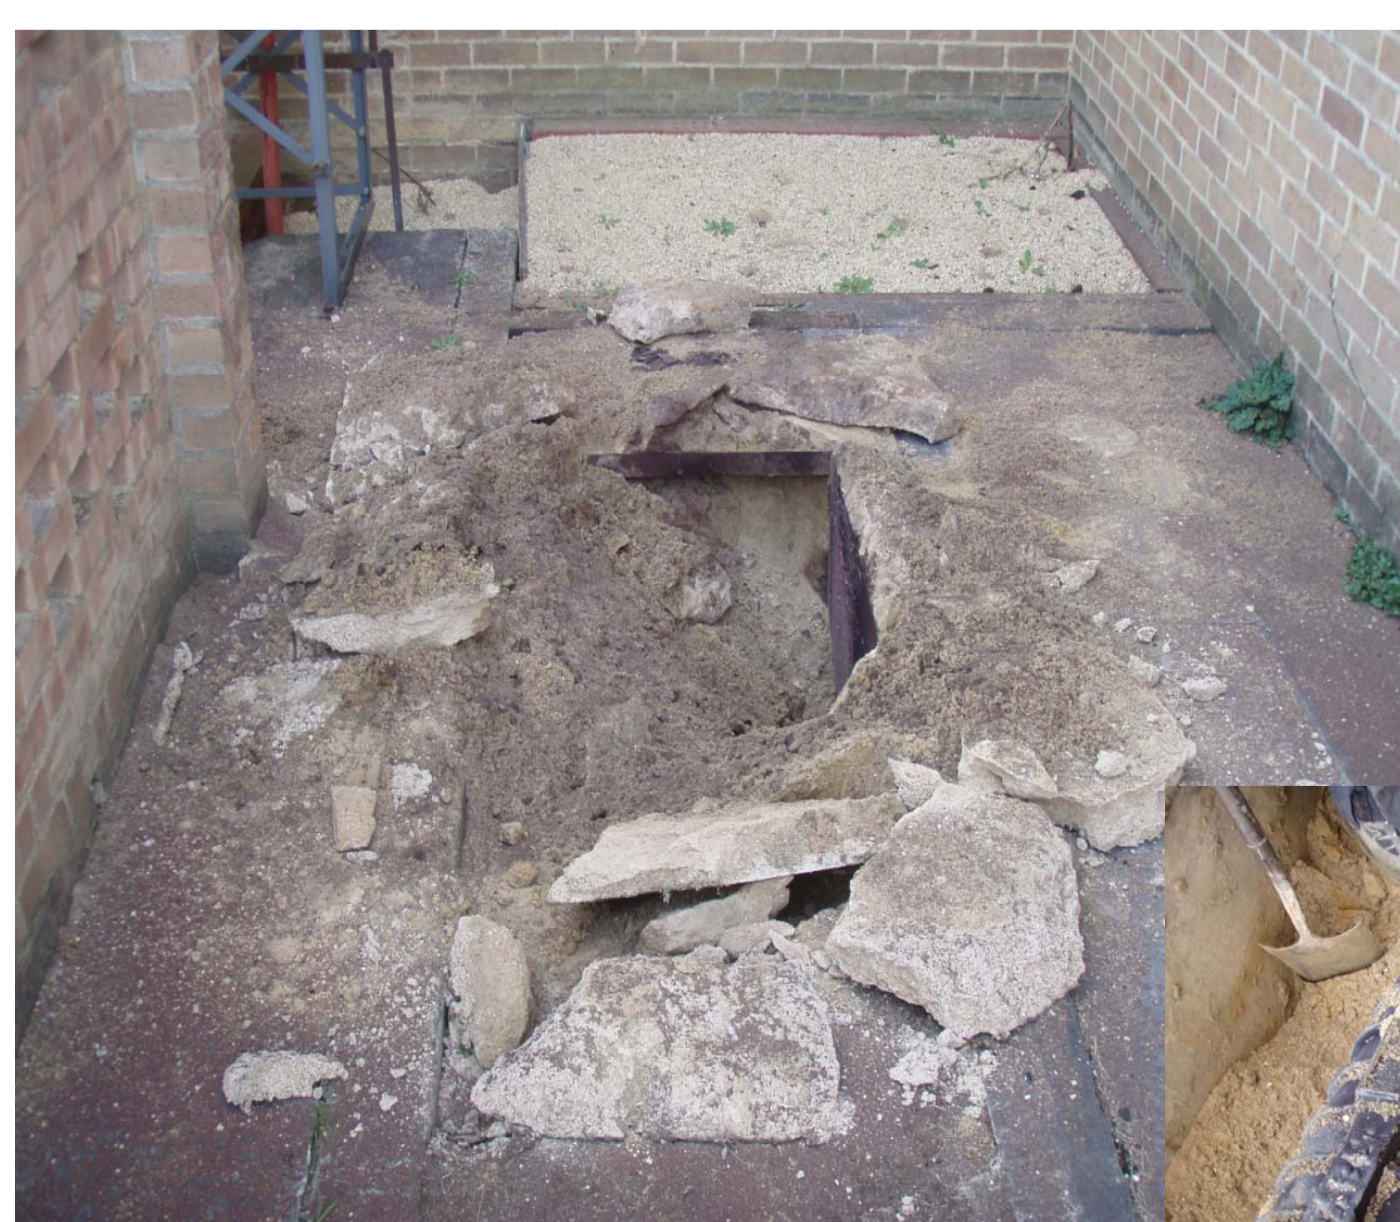
The 11kV Supply from SUB 10 to SUB 12 - Explosion! Fortunately area not accessible, no one was hurt but it was reported that a passer-by had to go home early. ISIS was down for approximately 1 day whilst a new joint was made.

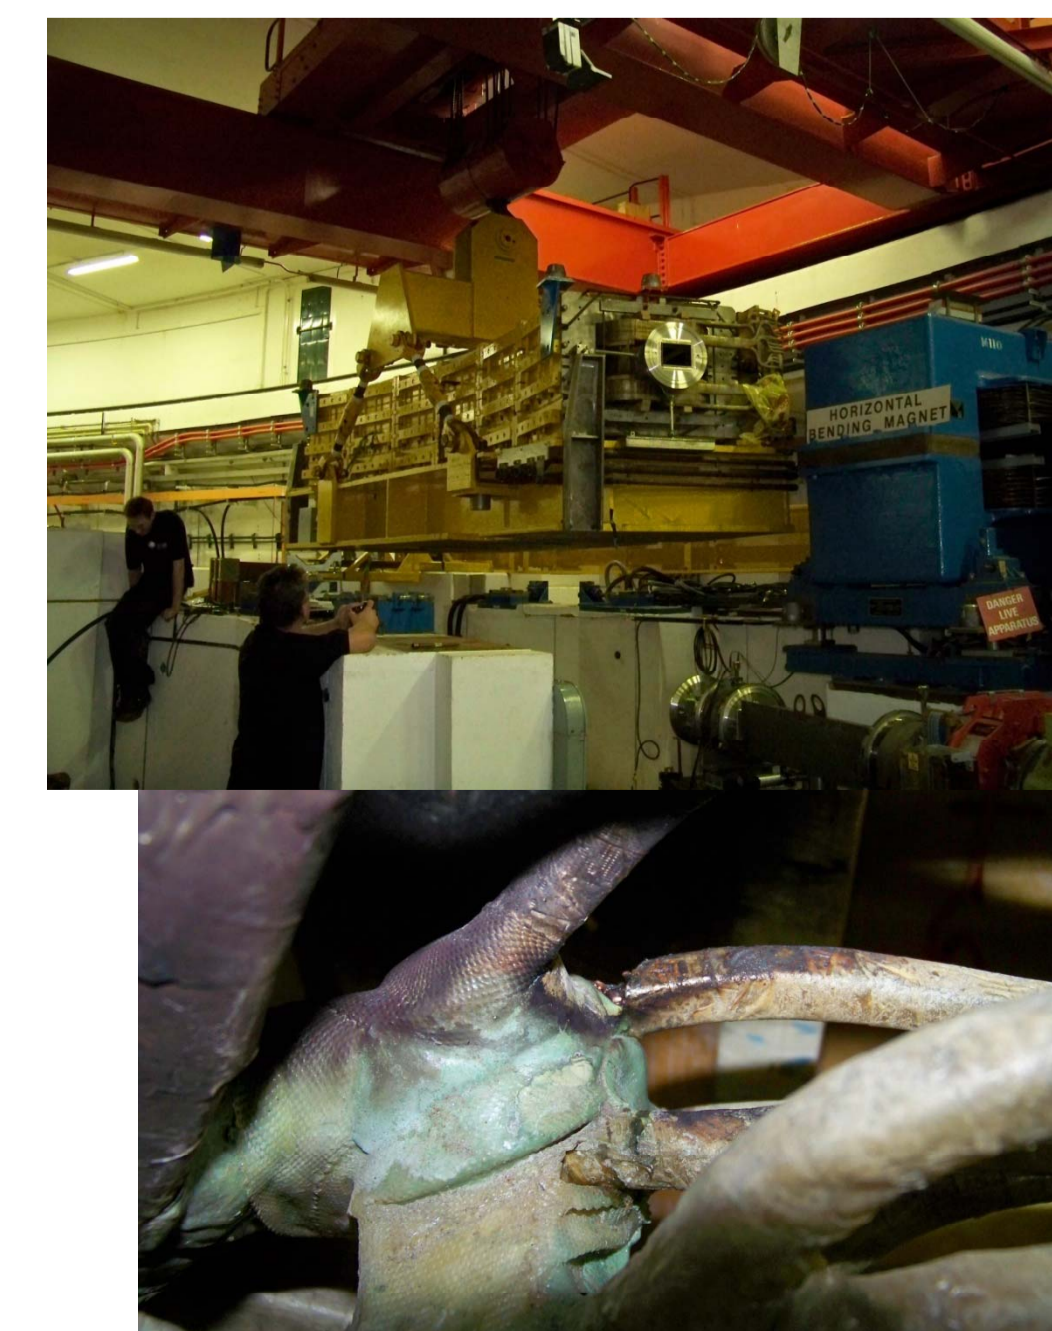
SP2 Dipole winding failure - May 2010, a leak in one of the dipole coils prior to a cycle starting forced a delay in starting up by an extra week. This particular dipole is situated underneath the Extracted Proton Beamline and required EPB components to be removed before the dipole could be accessed. Had this failed during a cycle it would have been 4 weeks off.
