# T24 - 11WNSDvg1.8Cu

Post mortem SEM inspection

A. Toerklep EN/MME  
G. Arnau Izquierdo EN/MME

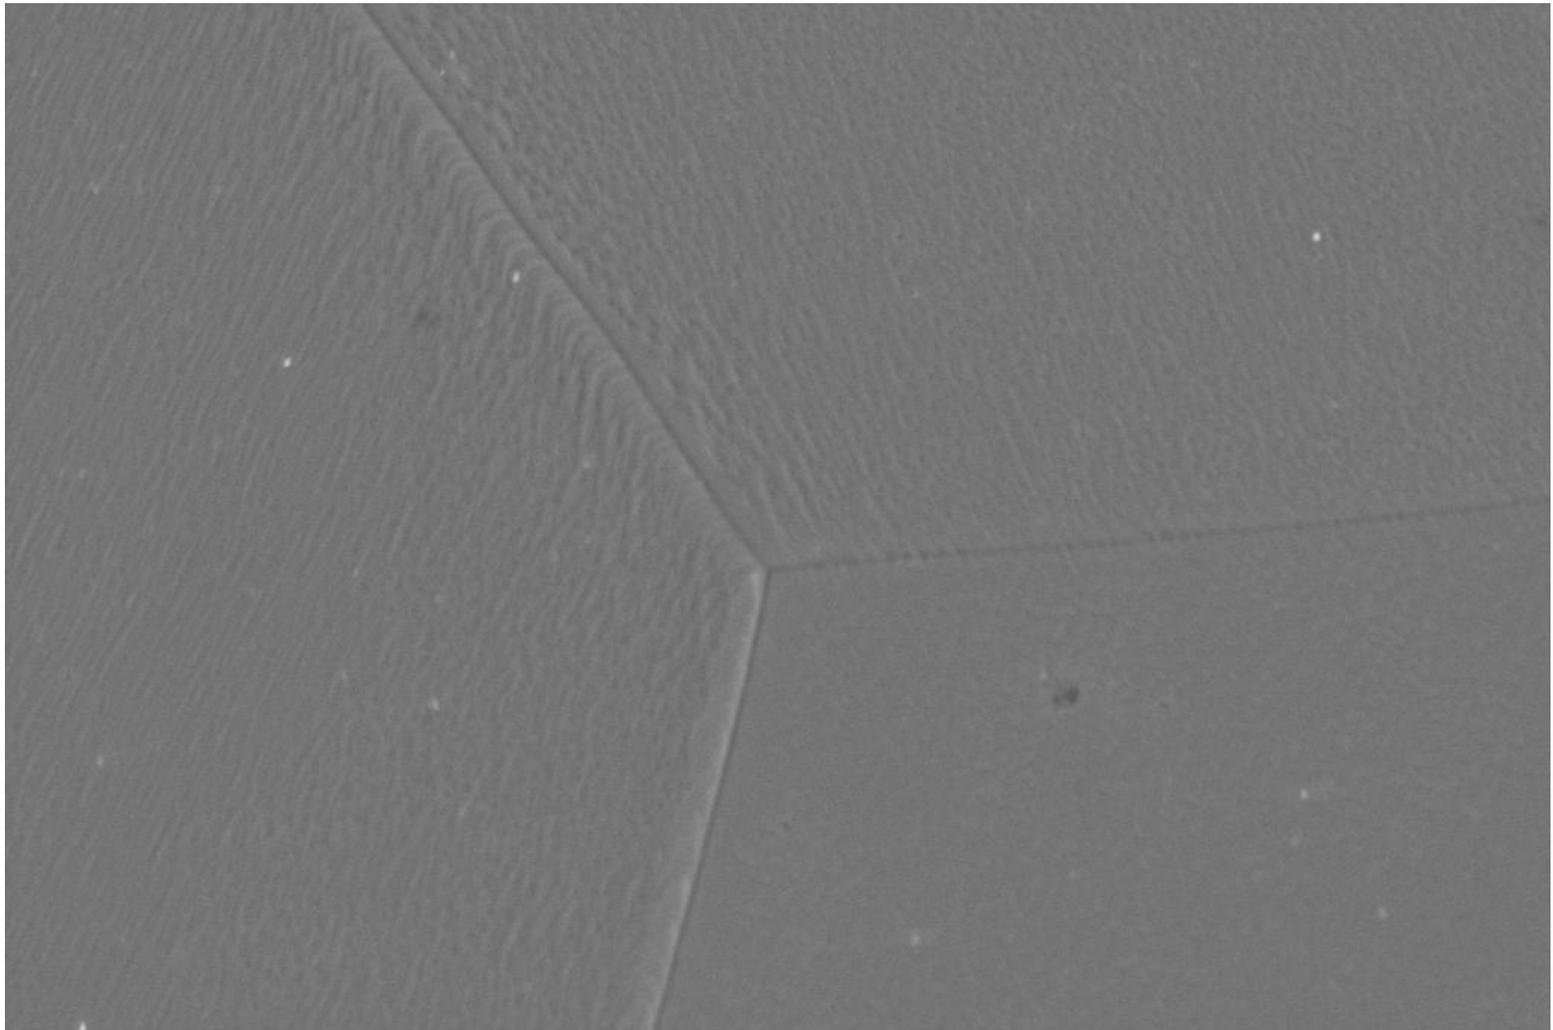
Reference surface (cavity wall away from iris tip):

- Faceting, as expected after vacuum heat treatments
- No traces of sulfur rich precipitates at the grain boundaries

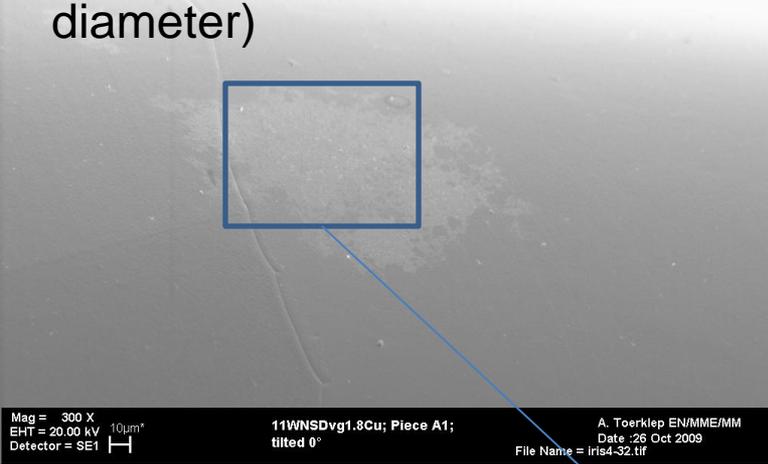
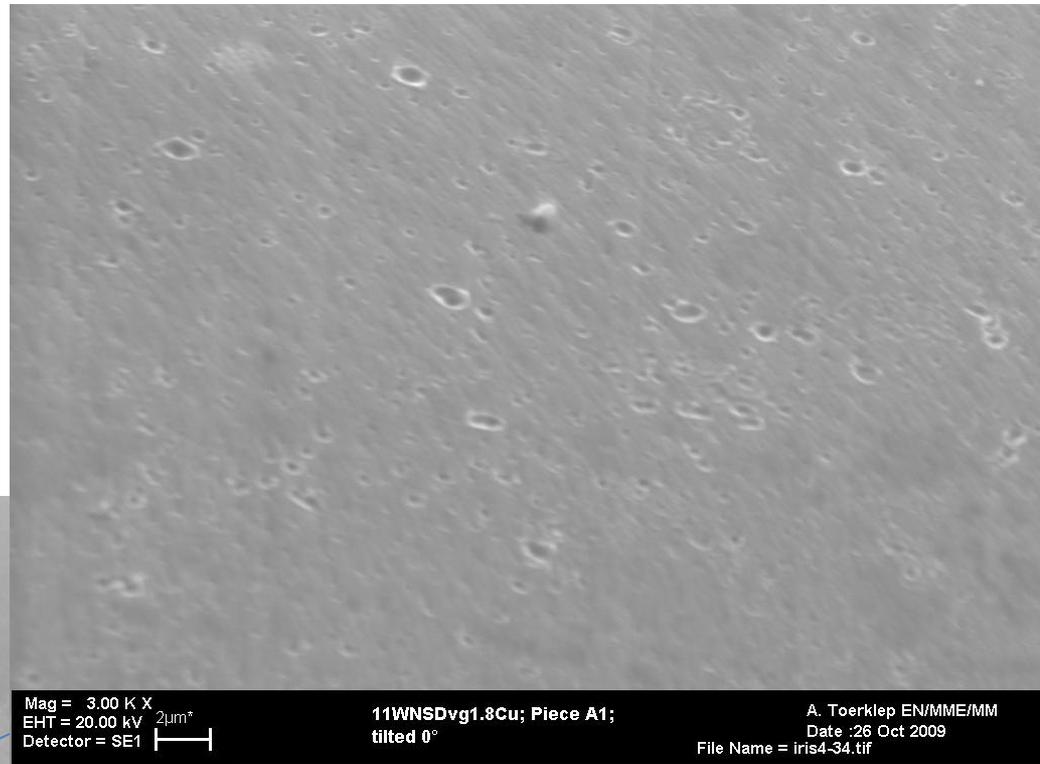
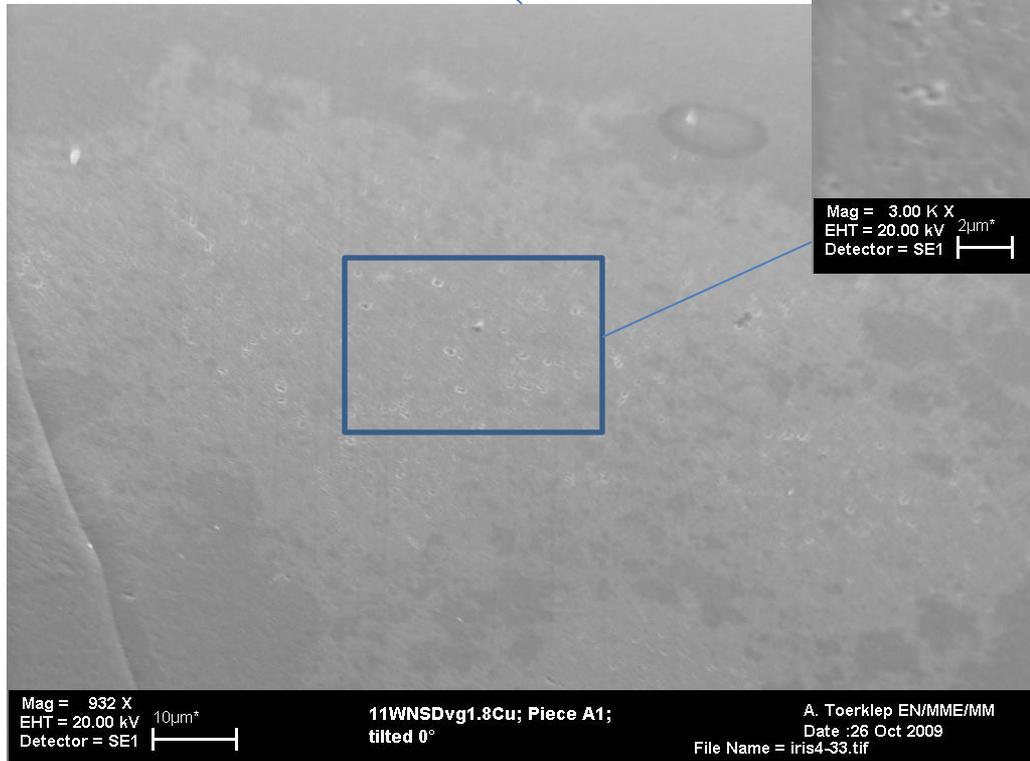
Most common feature are patches with only small craters (~1 $\mu$ m in diameter)

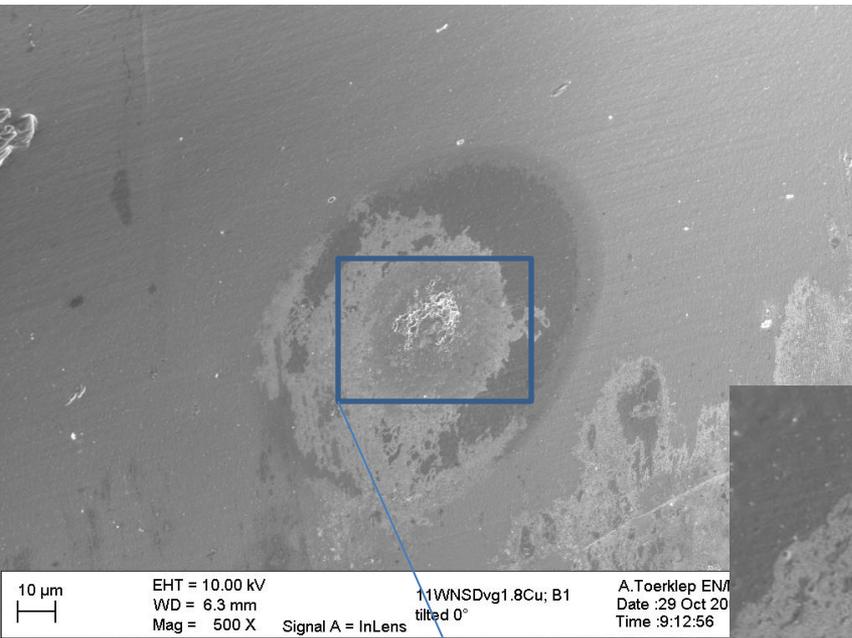
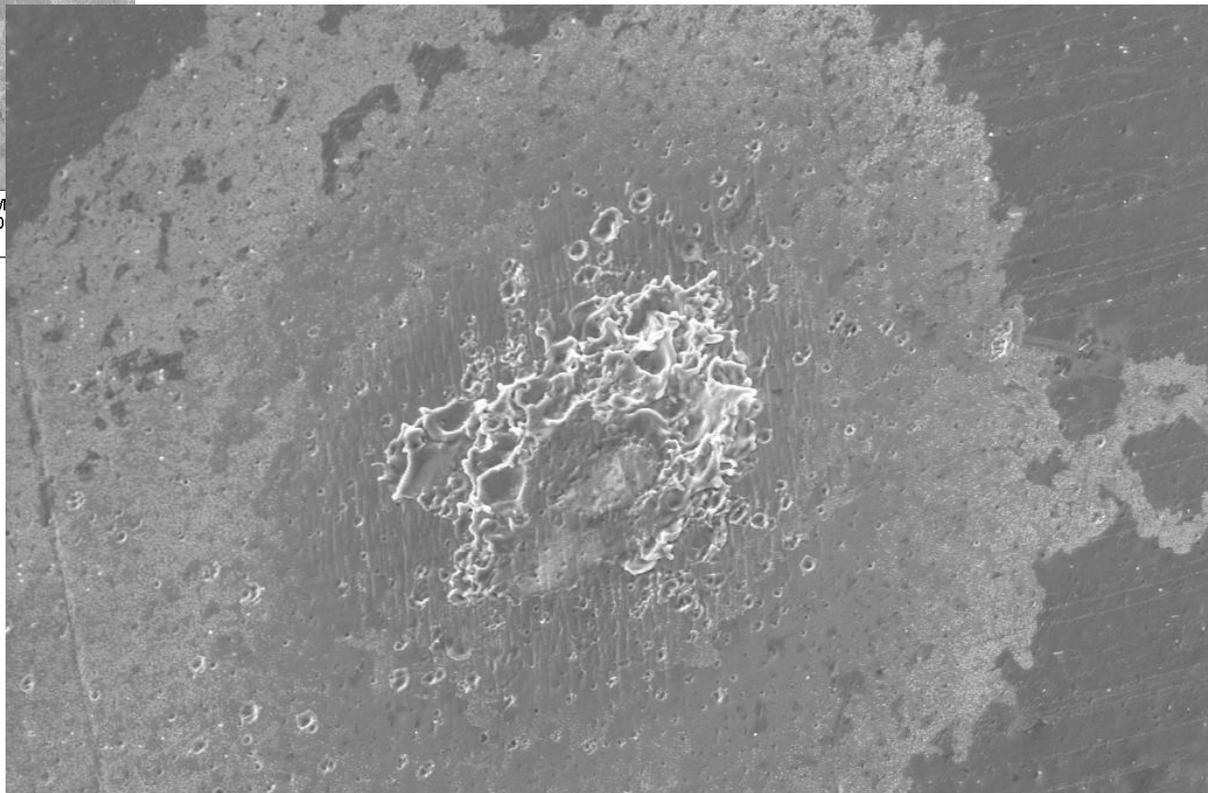
Patches containing bigger craters in the centre are also present but rarer

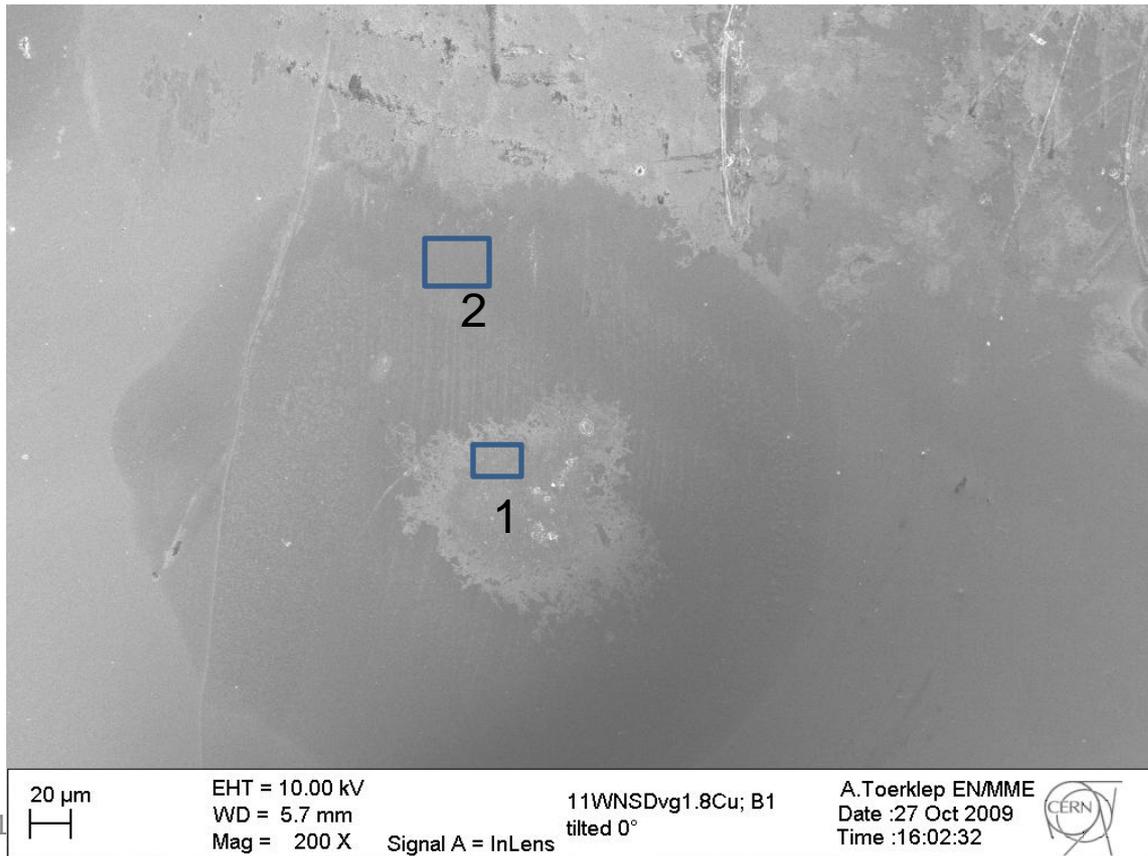
In some cases there are dark halos around the areas of activity

- Both areas show Cu with traces of C and O.
- Dark halos ( ) have slightly higher content of carbon (ex. area 2 vs area 1, 2% vs 1% from semi-quantitative EDS analysis)
- Some carbonaceous contaminant may have been vaporized during the thermal treatments or by the breakdown activity

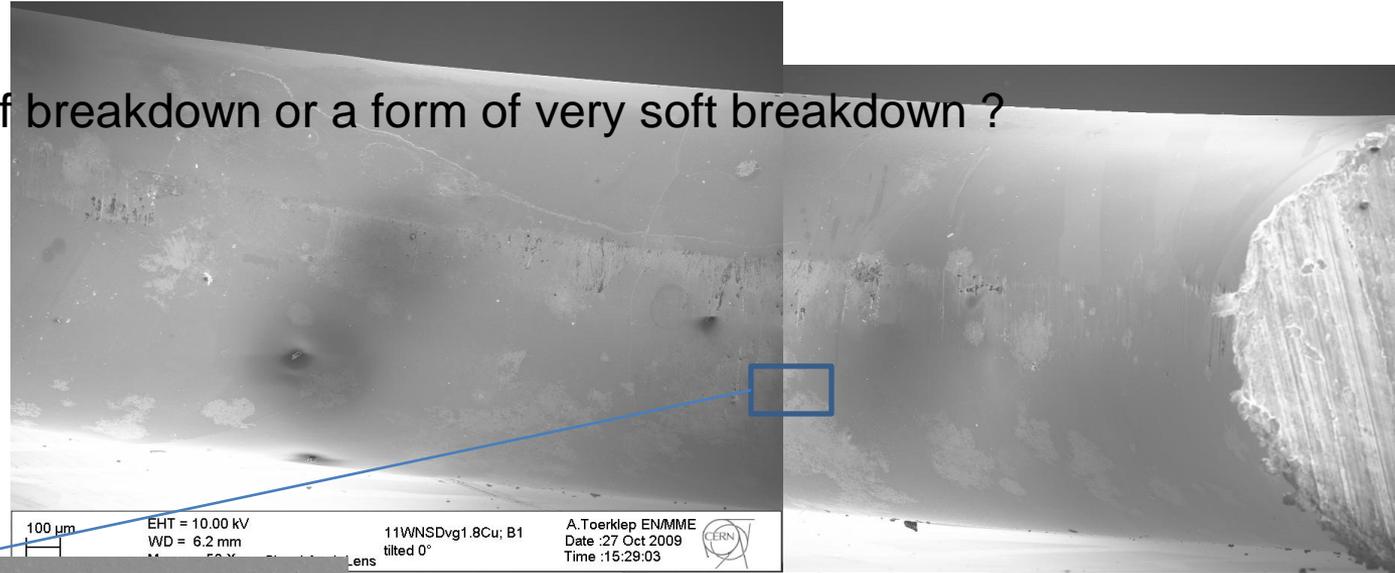
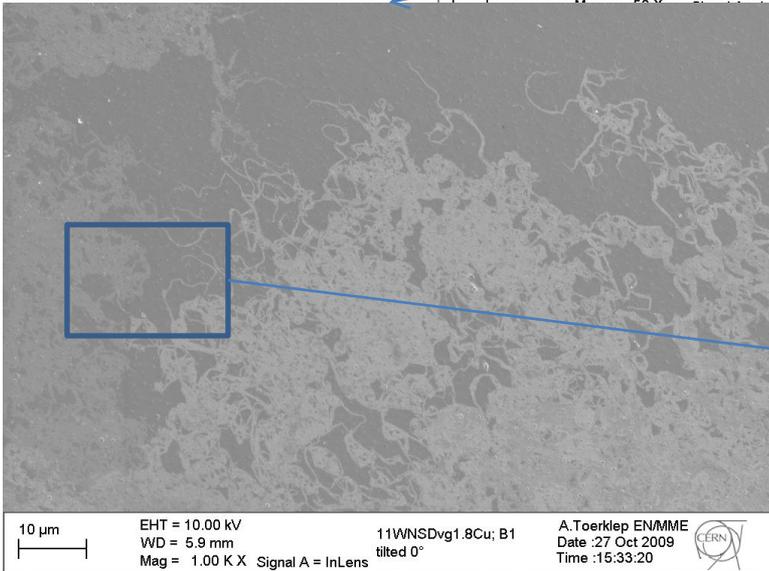
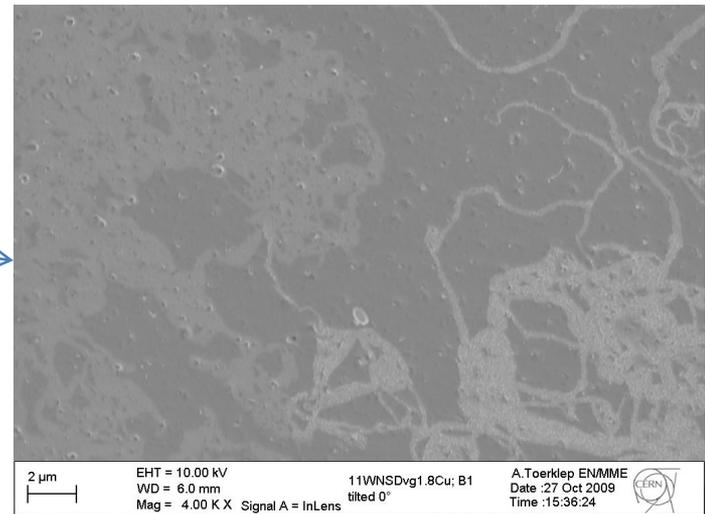
# Worm-like features

In most of the patches of activity the edges are not sharp but seem to be made of a mess of wrinkled lines

Is it a kind of prelude of breakdown or a form of very soft breakdown ?

Worm-like features are are:

- Very superficial, as seen from images. The contrast seen may be due reduction of some vey surface oxidation or contamination.
- Due to the RF, it appear in the region of the iris only, not in the other walls of the structure. also because in the middle the are (small) craters.
- More or less noticeable depending on the observation conditions (angle, detector)

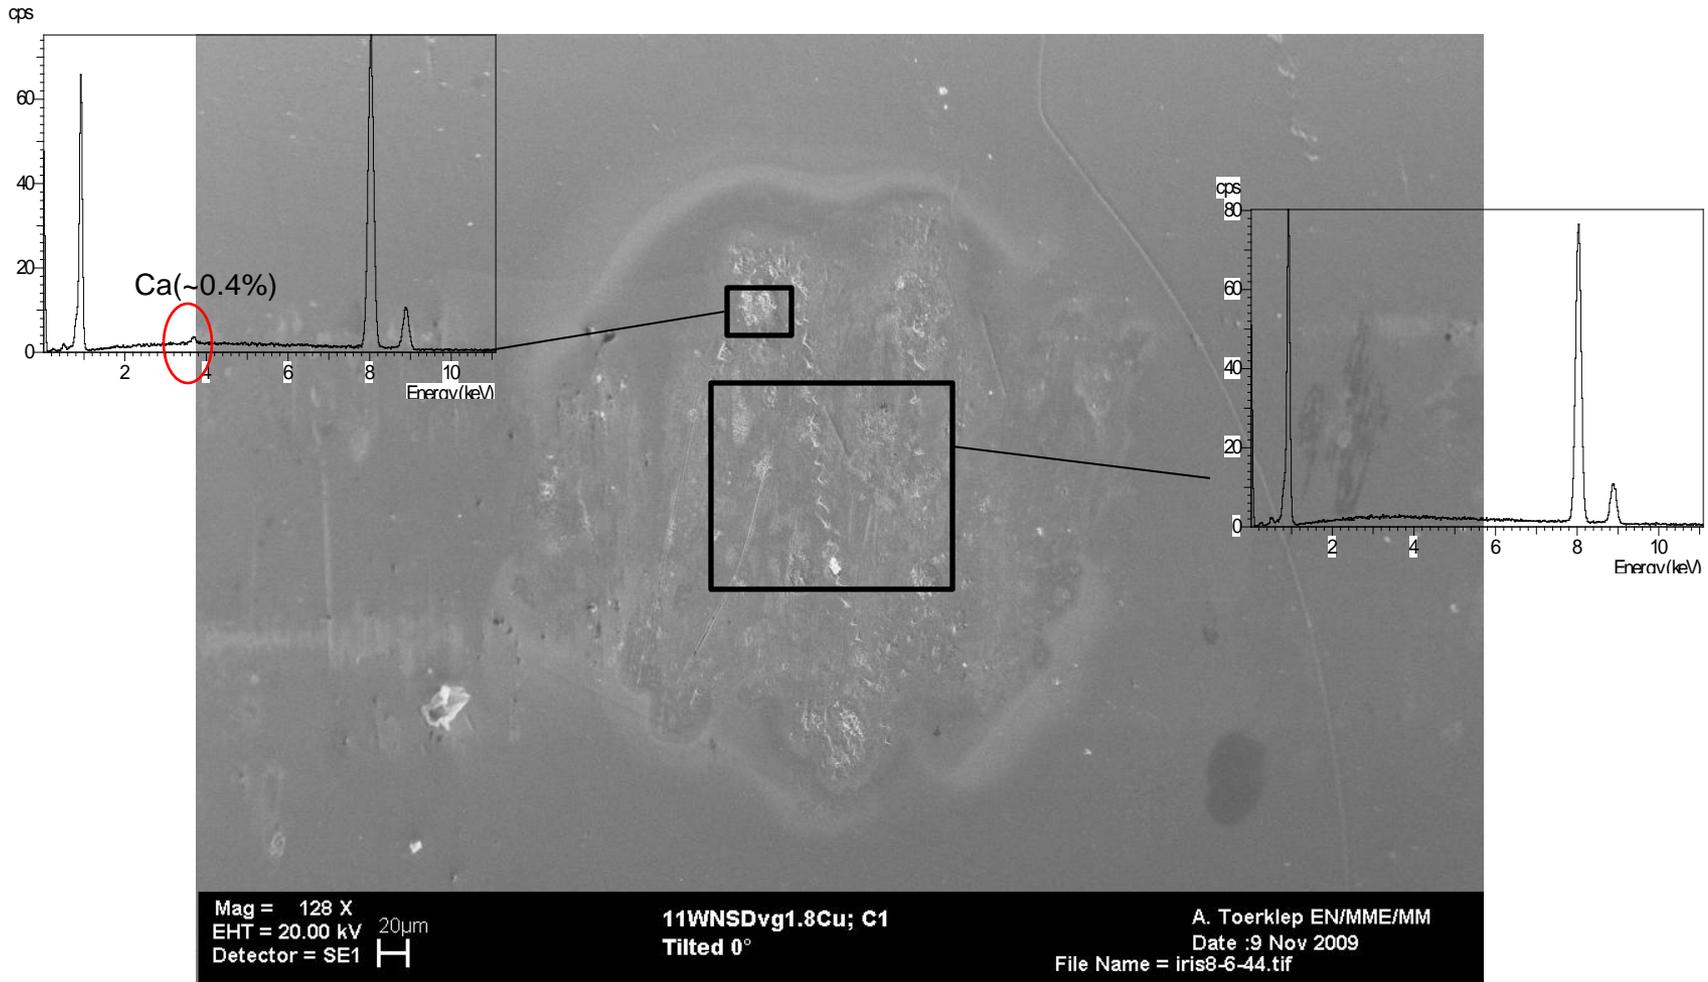
- EDS analysis in several breakdown areas show that the main traces accompanying the Cu signal are C and O
- One singular case was found with traces of Ca:

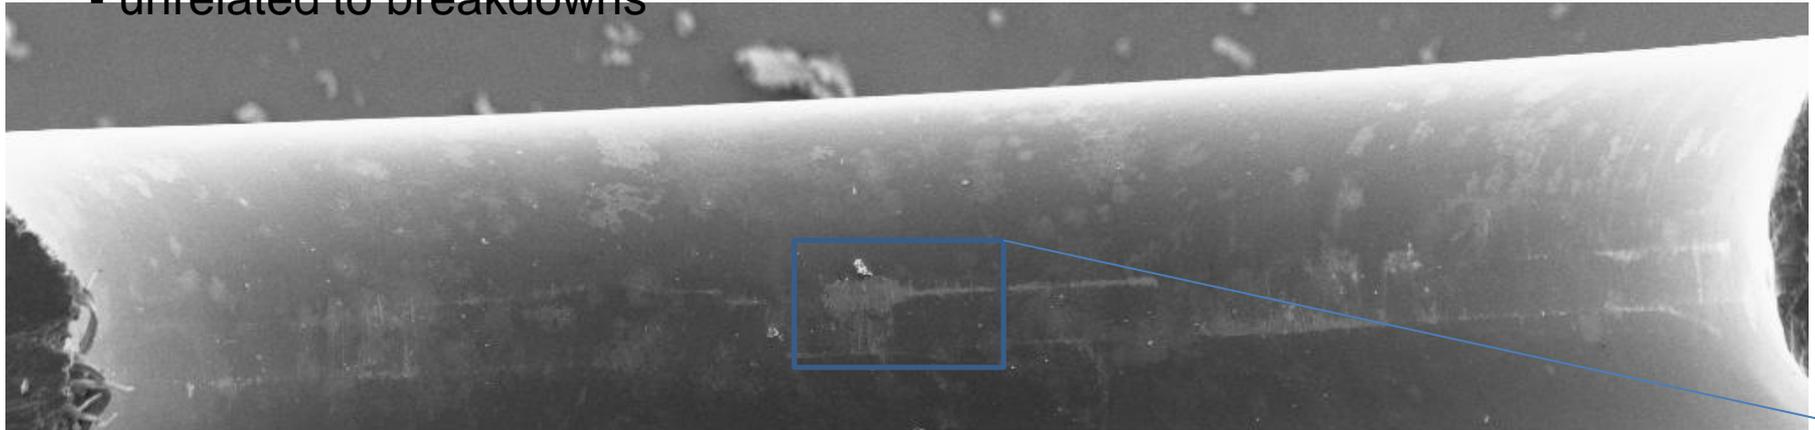
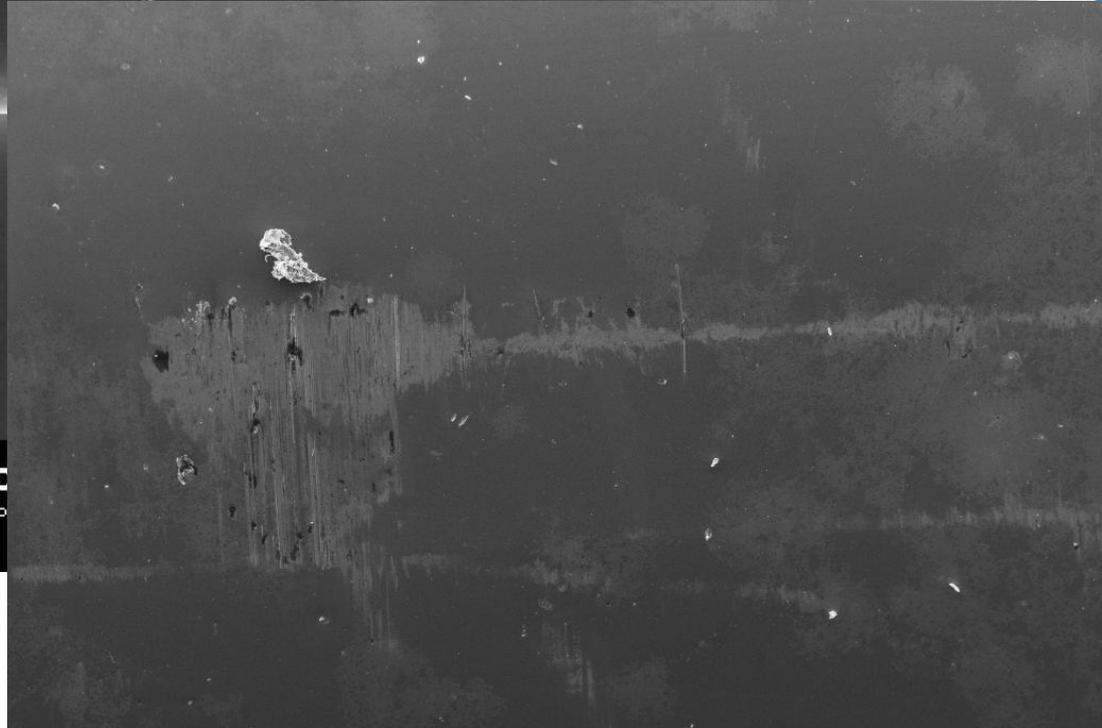
# Scratches

- on the flat top of every iris
- unrelated to breakdowns

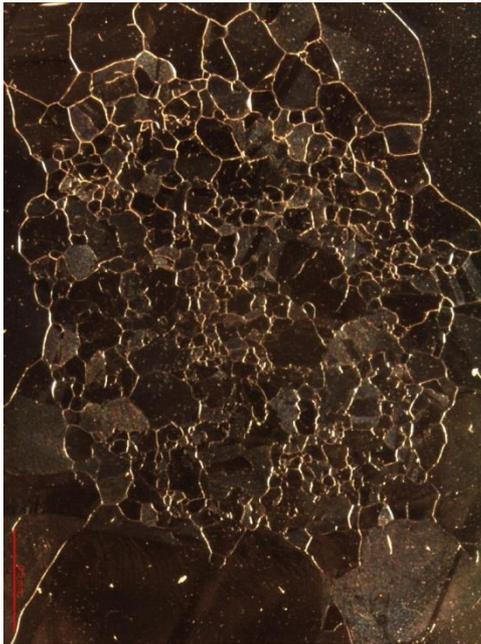
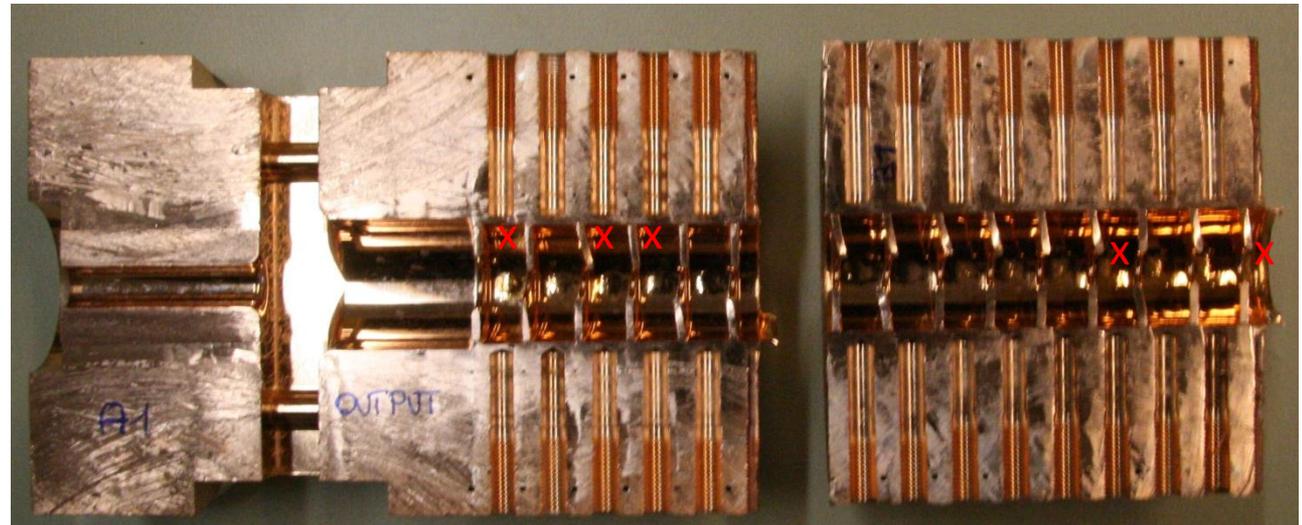
## Small crystals in regions deformed by tuning

- Explained by the recrystallization during the last heat cycle (removal of oxide) of regions that have cumulated plastic deformation during tuning
- No breakdown activity

**X** – small grain size from tuning

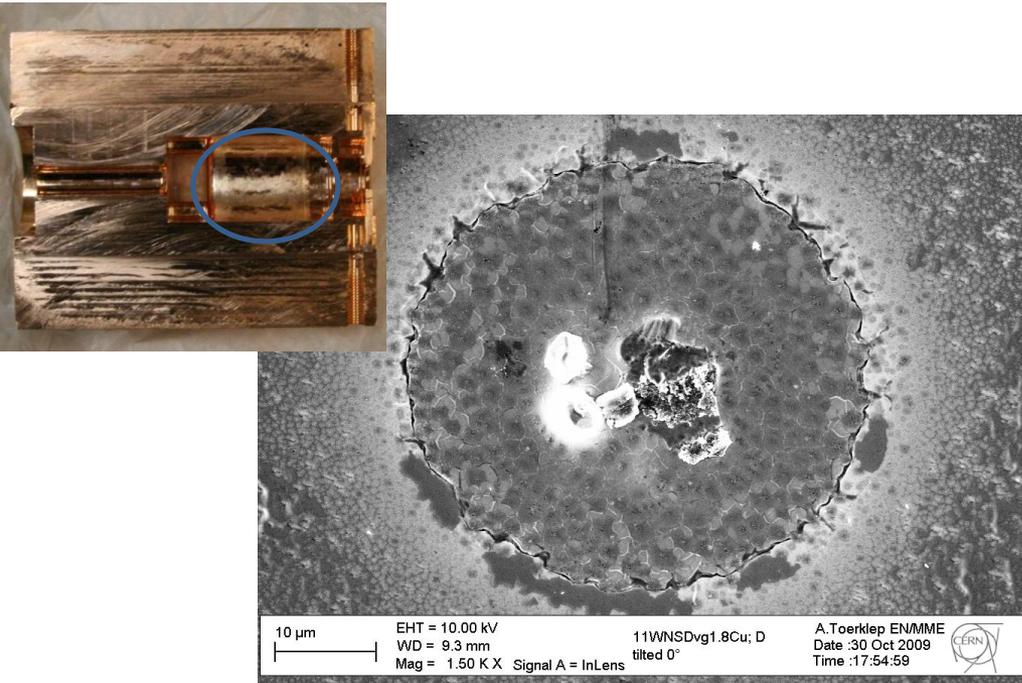
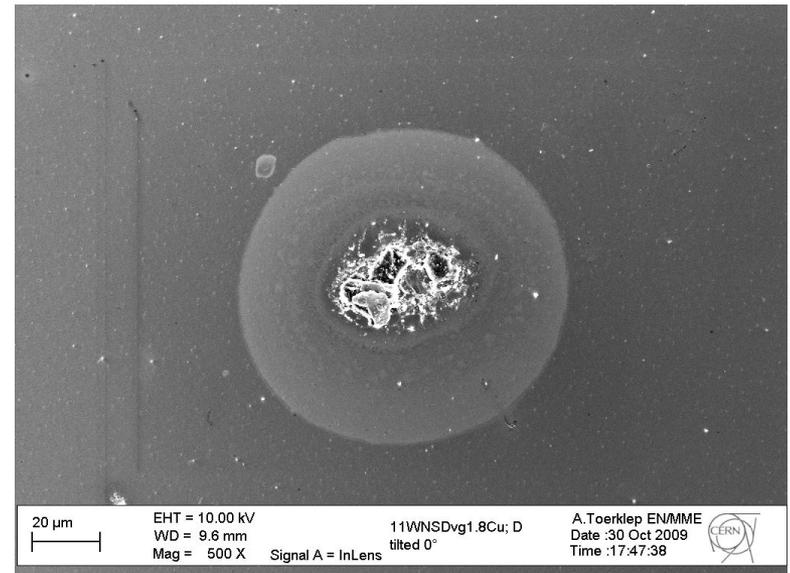
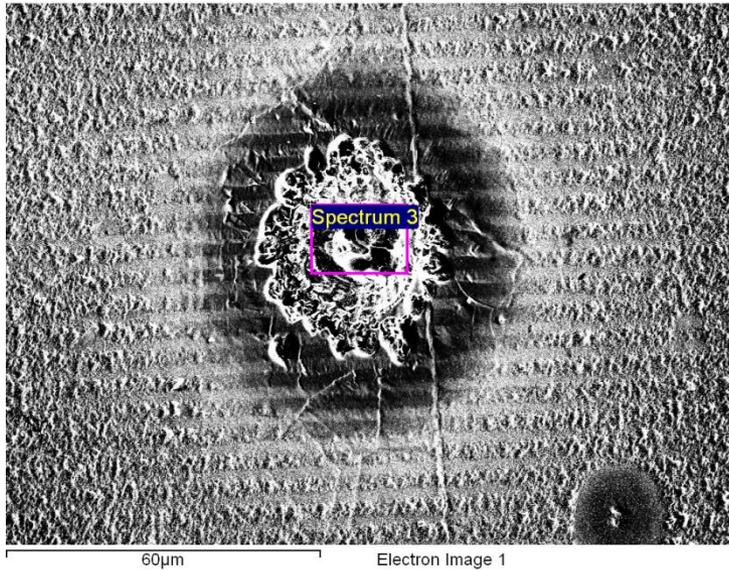
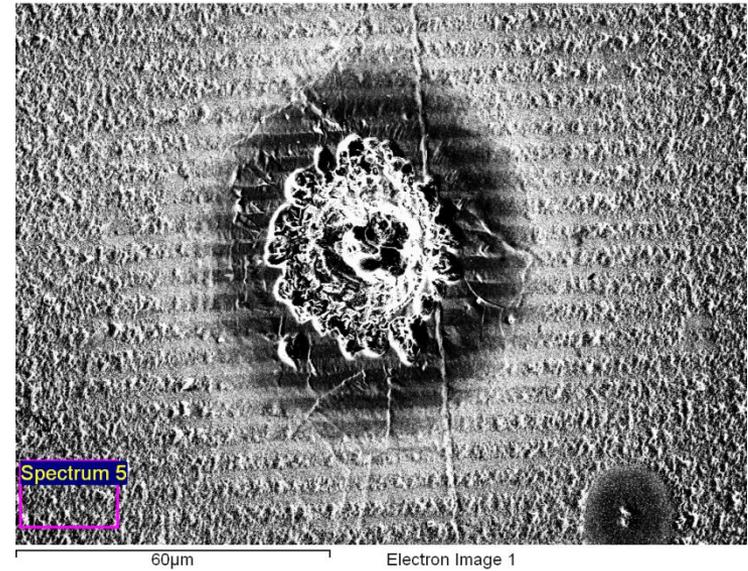
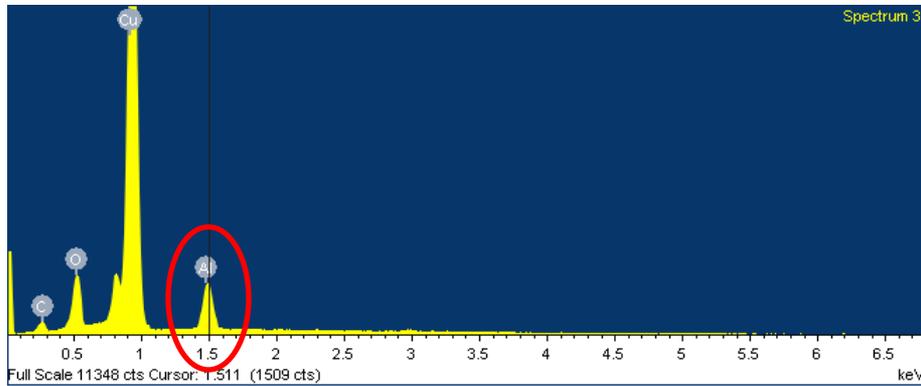
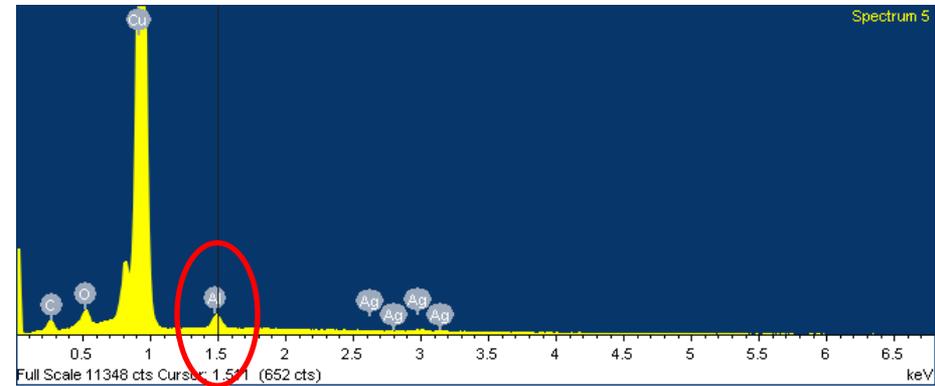
## Localised Al contamination on the inner surface of couplers

- Most probable cause is the presence of aluminum small particles laying on the surface that melted and combined with Cu during the brazing cycle
- No evidence of breakdown activity associated to them

All of the features shows aluminium.

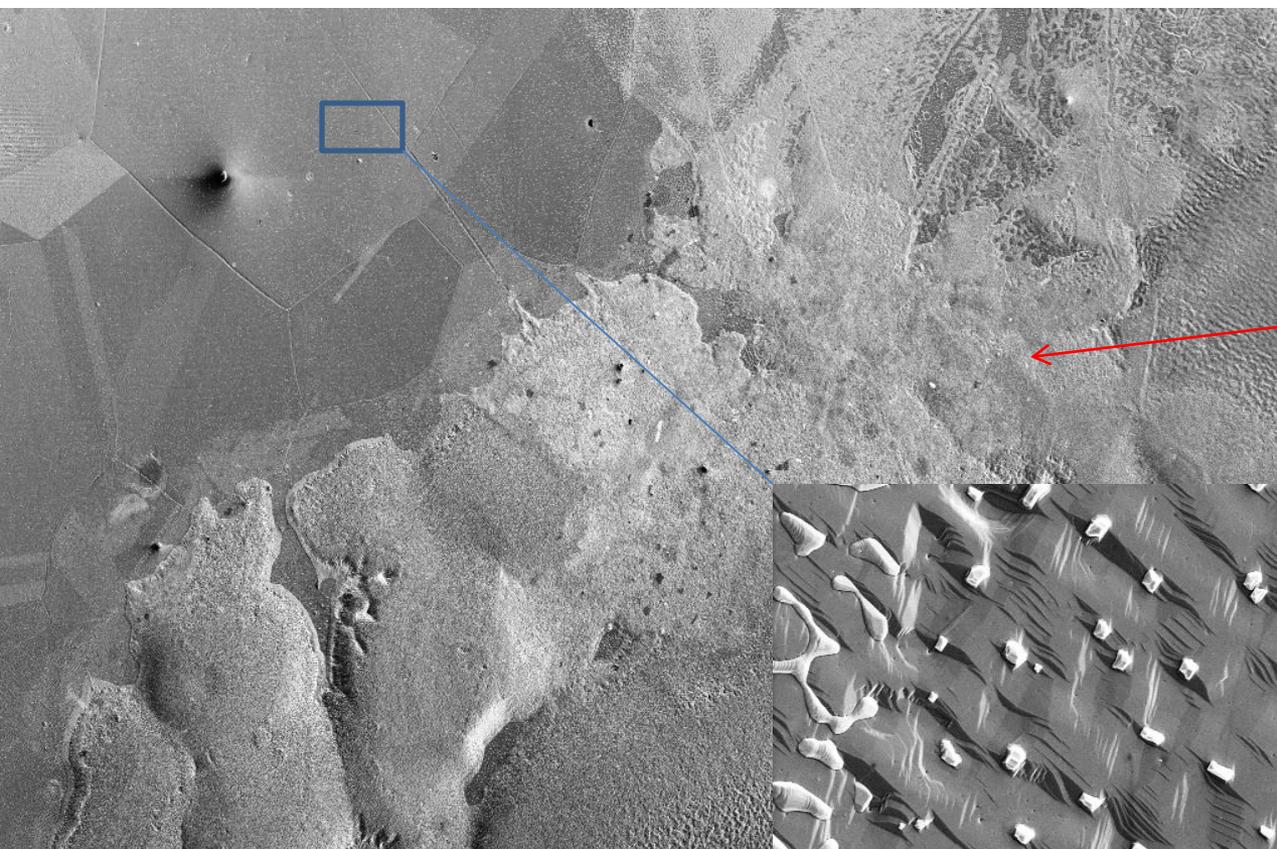
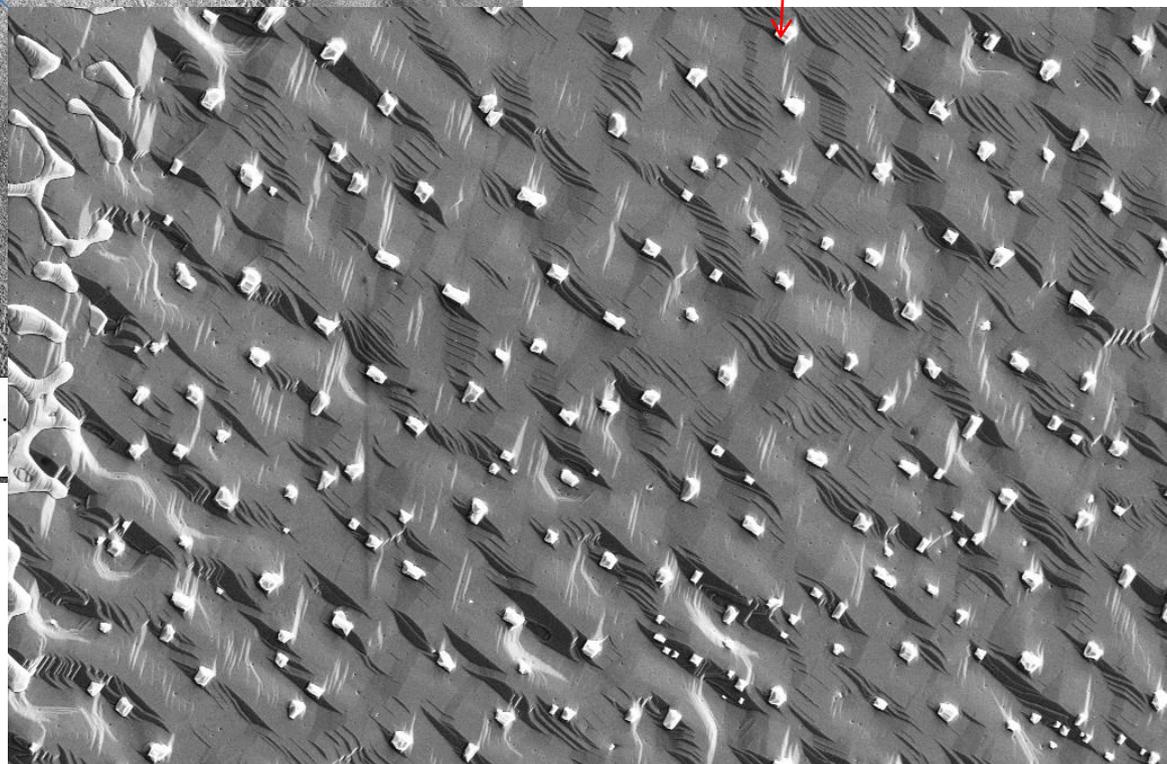
# Brazing – input coupler

- No activity related to brazing material.

Brazing material

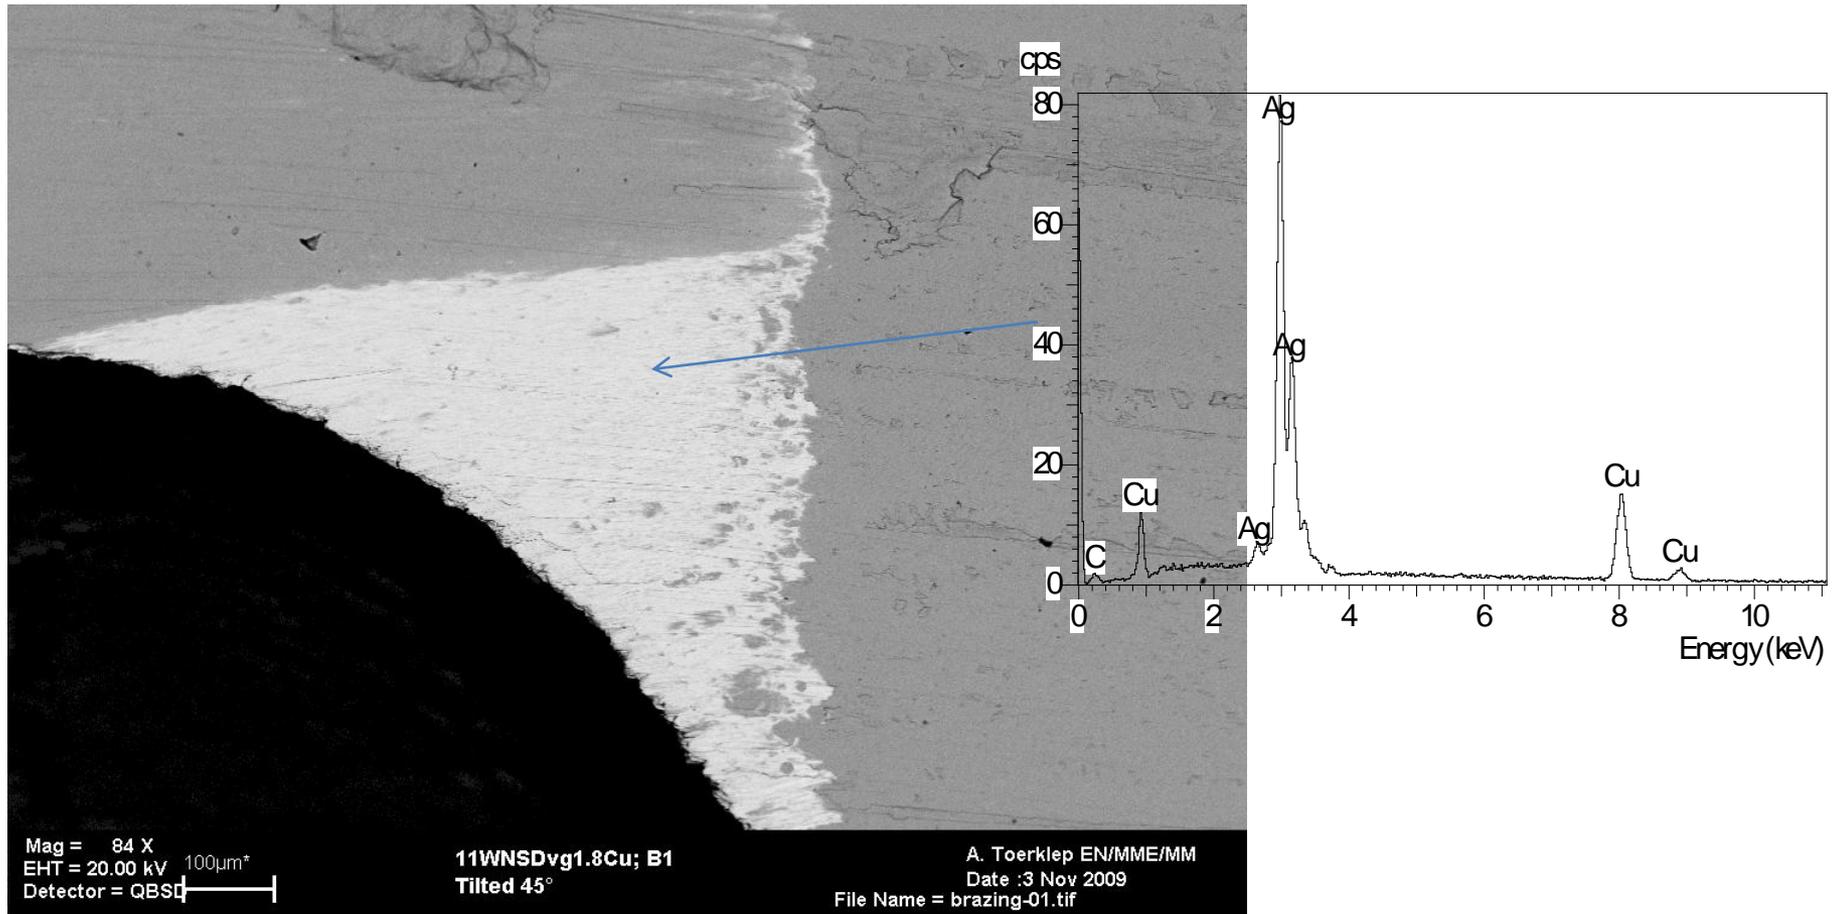
## Brazing – Output coupler.

- No traces of Palladium. (semi-quantitative results)
- Could be Ag-Cu eutectic instead of SCP1
- Cutting of sample would be needed for confirmation.
