# HIGH POWER KLYSTRON STATUS AT THE PHOTON FACTORY INJECTOR LINAC

S.Fukuda, S.Anami, T.Shidara, Y.Saito, H.Homma, K.Nakao, H.Hanaki and J.Tanaka  
 National Laboratory for High Energy Physics  
 Oho-machi, Tsukuba-gun, Ibaraki-ken, 305, Japan

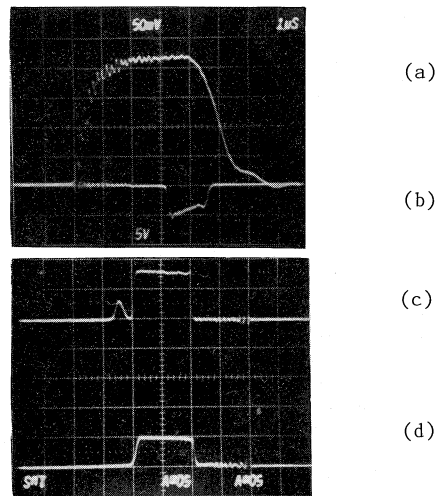
Diode oscillation is observed in 5 tubes. Generally the performance of these tubes are normal at the KEK test when delivered from the vendor, but oscillation occurs after a few hundred hours operation runs. This fact may mean that the cause is by getting worse the symmetrical cathode loading or the some part of the cathode. Frequency of this oscillation can be picked out from the pulse transeformer tank or input rf plug without any drive rf power and generally distribute to the range of 3.2-3.5 GHz. Theoretically this oscillation occurs inevitably at the some beam voltage under the space charge limited operation of the gun. Temporary way to quit oscillation is to lower the beam voltage below the threshold or heater voltage nearly to the temperature limited operation. Almost all these oscillating tubes barely quit oscillations in this way. Figure 3 shows the photograph of the wave shape of the diode oscillation.

Figure 3. Wave shape of the diode oscillation. (a) Pulse beam current, (b) Oscillation waveform without drive rf, observed from the input port, (c) Drive rf waveform without diode oscillation, and (d) with diode oscillation.
