## Floor Level Fluctuation in Accelerator Tunnel

Masashi J.SHIRAKATA, Hikaru SATO, Katsumi MARUTSUKA  
and Noboru TOKUDA

High Energy Accelerator Research Organization,  
1-1 Oho Tsukuba Ibaraki 305, JAPAN

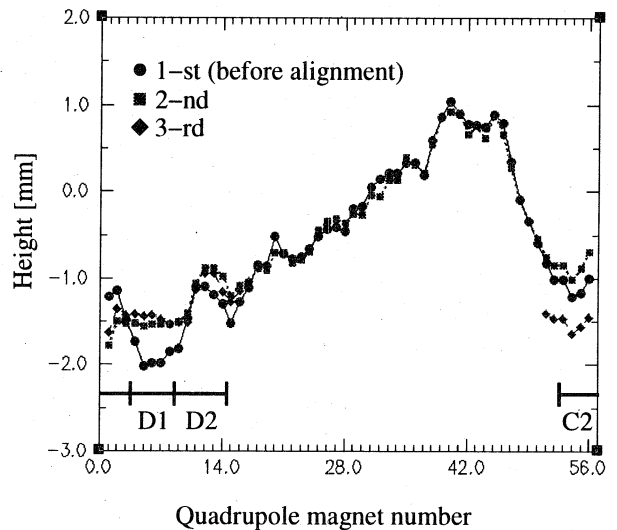
Figure 1. Height of Quadrupole magnets

In this work, a significant unconformity of the magnet height which became about 1 mm was observed by the second height measurement. The height of the

Height zero corresponds to the height of the exit of the booster synchrotron

quadrupole magnet differed after a round trip. It must be notified that the quadrupole magnets No.3 to 9 have already been adjusted to the No.2 (called I-1D) by the alignment work. In the first height measurement, magnet No.3 to 10 were apparently located lower with respect to the No.2. After the weekend these magnets became higher, especially for No.10, it became already higher than No.2, which is the reference magnet.

The floor level unconformity shown in Fig.1 can be explained by assuming these conditions:

- (1) Plate C2 is inclined (downstream end is LOWER)
- (2) Plate D1 is inclined (downstream end is HIGHER)
- (3) Plate D2 is raised

time before beginning the alignment work because of the weekend. There was a heavy rain from the Sunday to the Monday morning after long sunny days. It is supposed that plenty of water of this rain might move the floor plates in the main ring tunnel. In the third height measurement, the magnet height can be seen returning to the first state. The quadrupole magnets around the joint of the plates C2 and D1, and those on the plate D2 became higher compared to the second measurement. It collaterally supports the assumption that the rain makes the floor plates move upward and downward.

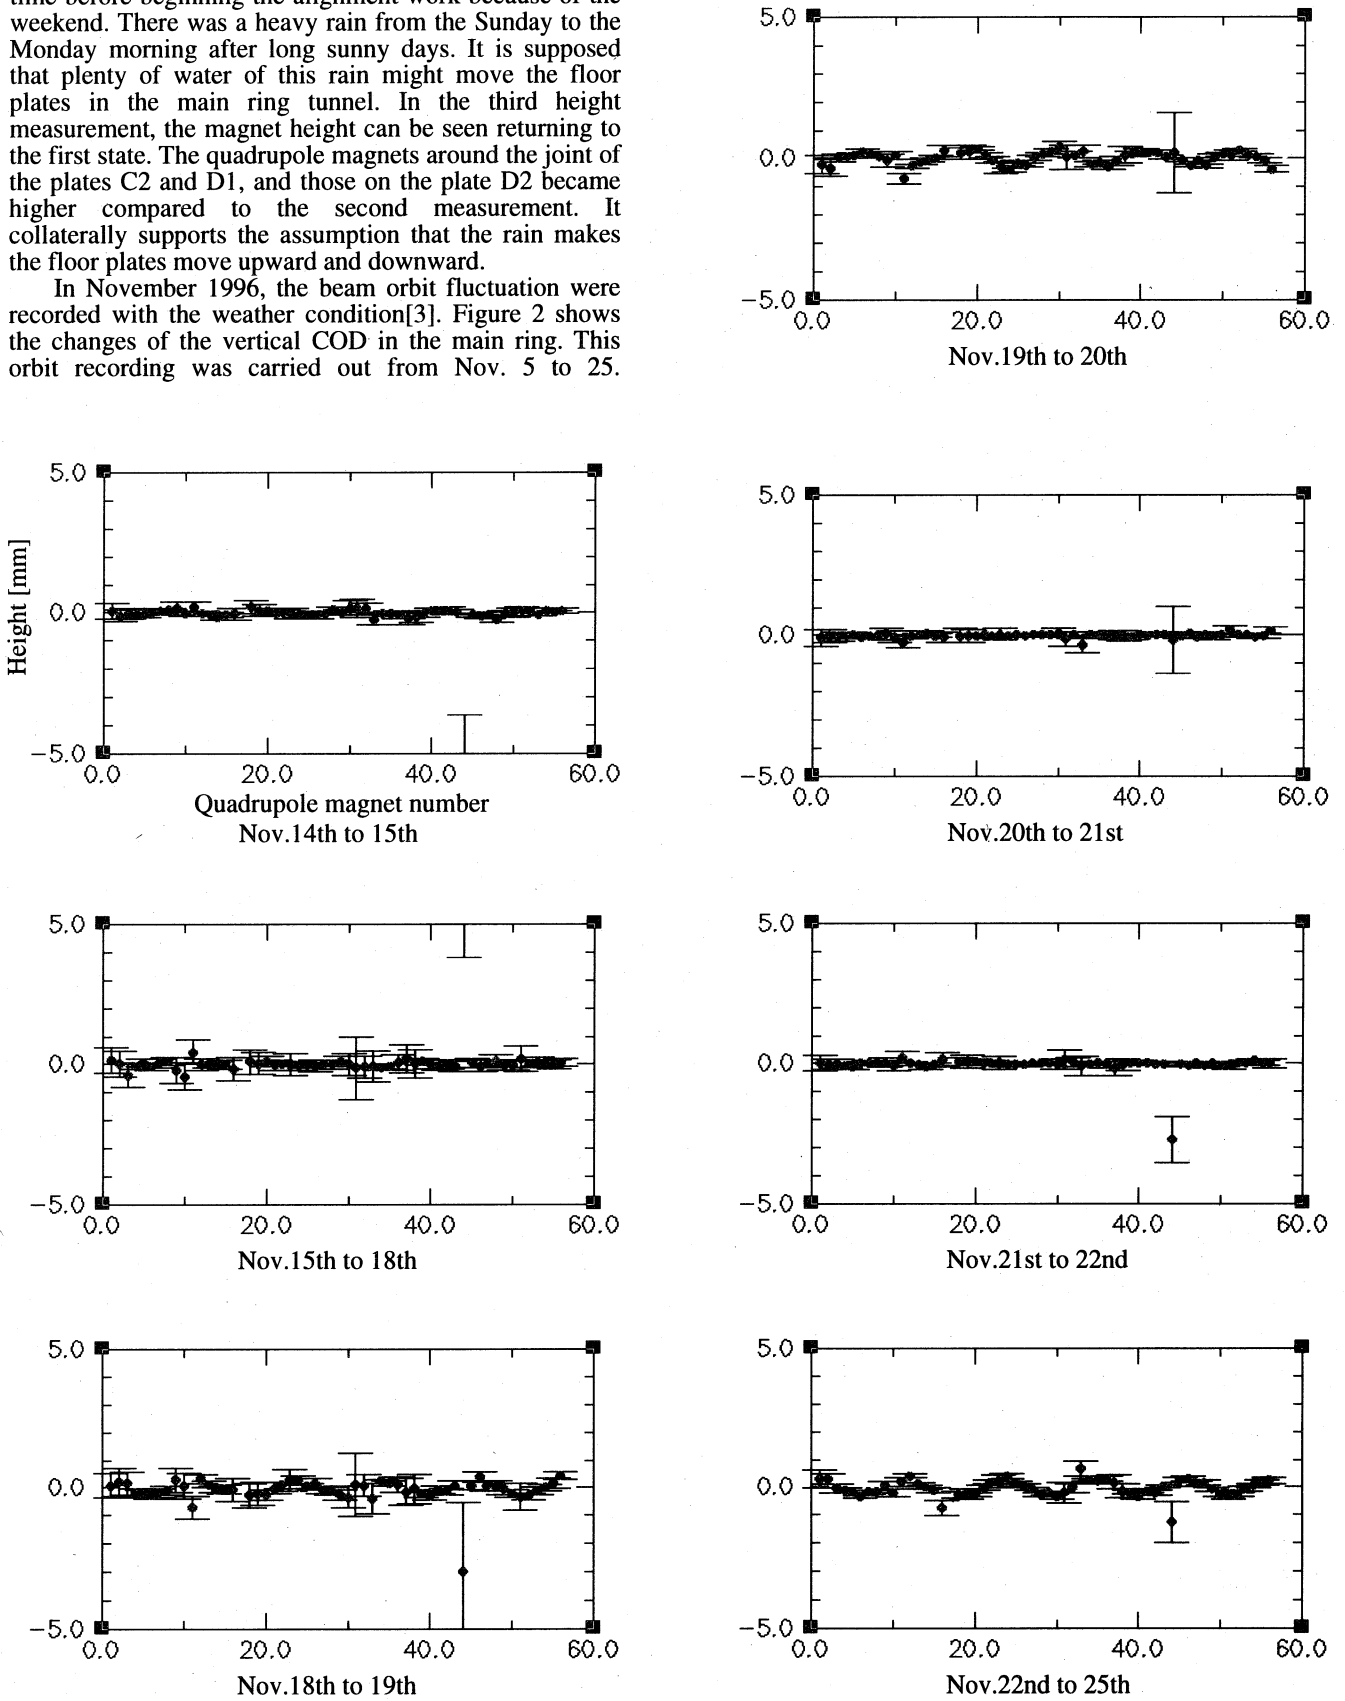
Figure 2. Orbit excursions in the vertical direction

The orbit change of about 0.5 mm was observed for three days of Nov.18th through 20th and four days of 22nd through 25th. These orbit excursions corresponds to the magnet deviation of about 200  $\mu\text{m}$ . During the measuring period, it rained twice on 15th and from 20th evening to 21st early morning. Soon after the latter rainfall, the large COD was observed as shown by Nov.22–25th data in Fig.2. Hence, the floor movements can be attributed to the rain. However, it is difficult to explain the correlation between the rainfall on 15th and the orbit excursion from 18th to 20th, because the amount of precipitation was little, and there was a time lag of four days until the orbit excursion appeared.

It is remarkable that the COD can change into the opposite phase. (See Nov.18–20th and 22–25th data in Fig.2.) It means the error source of the COD changed the polarity. Although the fluctuation on the power supply makes the COD, it cannot change the polarity. The assumption of floor plate movements well explain such characteristics.
