# SuperKEKB Accelerator Status

Makoto Tobiyama  
KEK Accelerator Laboratory  
(on behalf of SuperKEKB Accelerator Team)

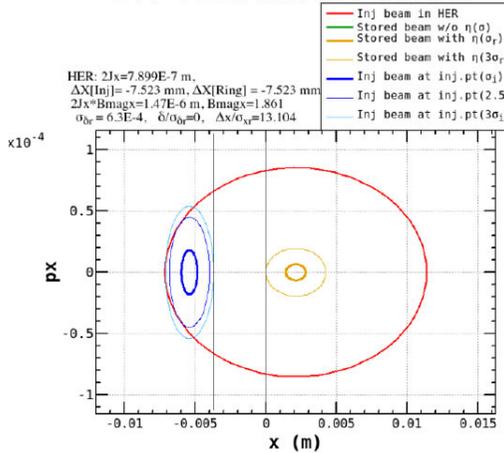
BI w/o cancel coil

DX=7.523mm at PINJAX0

**Betatron injection (BI):**

conventional method at SuperKEKB, horizontal distance at the injection region ( $\Delta X$ ) goes to betatron (horizontal) oscillation

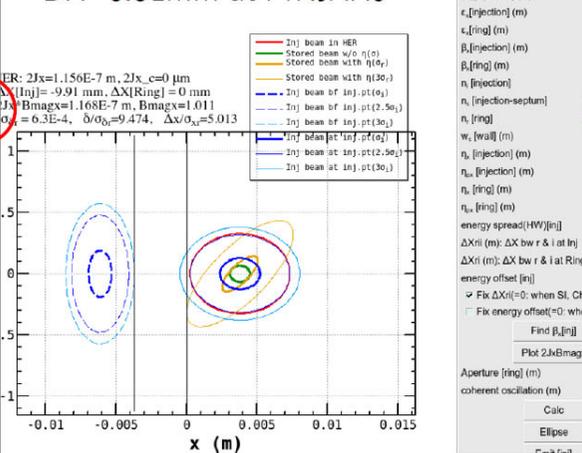
SI  $\beta y^* = 0.9\text{mm}$ , CW60% w/o cancel coil

DX=9.91mm at PINJAX0

**Synchrotron injection (SI):**

proposed method at SuperKEKB, horizontal distance at the injection region ( $\Delta X$ ) goes to synchrotron oscillation

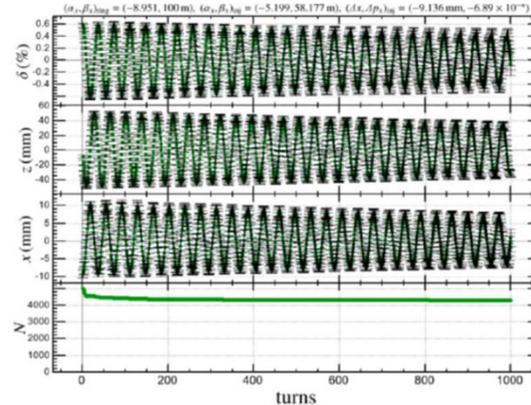
~85%

In synchrotron injection, beam-beam effects can be reduced, then the beam injection efficiency will come improved.

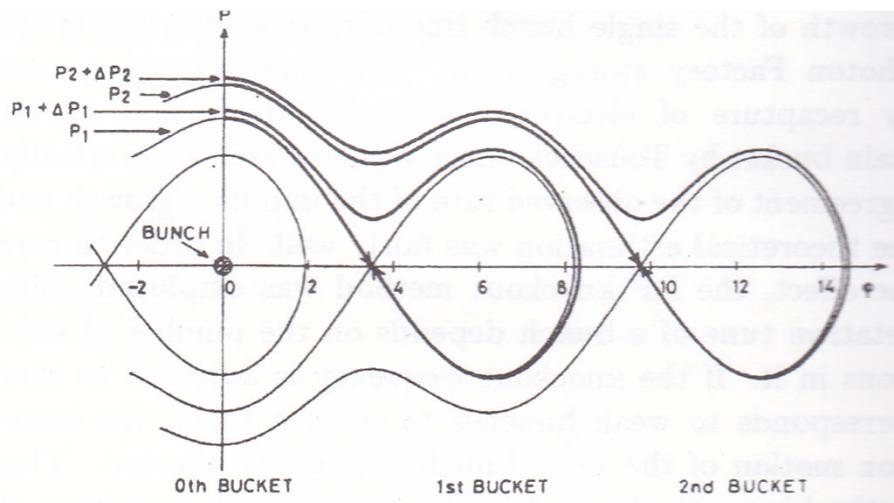
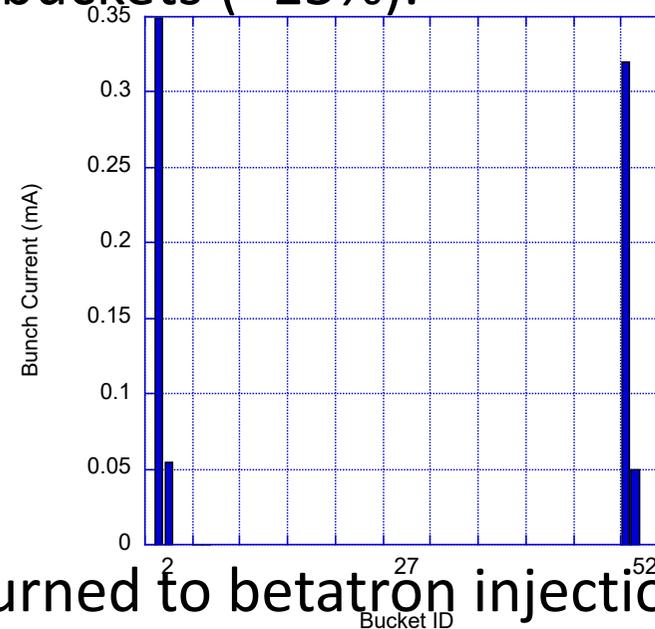
- For the collision optics with by\*~8 mm to 1 mm, we have struggled to get a good injection efficiency, but it did not work out for a higher repetition rate of larger than 12.5Hz.
- Significant charge leak to the following buckets (~15%).

- Given up synchrotron injection and returned to betatron injection.

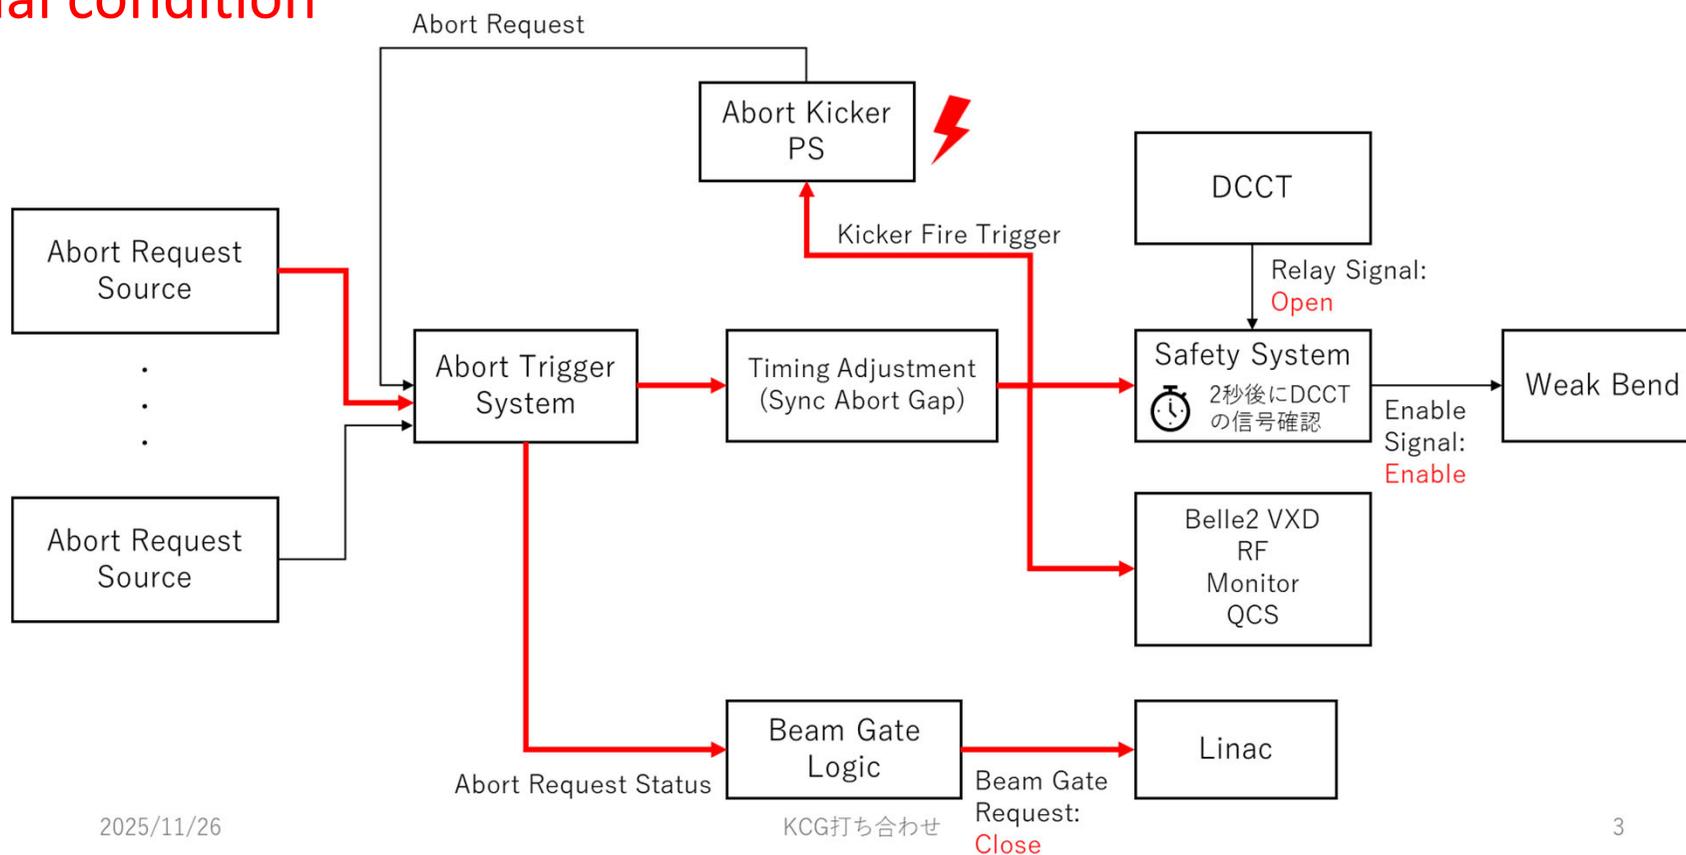
## Normal condition

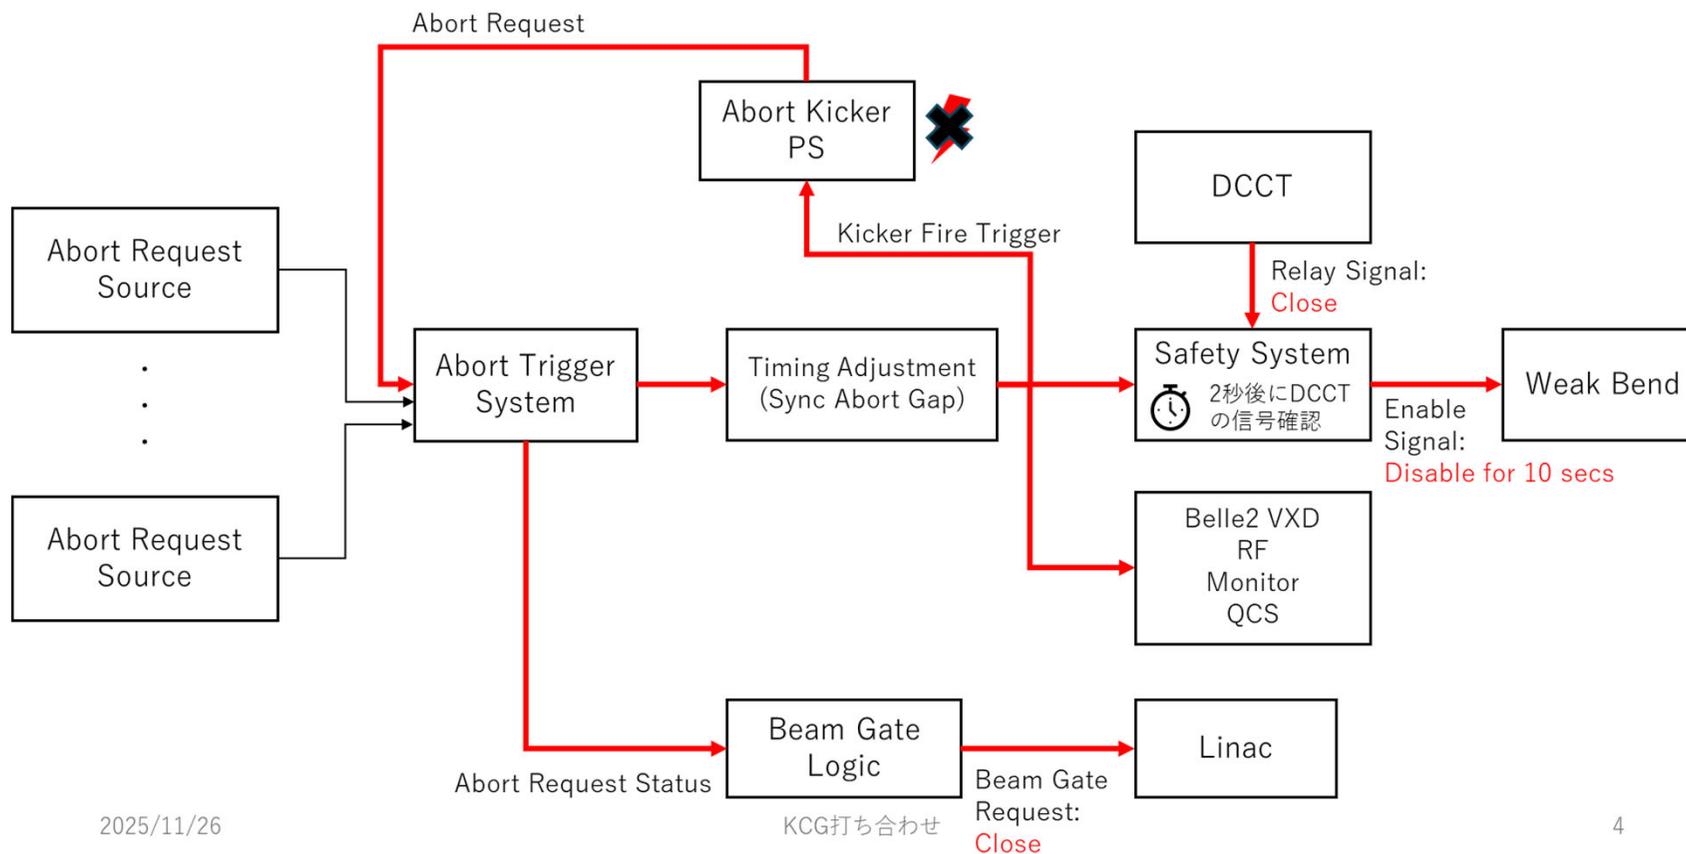
# Abort kicker malfunctioning

- Due to weak-bends cutoff, a large beam orbit primarily in the horizontal direction emerged with a time constant of 0.1 seconds, resulting in catastrophic beam loss.
- Simulation suggests more than 80% beam loss in the IR direction.
  - Large xy coupling.
  - Shrunk RF separatrix.
- The QCS on the L side caused a quench in all magnets, taking about 7 hours to restore the liquid level.

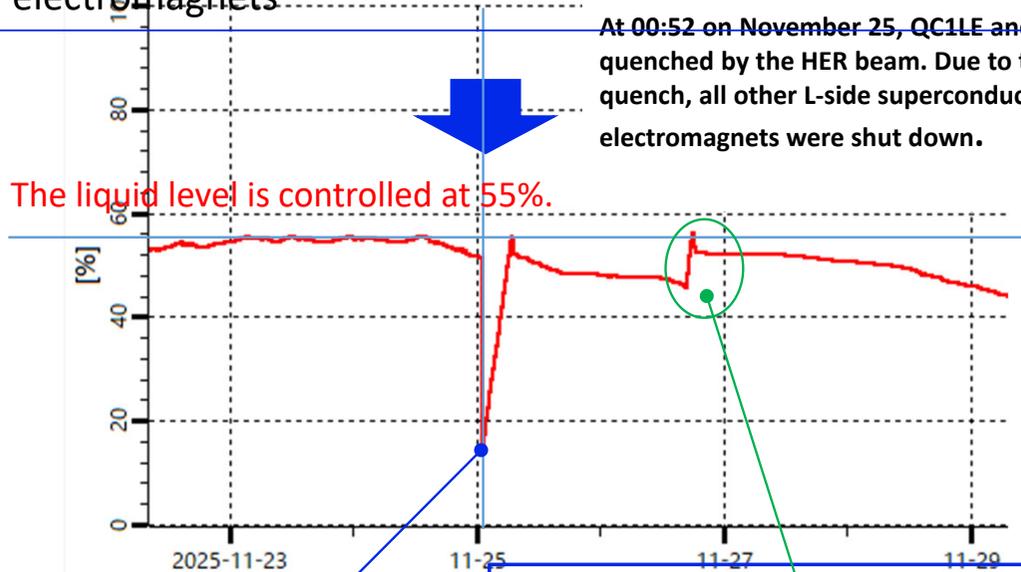
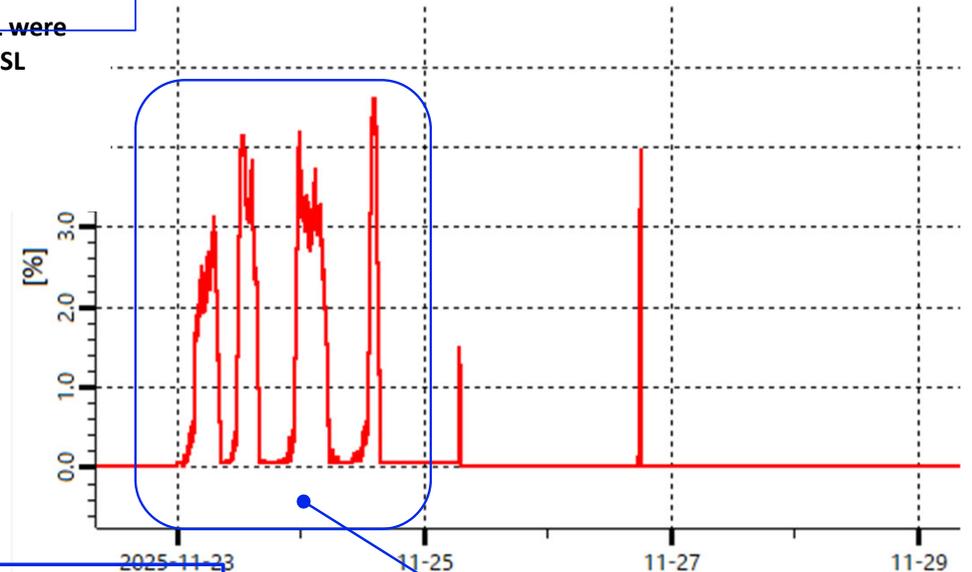
QS\_CRYO:LLIC611\_PV [%]

Liquid helium surface level near atmospheric pressure for producing supercooled liquid helium to cool QCSL superconducting electromagnets

Heater operation status to maintain liquid helium level at 55%

QCSL electromagnet quench reduced to 15%.

After system recovery from quench, the liquid level dropped to 46%. **Set all QCSL electromagnets to 0A and reduce the helium gas flow for current lead cooling to raise the liquid level.** (Reduce the heat load on the cryostat)

During normal operation, when the liquid helium level reaches 55% or higher, the heater inside the liquid helium container activates to maintain the level at 55%.

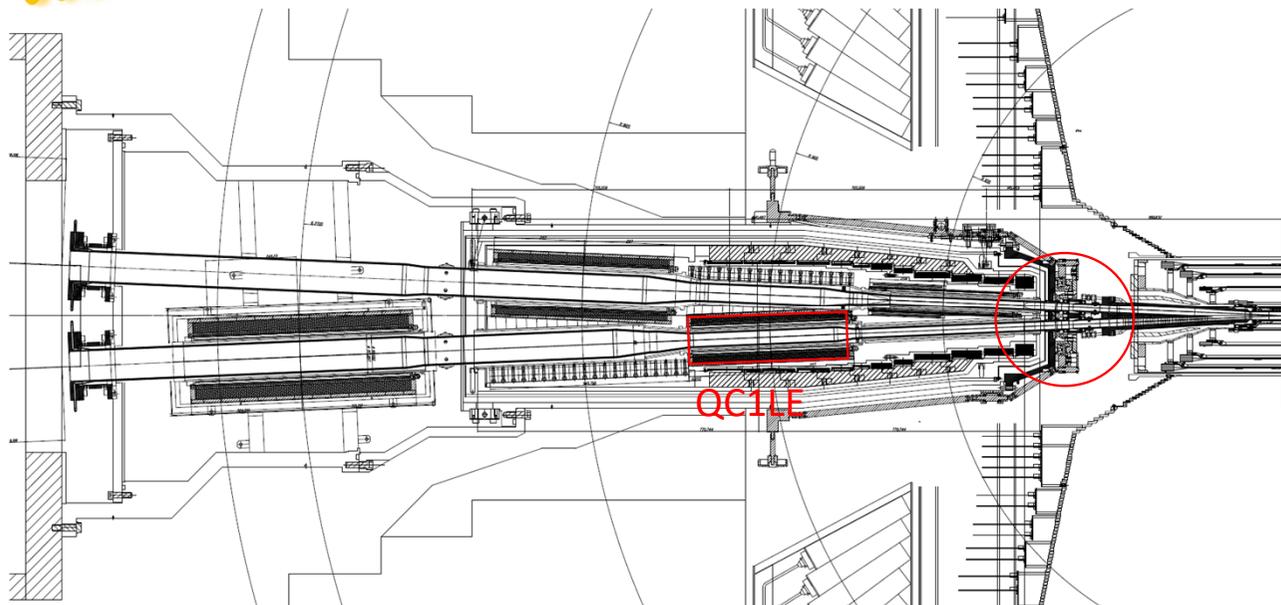
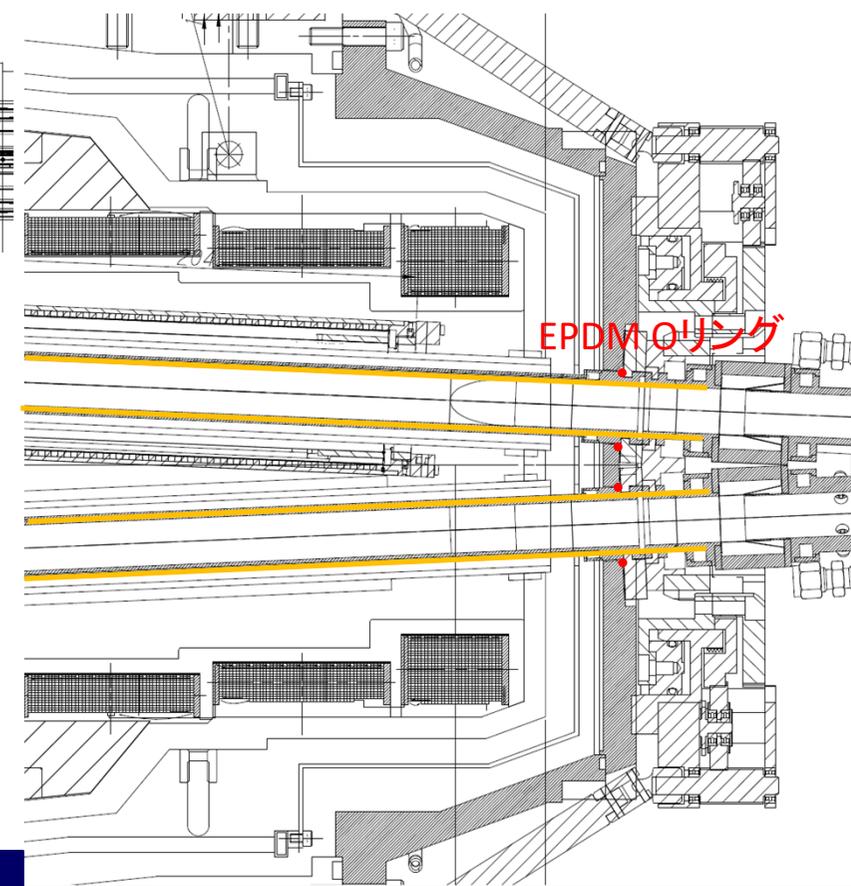
QCS-L side cryostat

## EPDM O-ring

The vacuum vessel (vacuum layer) of the QCS cryostat is sealed from the atmosphere using the end face of the vacuum vessel and the outer circumference of the beam pipe.

- The heat load of the QCS cryostat has increased.
  - Air leak in the thermal vacuum chamber.
  - Air leakage may have occurred due to deterioration of the O-ring at the cryostat tip, potentially causing air to condense on the surface of the liquid helium container.

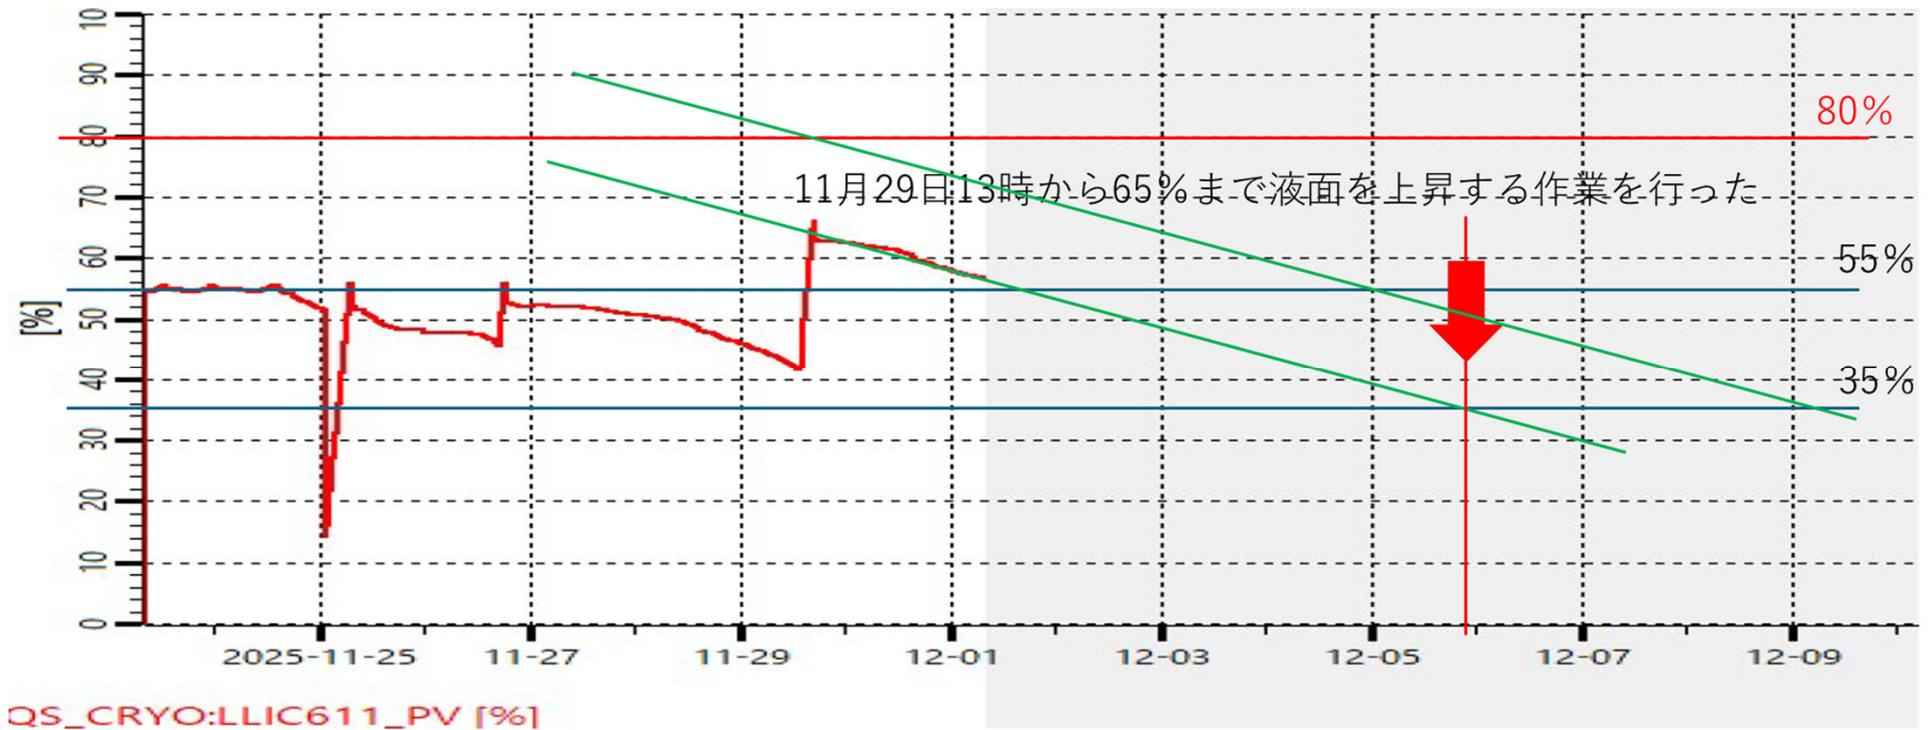
# Power off the QCS magnets and raise the liquid He level

Needs roughly 8 hours to increase the Li-He level. After the process, we need to re-do the optics correction (8h)

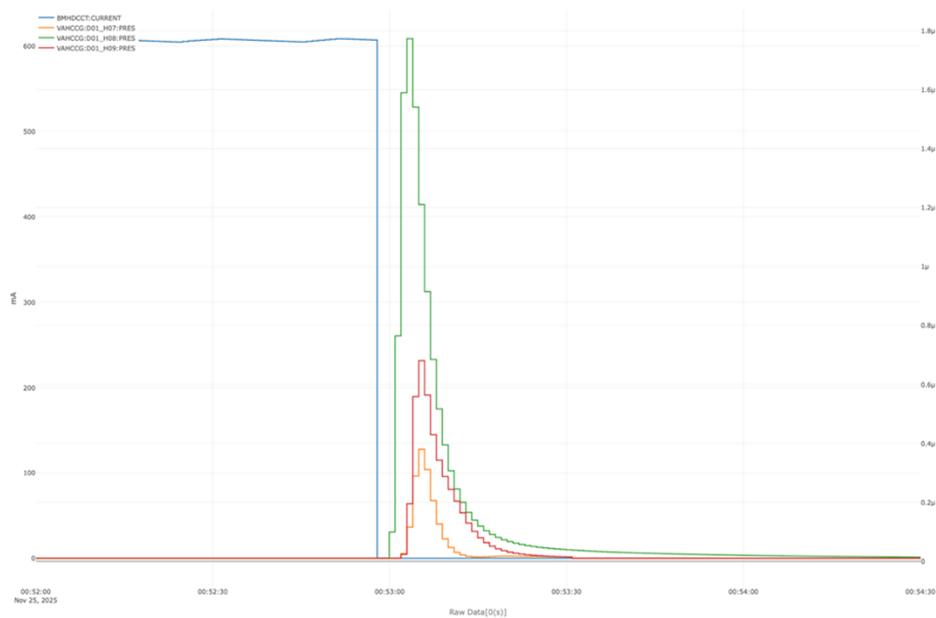
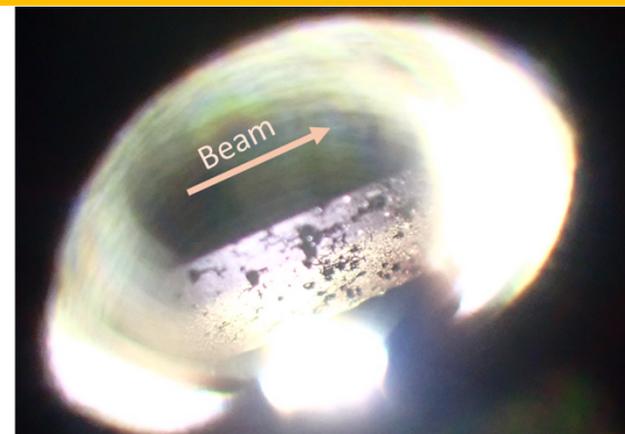
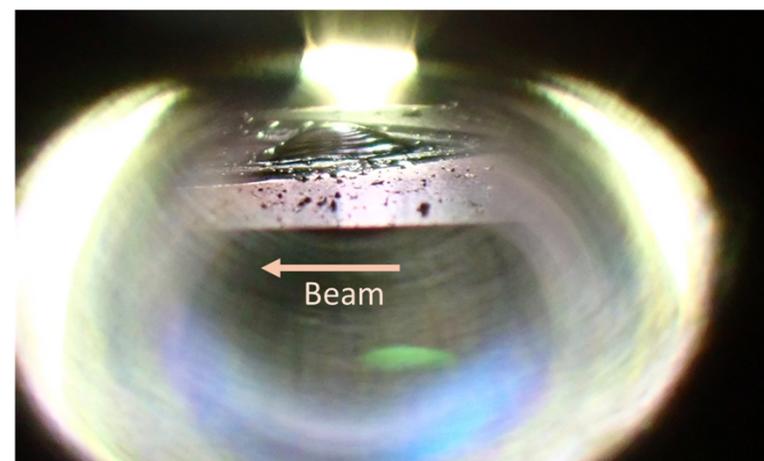
D01V1 BOTTOM

# D1V1 collimator head has been damaged

- By moving the damaged vertical collimator 1.5 mm horizontally and adjusting the other vertical collimators, we are currently able to continue operation while keeping the background to the Belle II detector within acceptable limits.
- However, this situation results in the vertical collimator being significantly narrowed, considerably reducing the HER's injection efficiency.

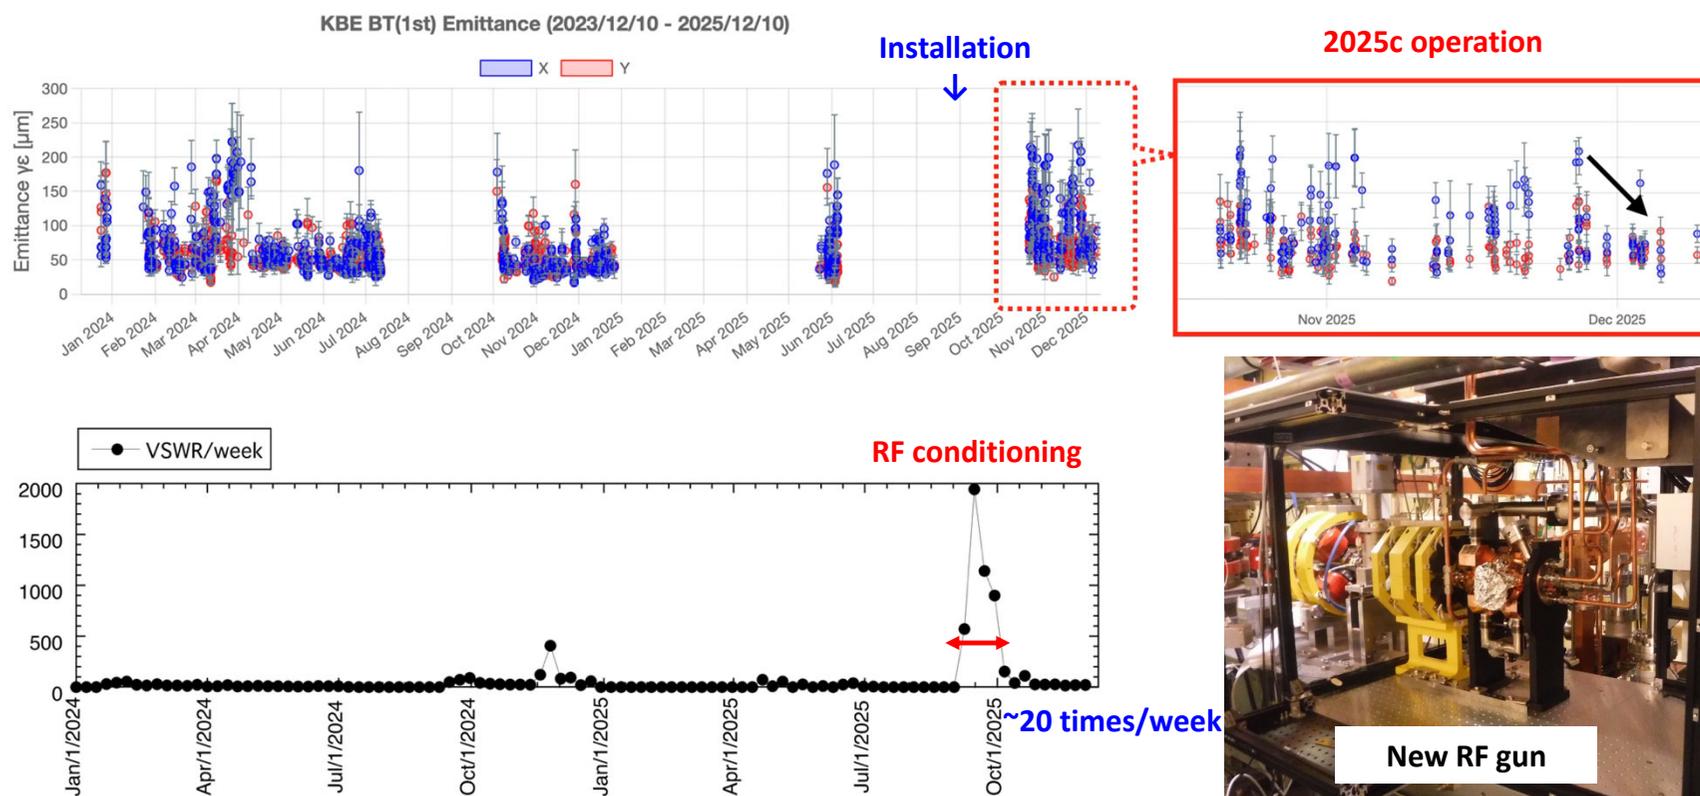
- New RF gun operation status  
Emittance and frequency of VSWR at the same level as before

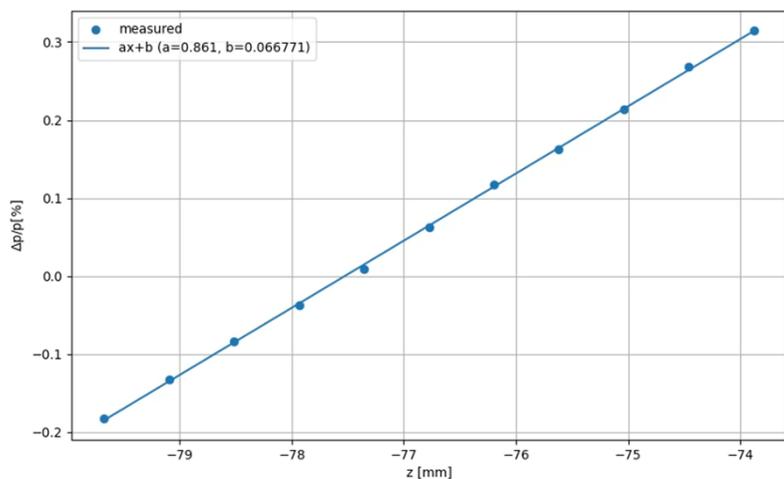
- Electron ECS operation status  
 Design  $V_c = 100$  MV and  $R_{56} = -0.7$ m attained  
 Energy compression confirmed

Measured voltage : 100.08 MV

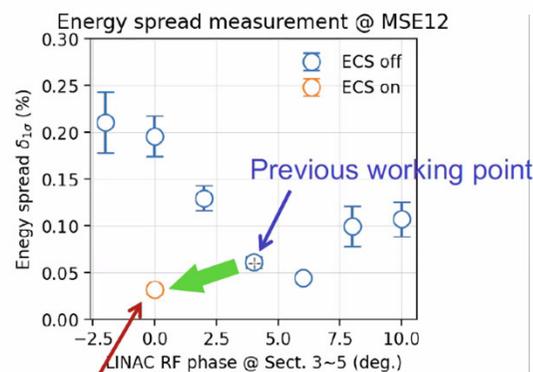
## BTe-ECS Verification @ MSE12

Present working point

Present energy spread is  $\sim 0.032\% < \sim 0.061\%$  (2024 working point).

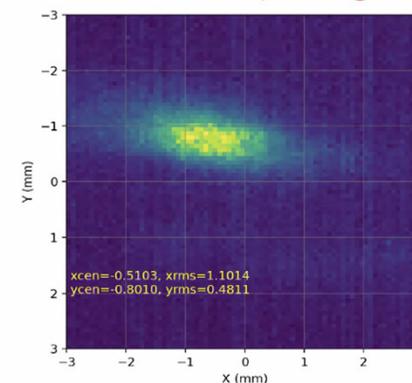
## Nominal beam profile @ MSE12

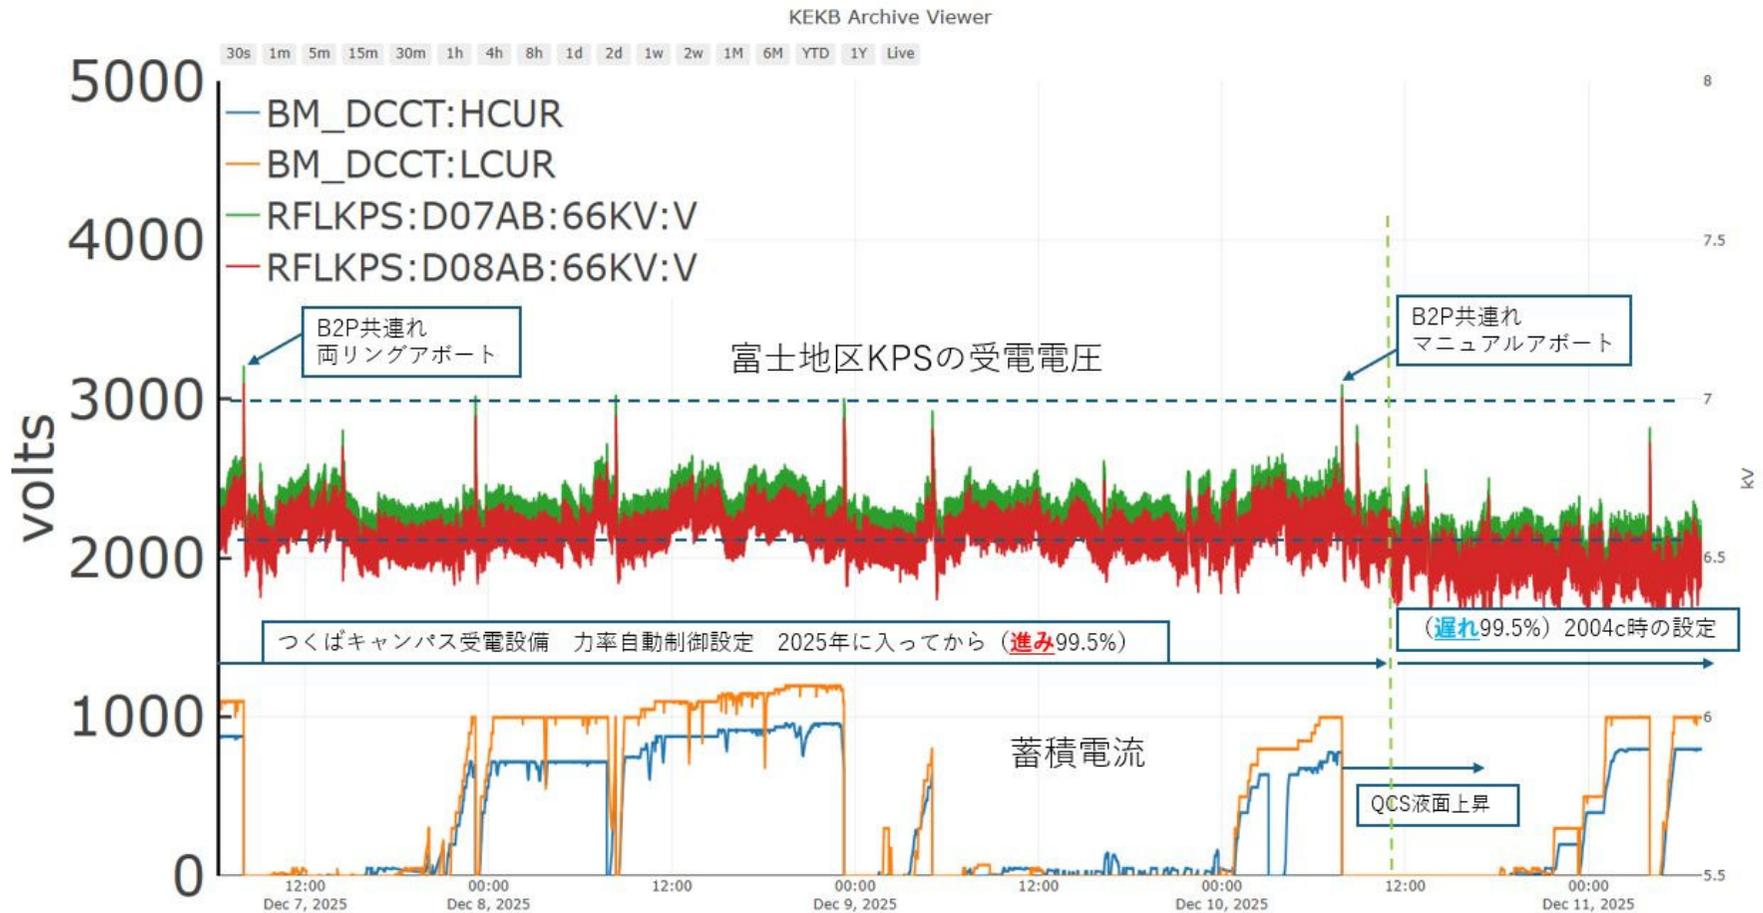
# B2P power supply down due to overvoltage of the primary 6.6kV line

- The LER bending magnets power supply (B2P) tripped due to a primary voltage (6.6kV) overlimit interlock (occurred twice) caused by the trip of all RF sources of Fuji area due to beam abort.
- After investigating the cause with KEK's Facilities Department, it was determined that the settings for the power factor correction capacitors at KEK's power receiving section—intended to improve power efficiency—differed from those used in fiscal year 2024 (having been adjusted toward greater energy savings). These settings were reverted to their original configuration.
  - Efforts were also made on the RF side to reduce power consumption in the Fuji area.
  - After this, the B2P power supply is not interlocked.

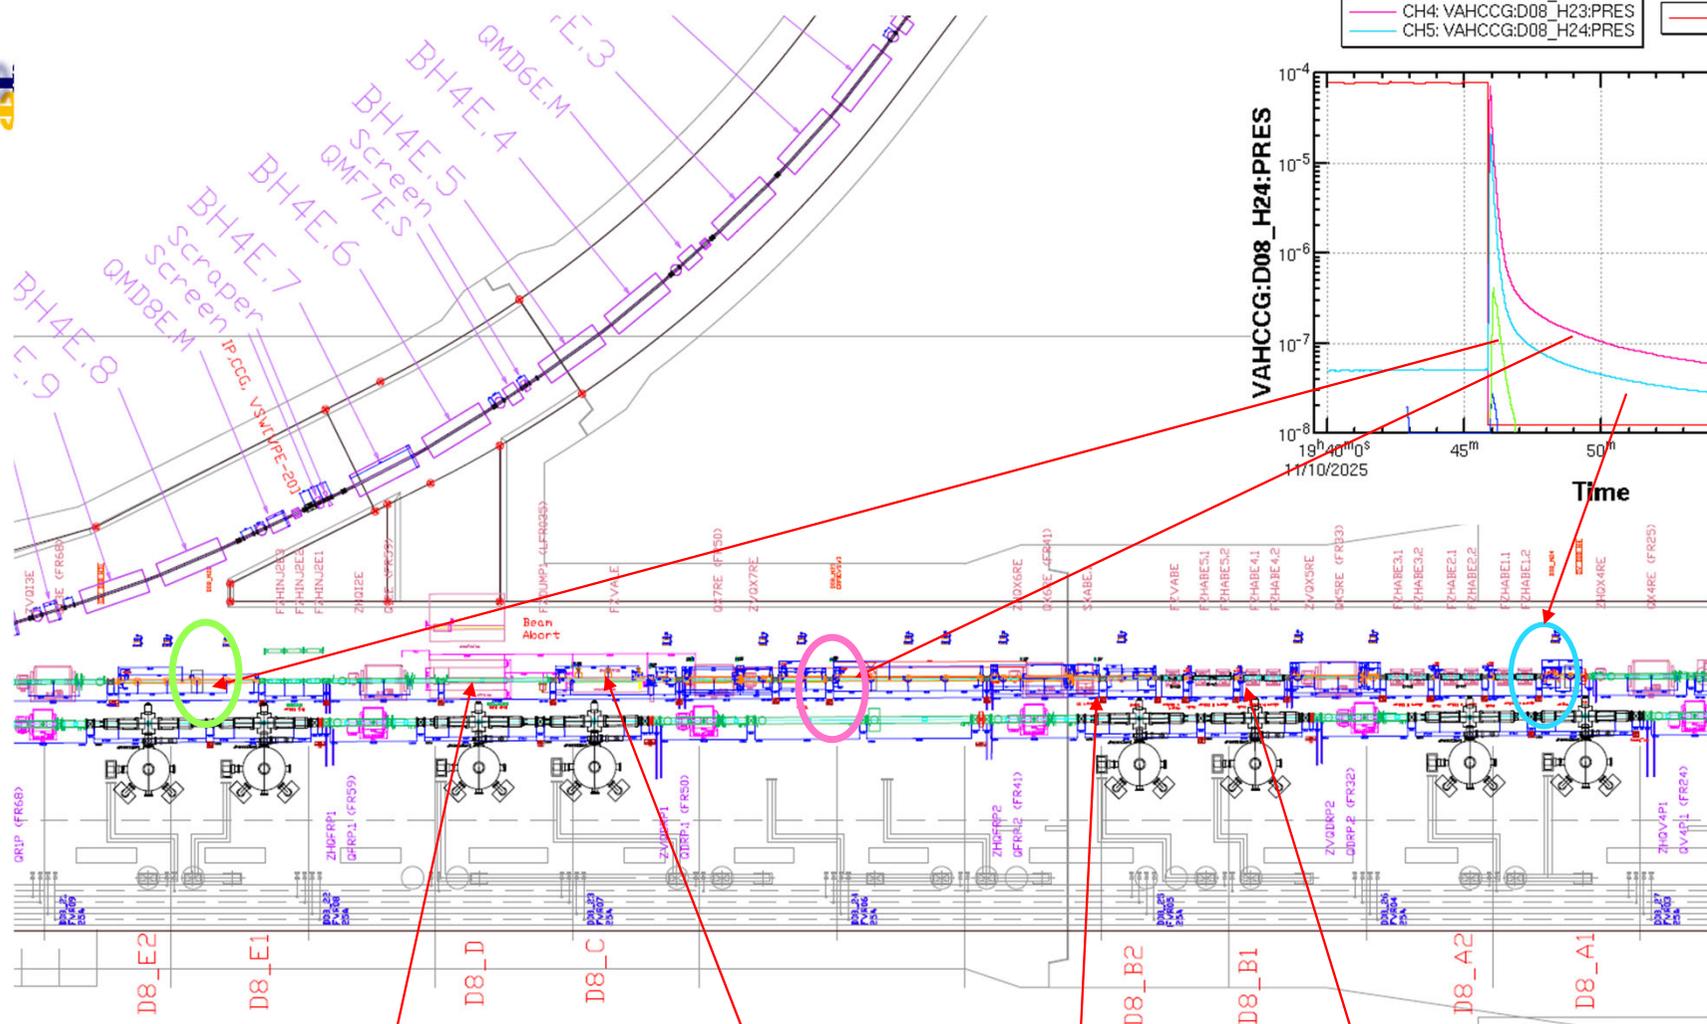
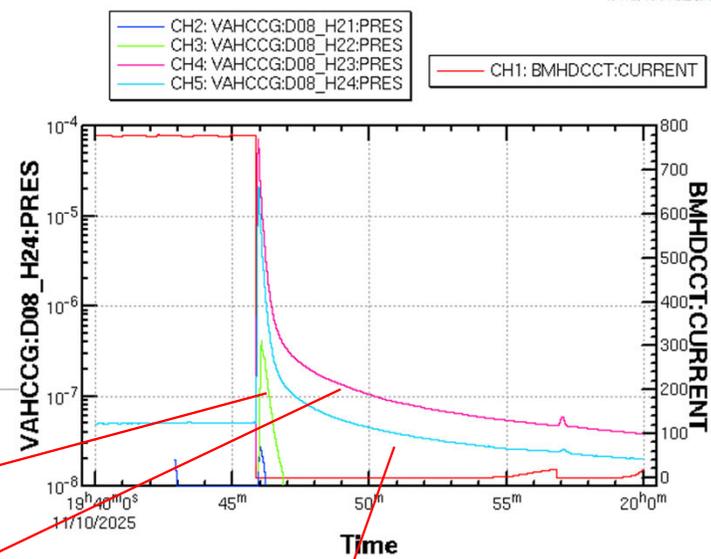
- Successfully with the detuned optics, but
  - Damage the vacuum chamber wall (and flange) around the beam dump due to the aborted beam, which resulted in a large vacuum leak after one day of operation.
  - The issue was temporarily resolved by re-examining the trajectory of the abort beam and modifying it to maintain sufficient distance from the chamber wall.

ビームダンプ

ランバートゾン

アボートキッカー

リーク箇所

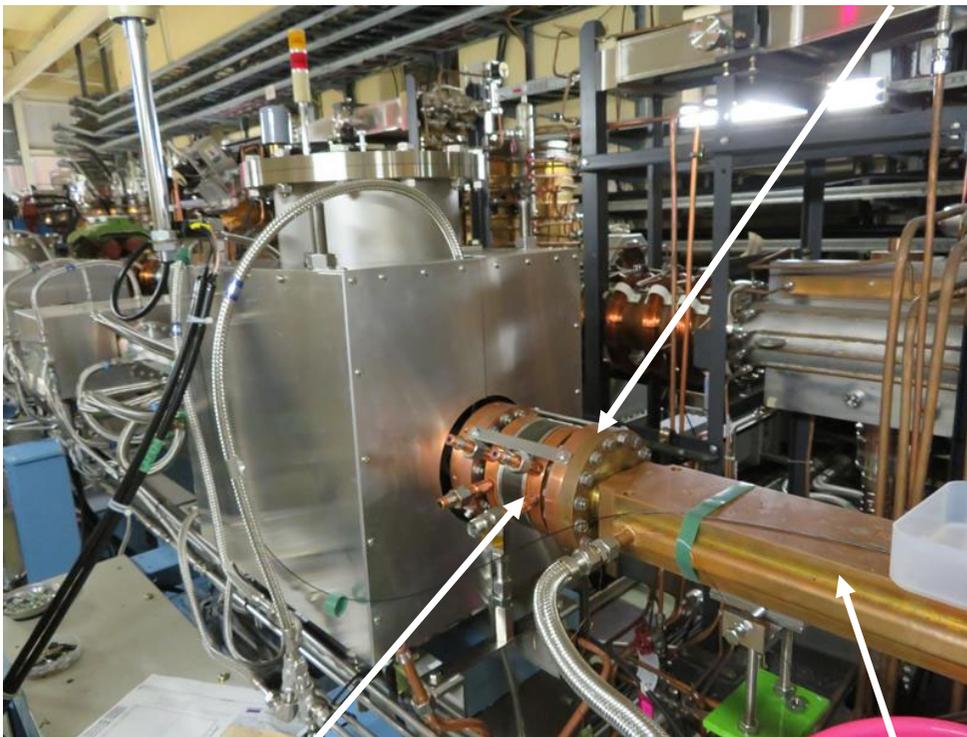
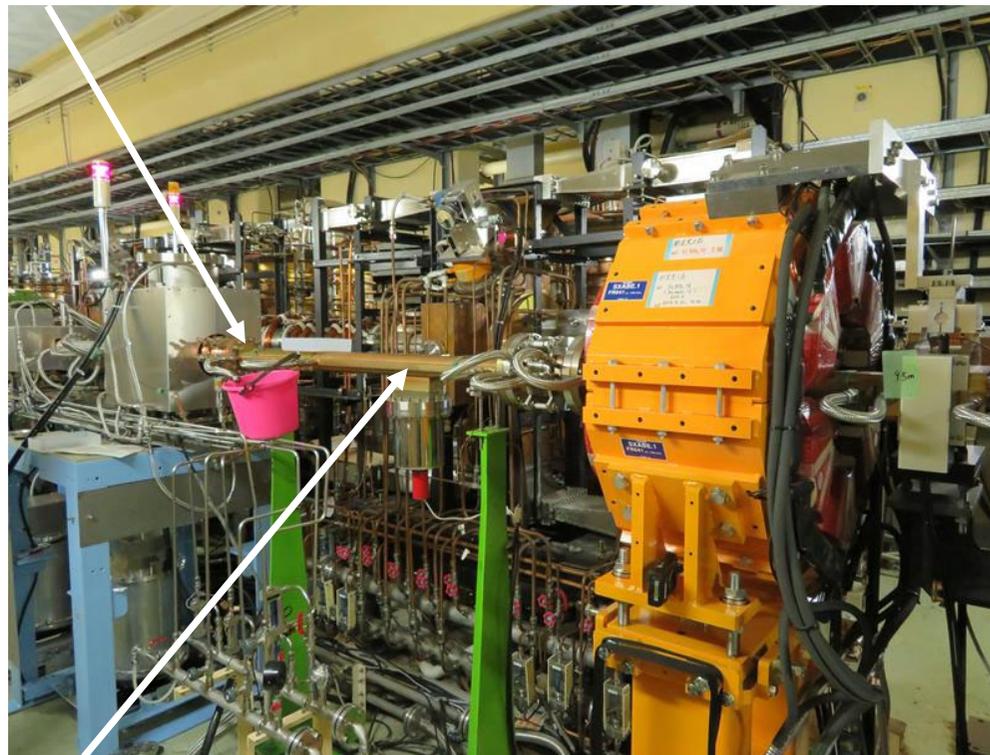
## リーク箇所

ベローズ

テーパークェンバー

このチェンバーでH60 x V40からH104 x V50に変換

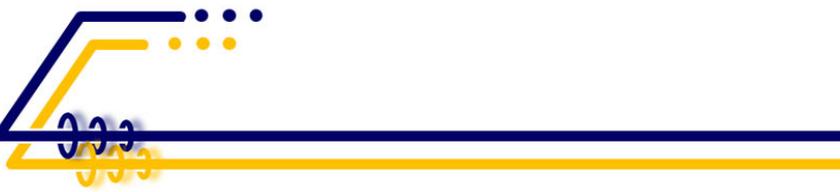
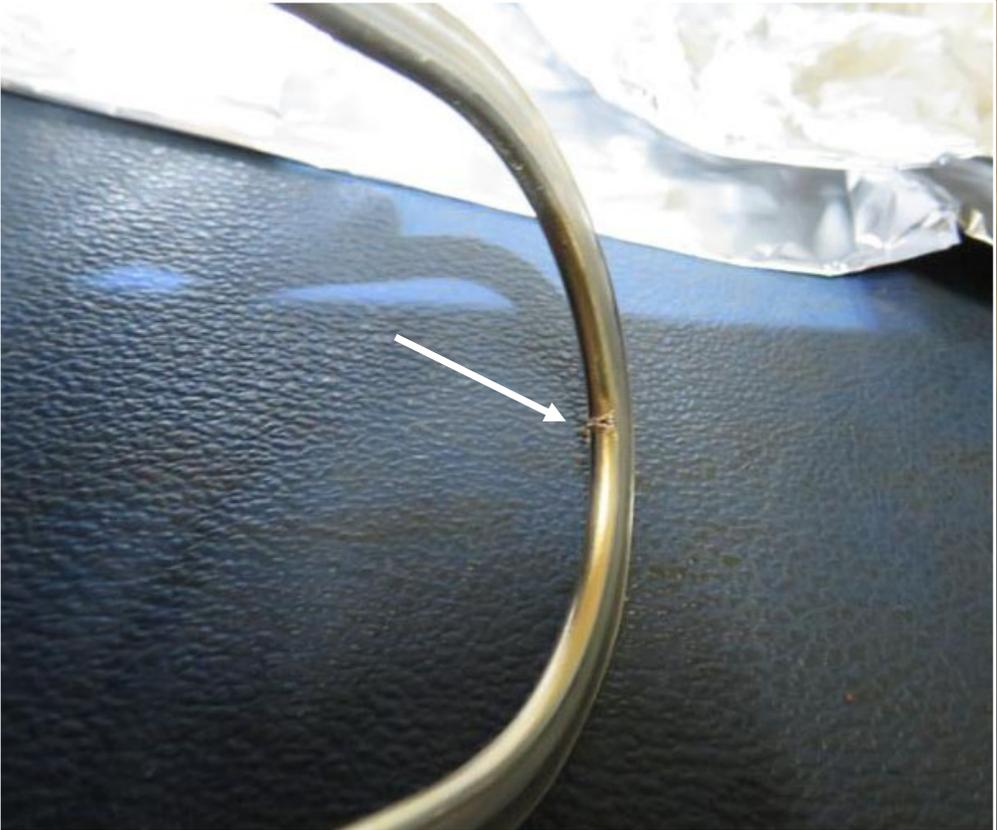
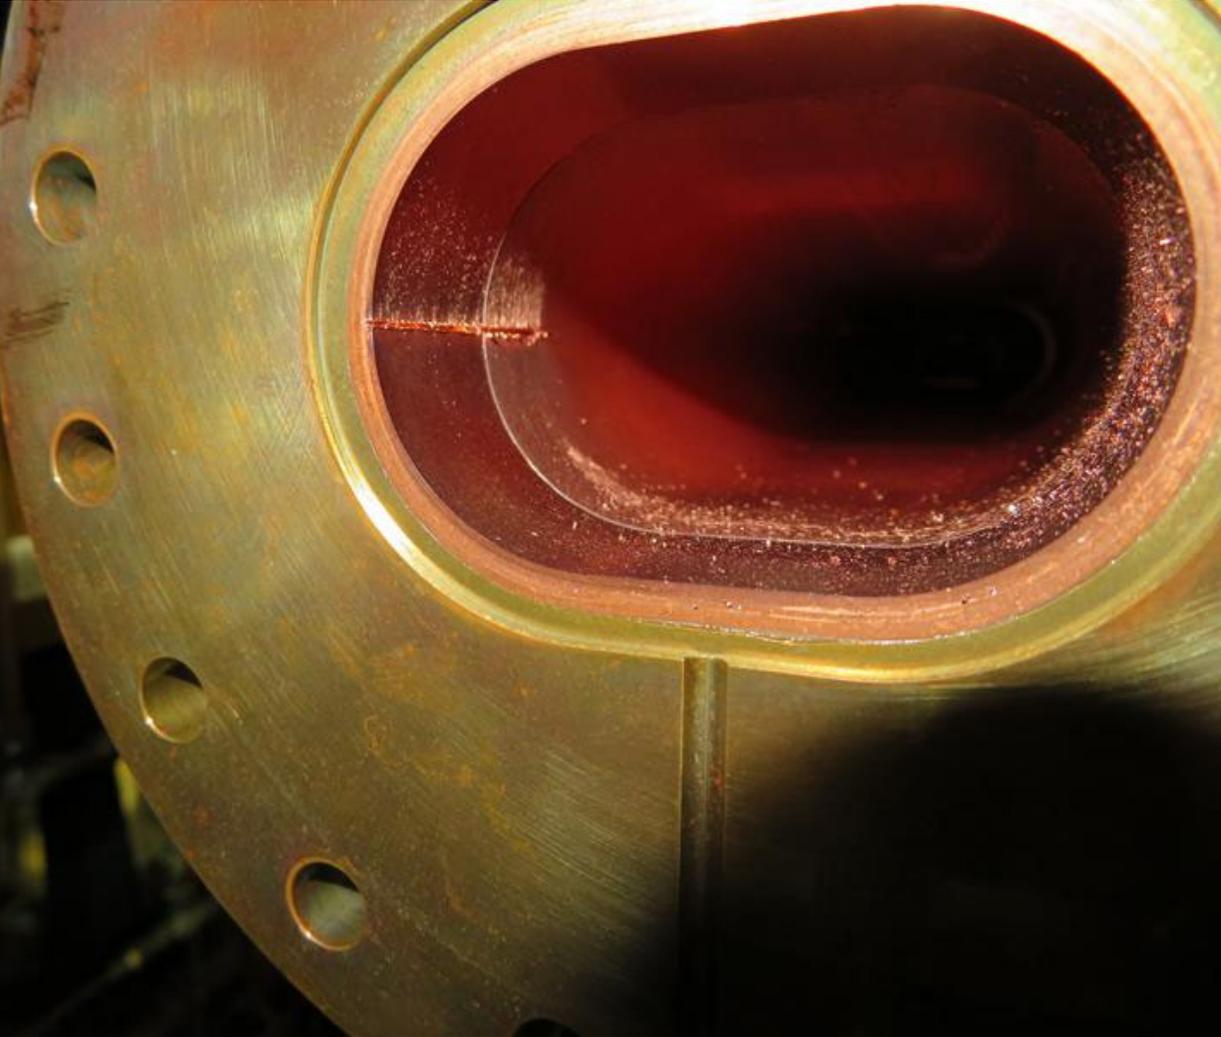
リークしたフランジの  
ヘリコフレックスガスケット

リークしたフランジ側から見たテーパ chambers
