LCLS RF GUN COPPER CATHODE PERFORMANCE *

Abstract

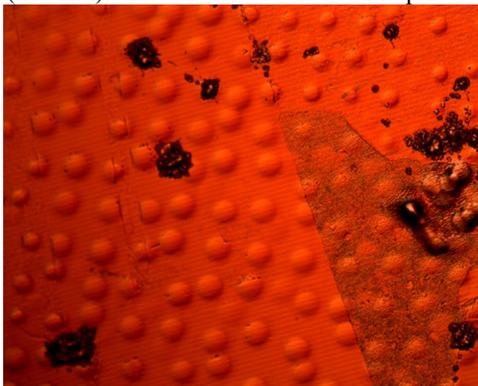
Figure 1: Microscope 20x image of cathode #1 (horizontal image field $\sim 700 \mu\text{m}$); courtesy of J. Feng, V. Yashchuk and H. A. Padmore of LBNL.

The composition of surface contamination of cathode #1 has been studied by surface science techniques using the SSRL facility. XPS and XAS measurements revealed mainly hydrocarbon species on the surface but also species that can be associated to the copper bulk chemistry (Pb, Bi, S). Surface morphology has been studied by SEM, optical microscopy and micro-interferometry. The latter techniques revealed the impact of laser cleaning. Figures 1 and 2 show the indentations caused by the laser exposure that occurred during the laser cleaning attempt.

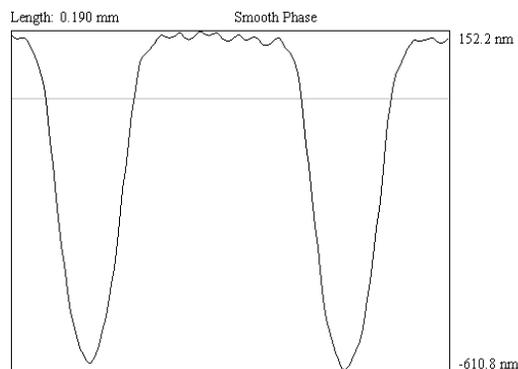
Figure 2: Lineout of micromap image showing indentations caused by laser cleaning; courtesy of J. Feng, V. Yashchuk and H. A. Padmore of LBNL.

The method of laser cleaning has been applied previously to remove surface contamination from copper cathodes at SLAC and elsewhere [4,5,6]. Subsequent surface analysis of cathode #1 revealed surface damage due to the high laser fluence. Also, with the first cathode we were not able to maintain the high QE obtained immediately after performing this procedure.

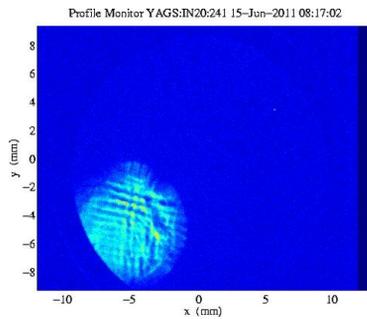
Figure 3: Emission pattern after laser cleaning of cathode.

Rastering of the laser spot across the cathode's surface again created the grid-like electron beam emission pattern but subsequent scans using a larger spot size and smaller steps created a more uniform emission pattern. Figures 3 and 4 depict the emission pattern from the laser cleaned cathode, imaged using the solenoid set to point to point imaging on a YAG screen. Using this technique, we achieved a QE of mid 10^{-5} and emittances of $\sim 0.7 \mu\text{m}$ in both x and y planes.

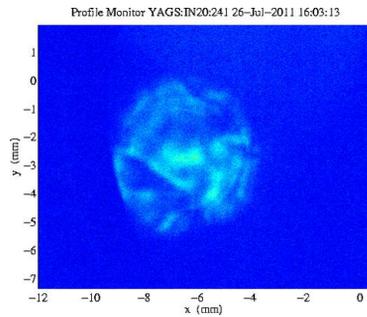
Figure 4: Uniform emission pattern after refinement of laser cleaning method. Structure is dominated by crystal grains.

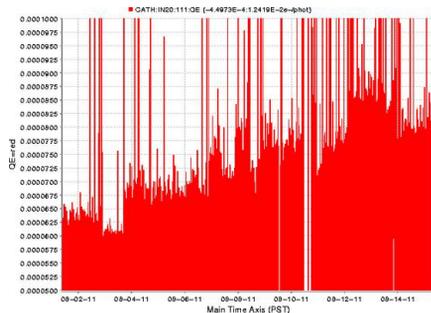
Figure 5: History of quantum efficiency after laser cleaning shows an upward trend.

During the following weeks of operation we observed a slow increase in quantum efficiency and, more importantly, also a decrease in emittances (figure 5 and 6). Currently, the QE is $> 7 \cdot 8 \cdot 10^{-5}$ with emittances of $\sim 0.4 \mu\text{m}$ in the x and y planes. This improvement is not

fully understood. The QE increase may be attributed to the slow improvement of vacuum conditions in the RF gun. The continued effort of machine tuning contributes to improved injector emittances.

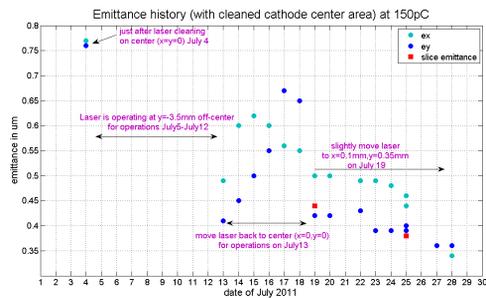
Figure 6: History of injector emittances after laser cleaning shows an upward trend.
