How J-PARC recovered from the big earthquake

KEK / Fujio Naito

Recovery Status of J-PARC from Damages by the 3.11 Earthquake

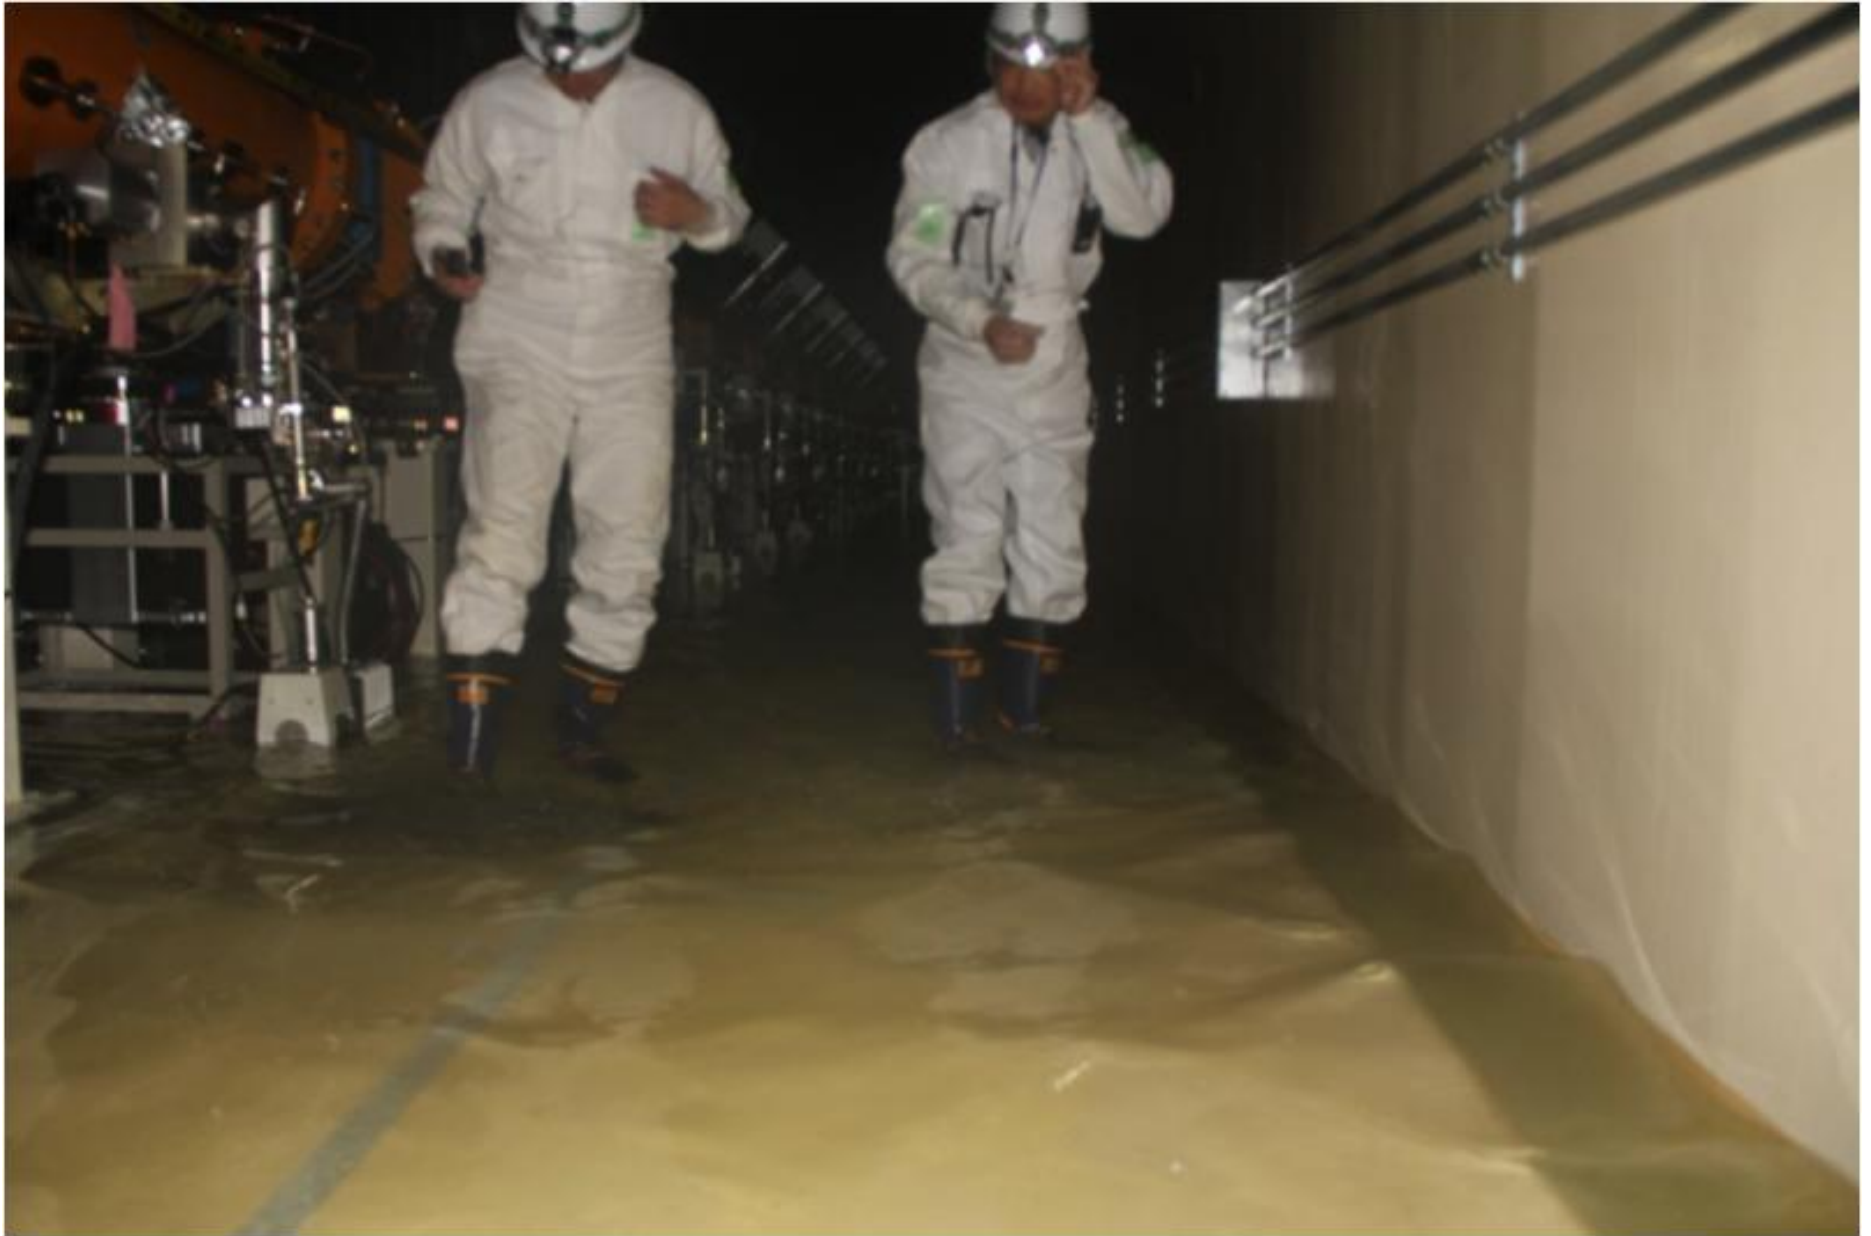
Linac Tunnel on March 24, 2011

On March 17 the water level was only 1 cm, but it increased to 10 cm (100 tons) on March 24. The water was pumped out with a rented electric generator. PH=11 and tons of acid were necessary to neutralize water.

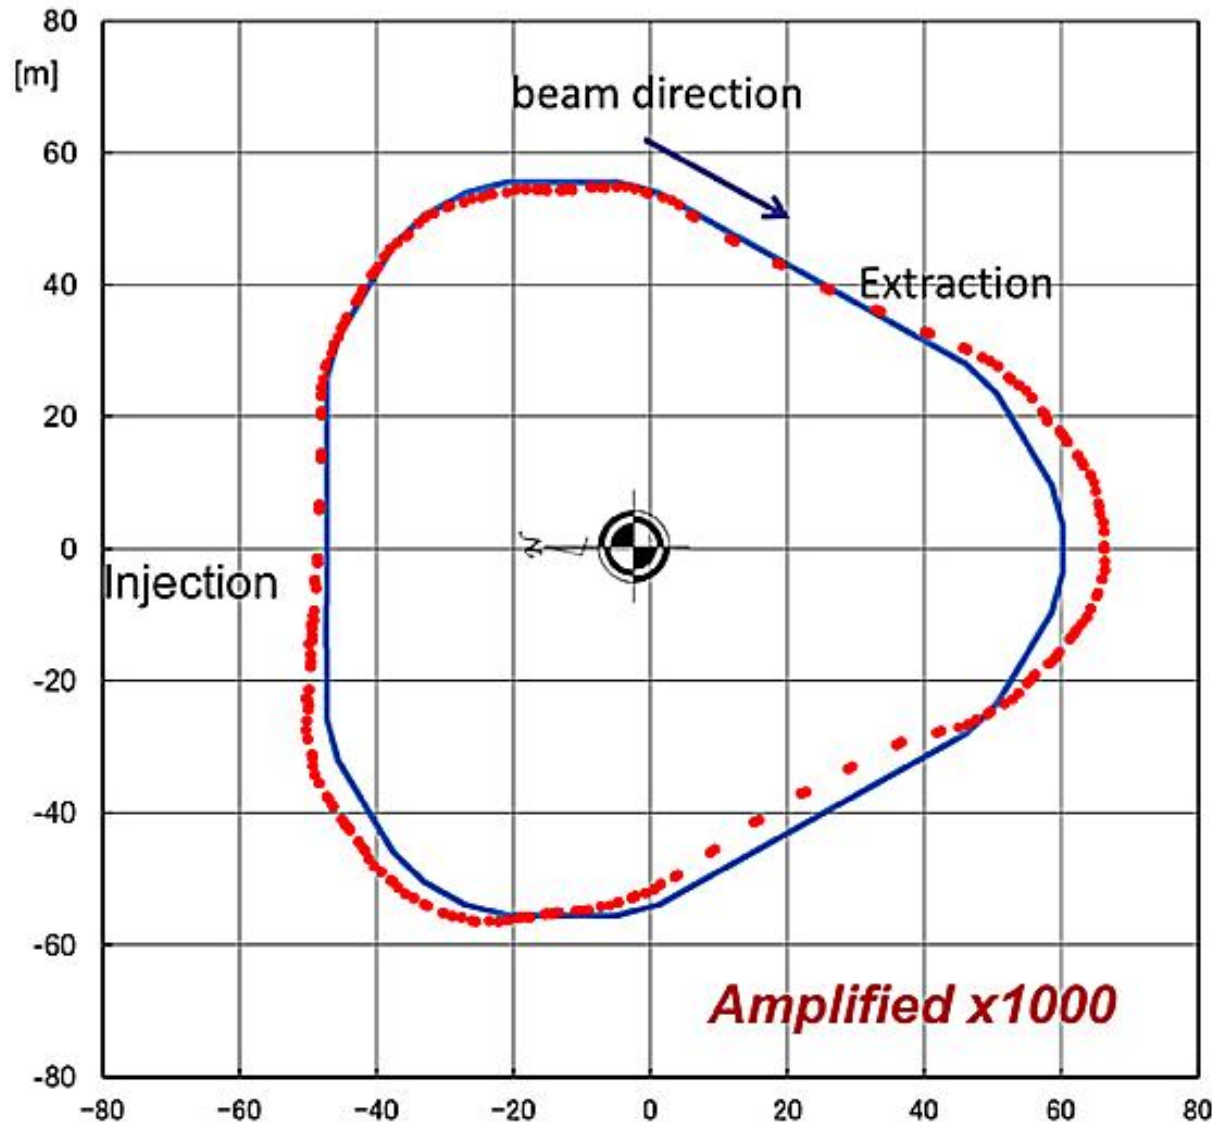
Rapid Cycle Synchrotron (RCS, 3GeV)

- No serious damages on the equipment/instruments in RCS tunnel.
- Position of all equipment/instruments were measured.
The maximum displacement is 3.7mm vertically & 10mm

Blue : Reference positions of the magnet
Red: Measured positions after the earthquake
(Please note the magnitude of displacement is amplified x2000.)

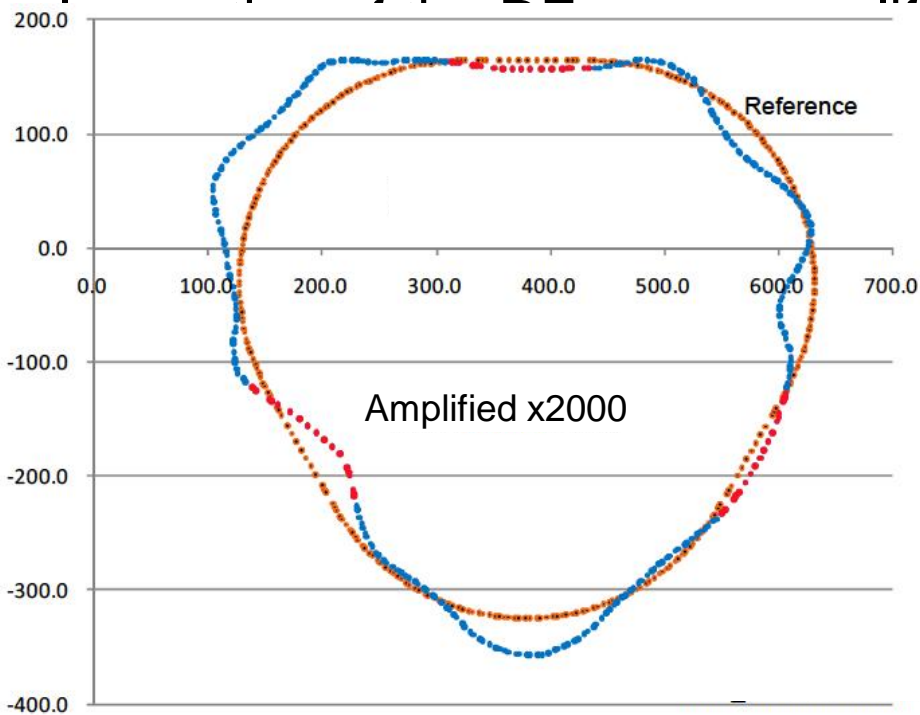
Main Synchrotron Ring (MR, 30GeV)

- There were no serious damages on all MR equipment/instruments, such as magnets.

It, however, appeared they misaligned in both vertical and horizontal directions.

Orange : Reference positions of the magnet

Blue & Red: Measured positions after the earthquake (Please note the magnitude of displacement is amplified)

- Some magnets misaligned greatly are re-aligned with replacing a stage.

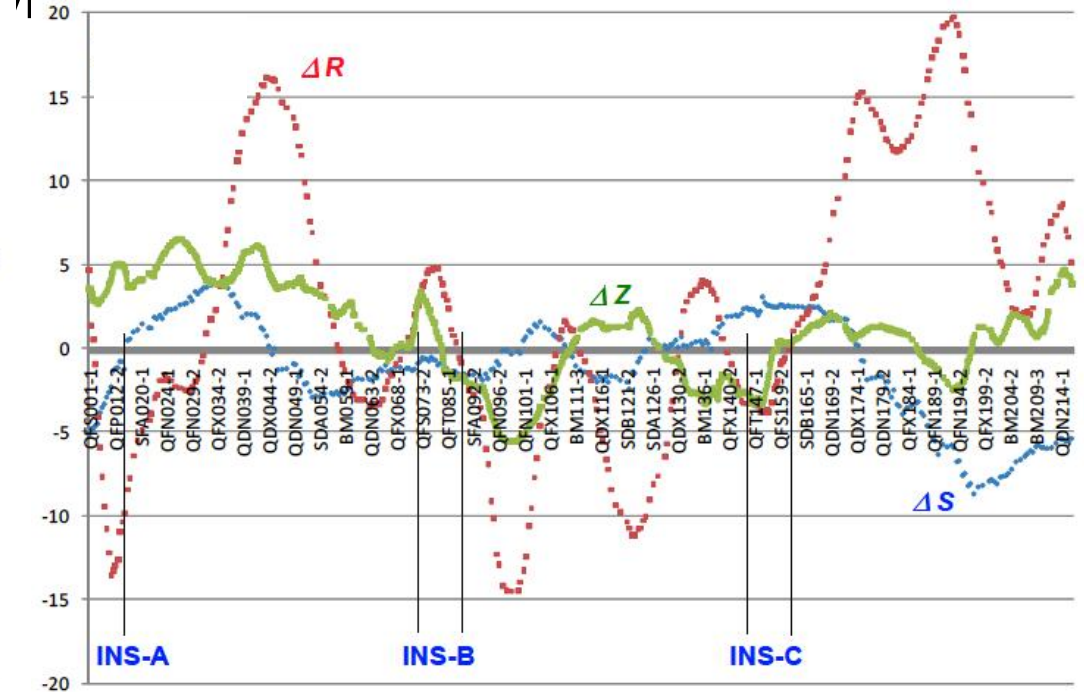
Magnet displacement from the reference line

Green : vertical direction
 Red : horizontal direction
 Blue : beam deirection

Alignment system has been completed

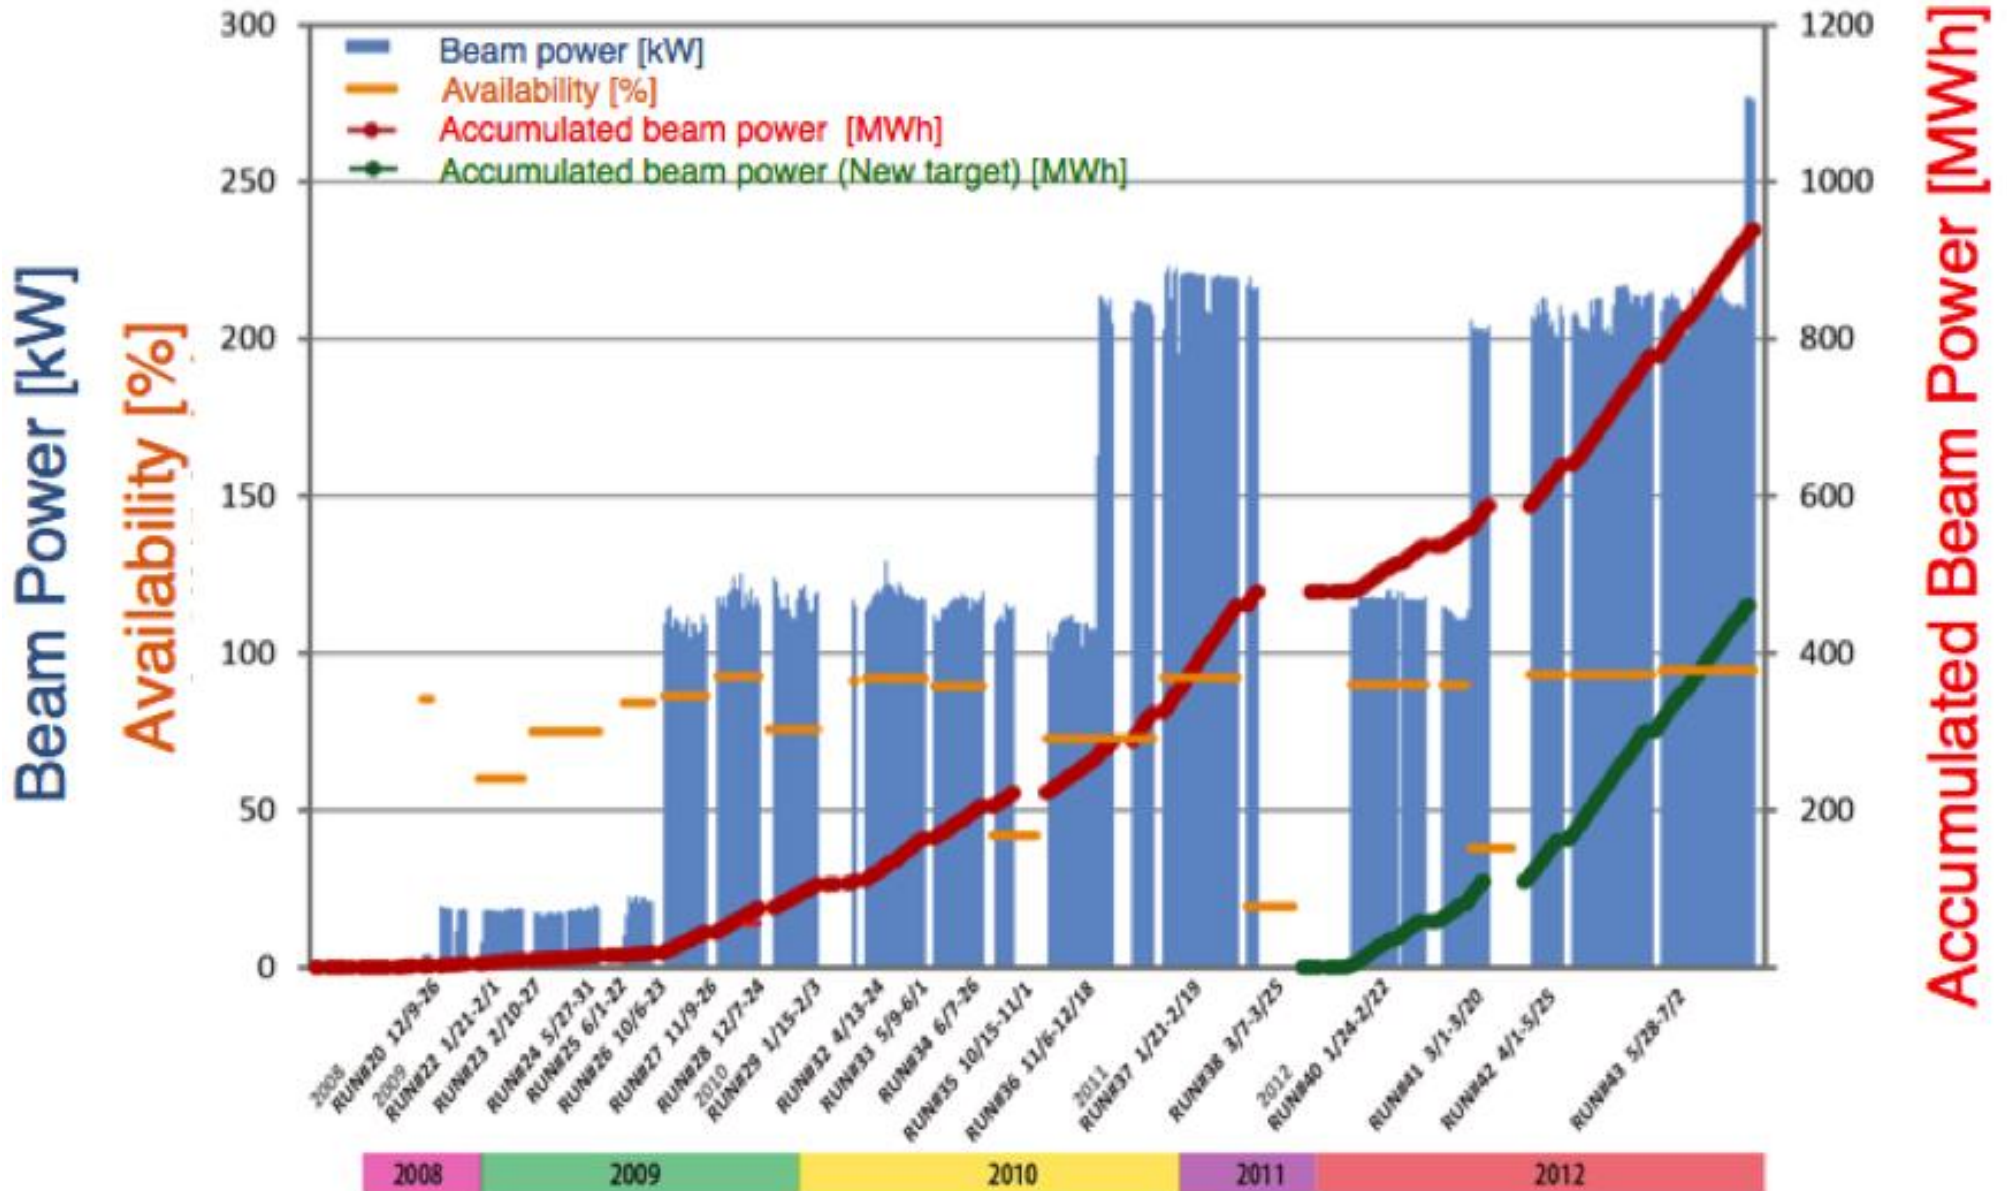
History of beam delivery from RCS to MLF

In the last three days, 275 kW beam was delivered to MLF. Stable operation of 275 kW was successfully demonstrated.

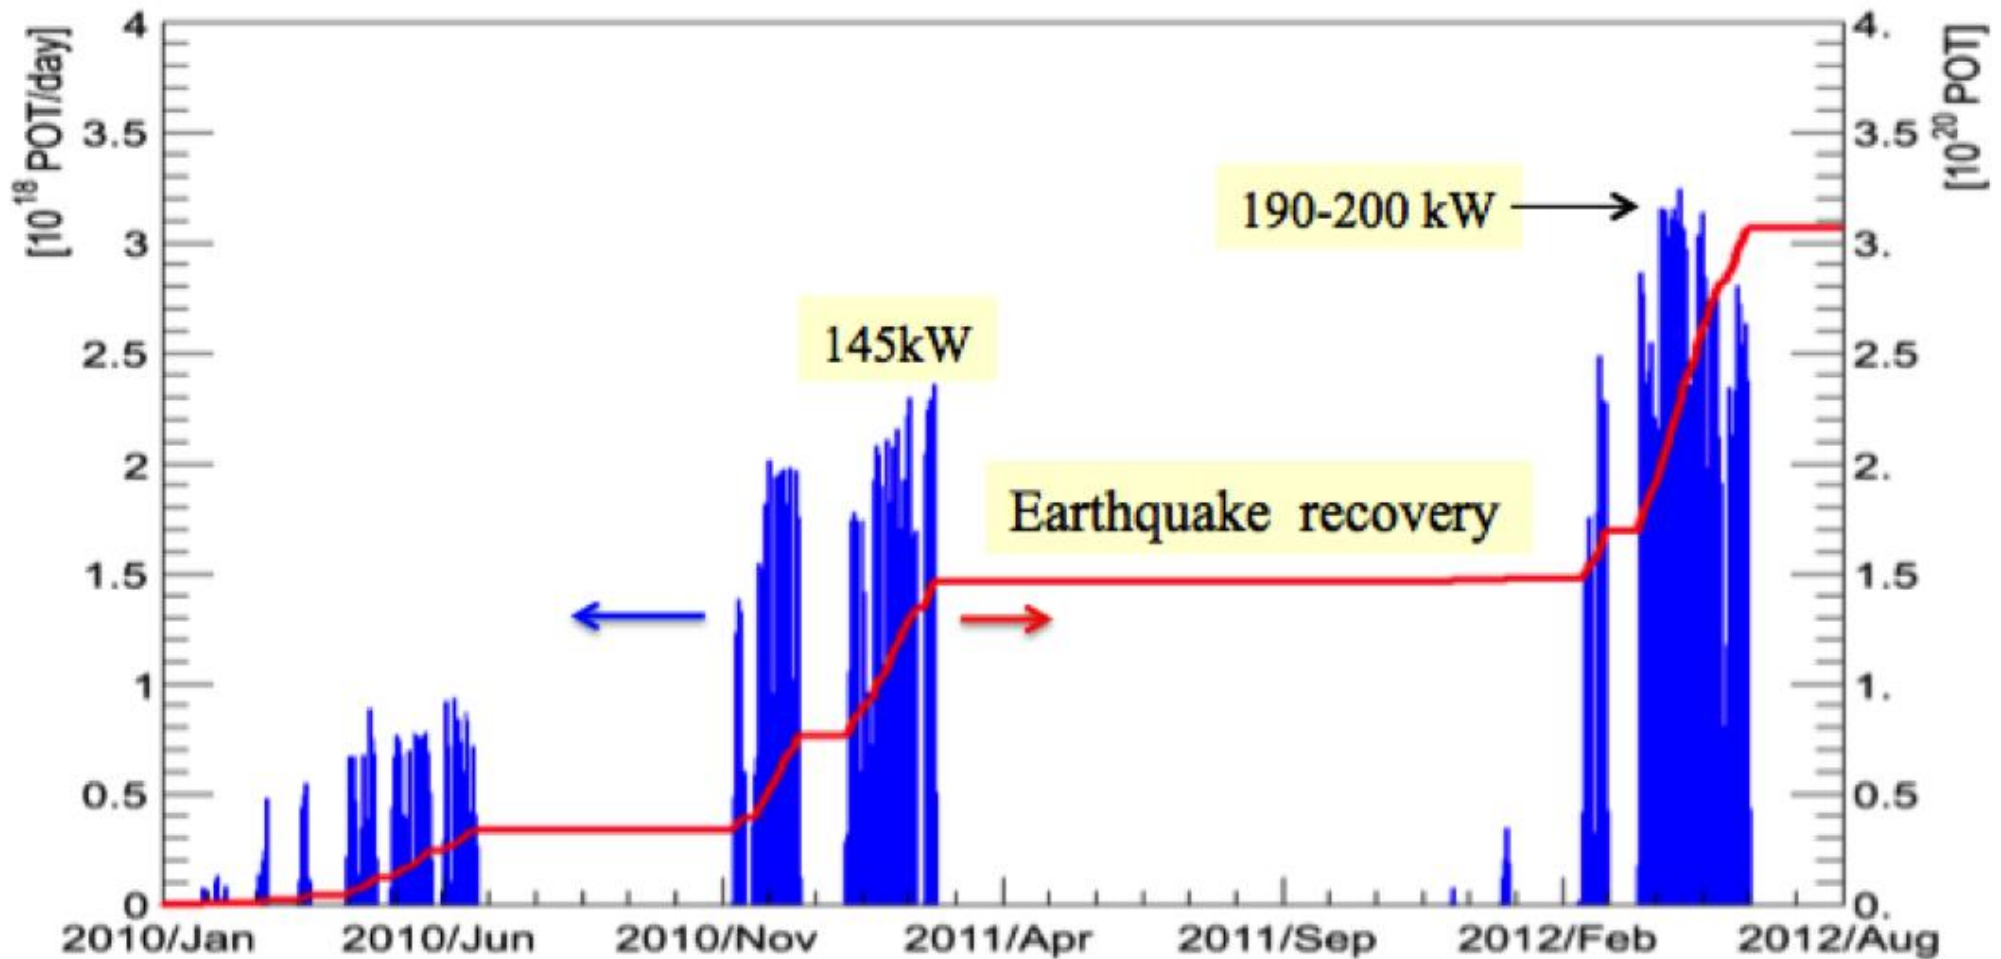
History of beam delivery from MR to the T2K experiment

Delivered POT to Neutrino Beam line (MR-FX)

Operation for beam delivery to the T2K before summer 2012 was finished on June
T2K accumulated the beam of $\sim 3 \times 10^{20}$ POT.

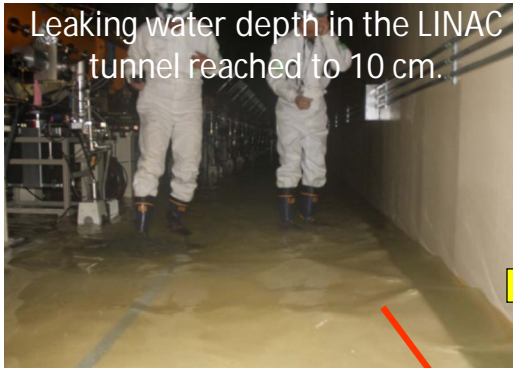
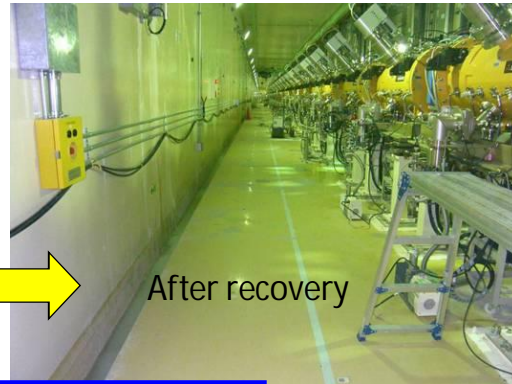
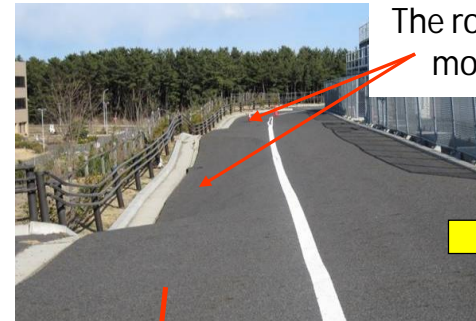
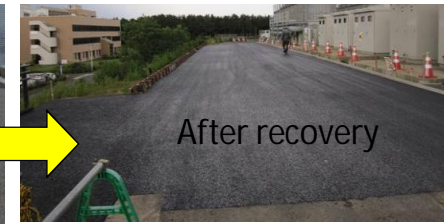
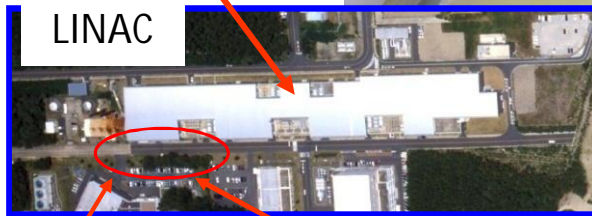
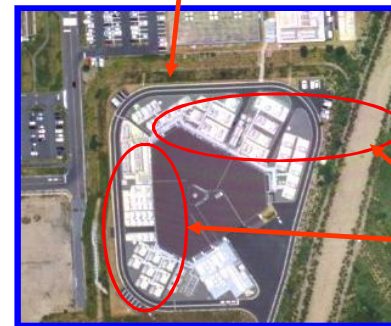
Damages and Recovery Status of Accelerator Facilities

- Fortunately no victims at J-PARC, but severe damages on the facilities, such as piping systems, power devices, and instruments. We also had land subsidence at many places around buildings, water leaks, and misalignment of electromagnets and shielding blocks.

The approach to the LINAC entrance subsided more than 1 m. In contrast, the front road raised a few 10s cm.

Still under the construction

Re-leveled the basis

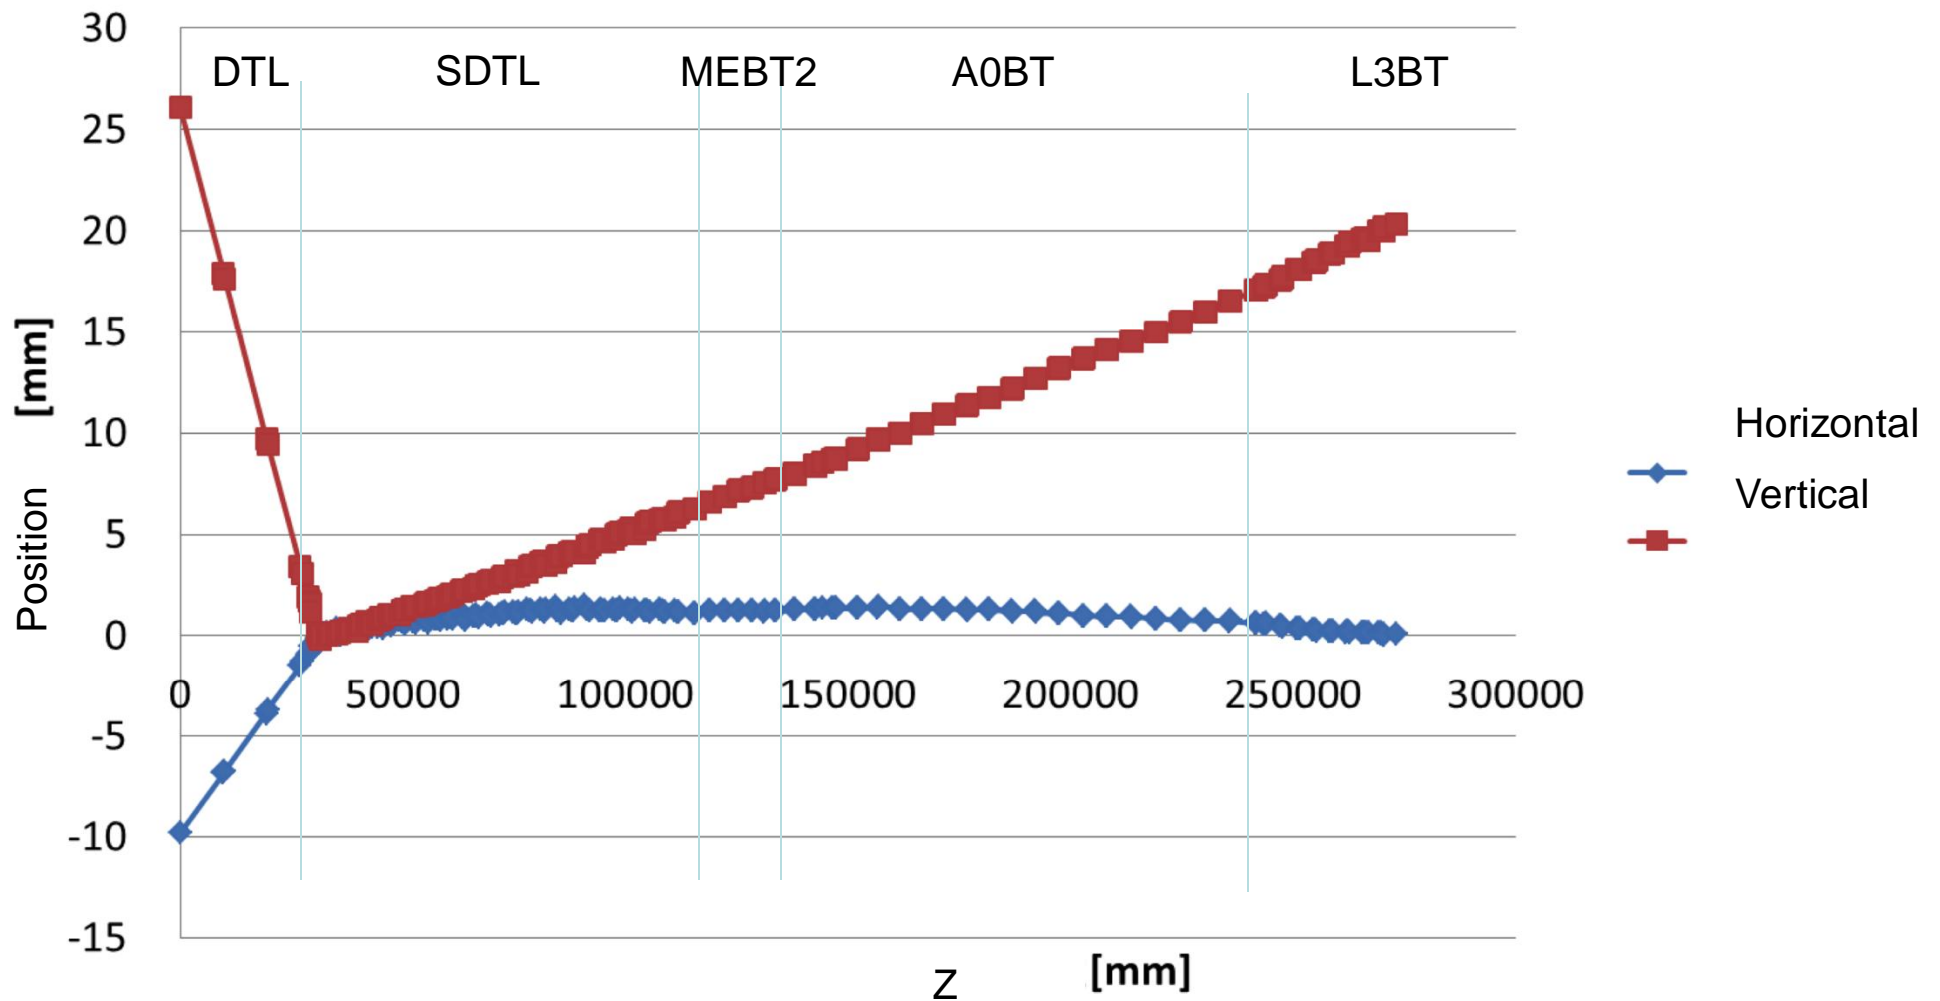
Alignment result of the linac

Bending angle at DTL end : 0.91-mrad horizontally, 0.28-mrad vertically.

In the SDTL & A0BT section, the displacement is 1.5-mm in maximum for horizontal direction.

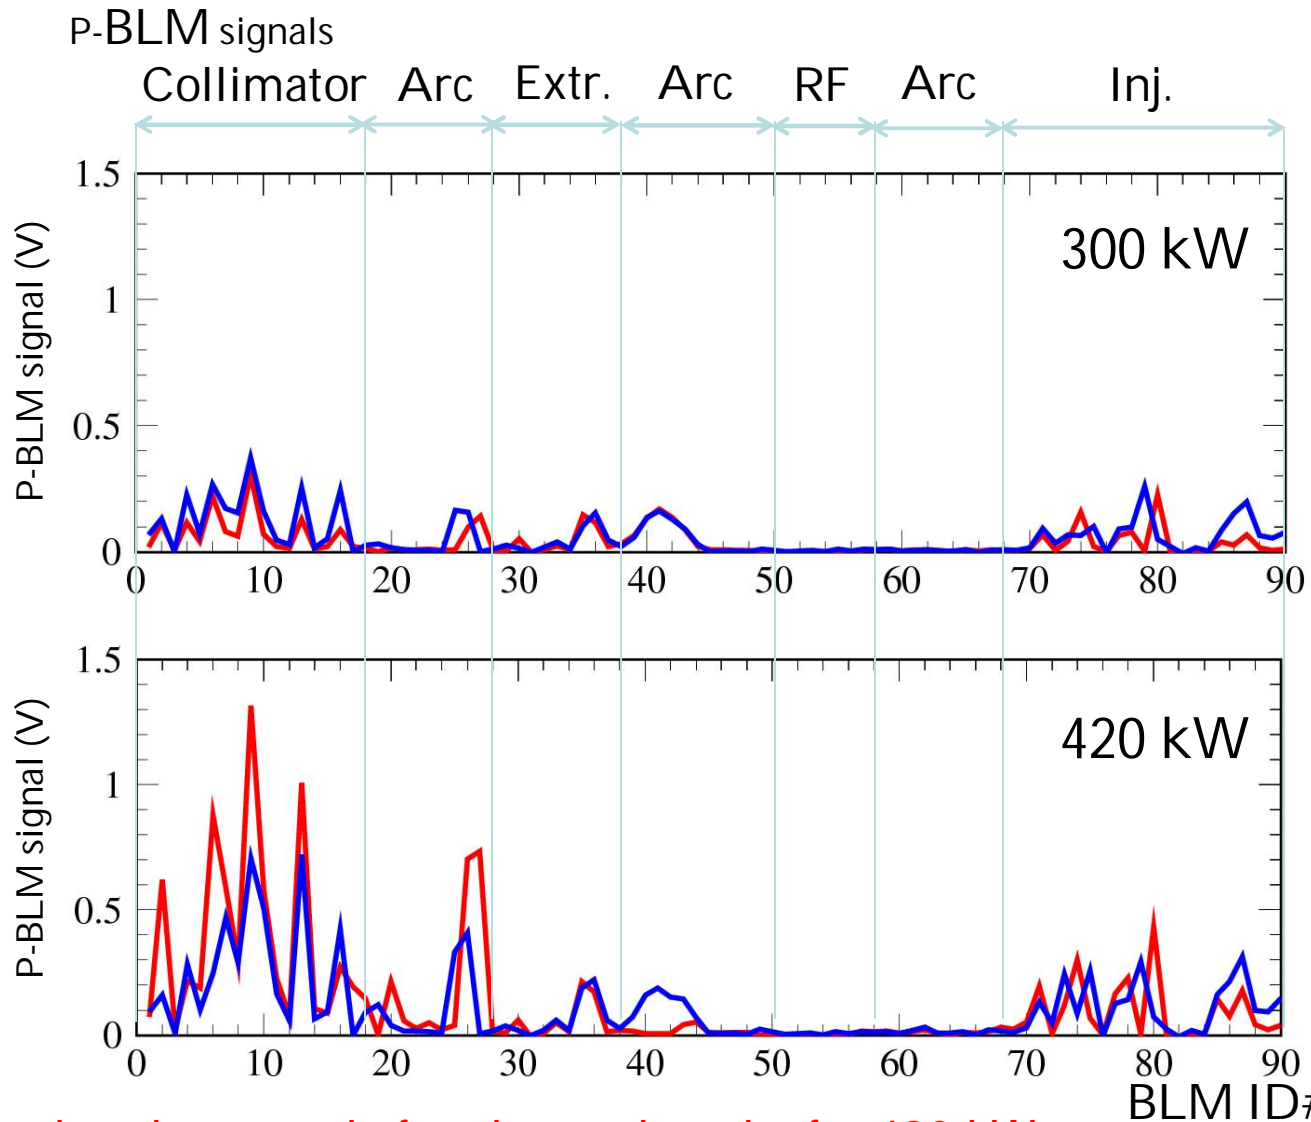
Beam loss in RCS with the beam > 400 kW

— Before the earthquake
— After the earthquake

Beam loss increased after the earthquake for 420 kW

Particle loss before the earthquake: $\sim 0.4\%$

Particle loss after the earthquake: $\sim 0.8\%$

In the summer of 2013, the entire
adjustment of the RCS will be done
