T24 structure fabrication

Production meeting, 20091126

T24#1 fabrication

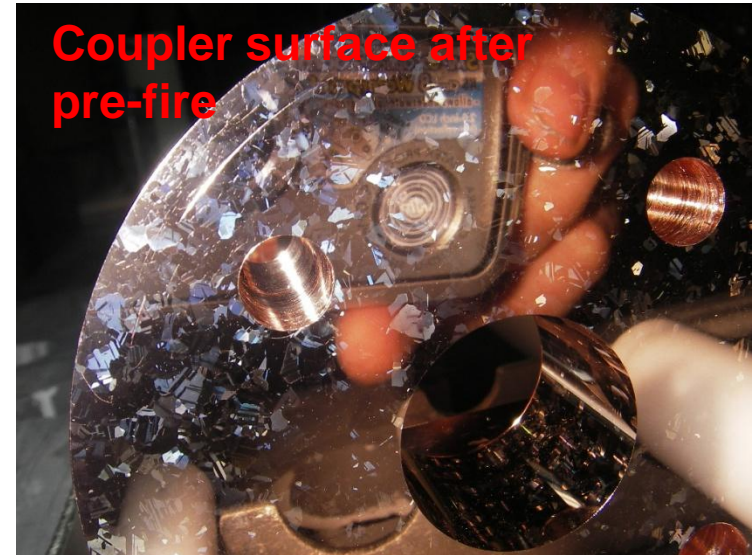
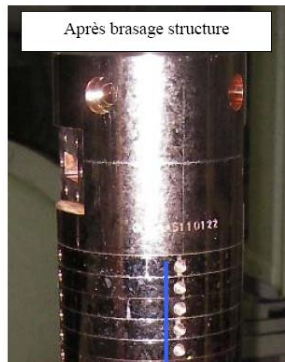
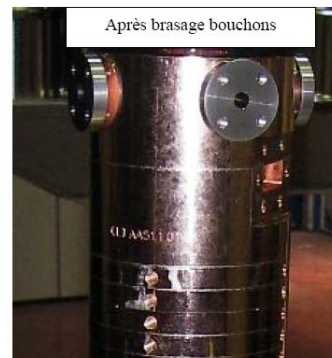
EDMS#10000659

- Pre-fire of disks at 1040 °C
- Brazing of all structure 815 °C, SCP1
- Brazing of cooling circuit 790 °C, eutectic AgCu – **spots of braze filler material**

Zone brasé - présence de cordon de brasage

EDS analysis of brazing filler metal dropped out - The drops of filler metal in structure 11WNSDvg1.8 have a composition close to the Ag-Cu eutectic with **no evidence of Pd.**

- Traces of braze filler material (couplers + outside surface)
 - Compatibility of brazing design (Ag/Cu/Pd ~ 800 C) with pre-fire at 1040 C in Ar (sharp facets observed)
- Oxidation of the structure in clean room
