Sudden Beam Loss (SBL)

2024/6/3 B2GM H. Ikeda

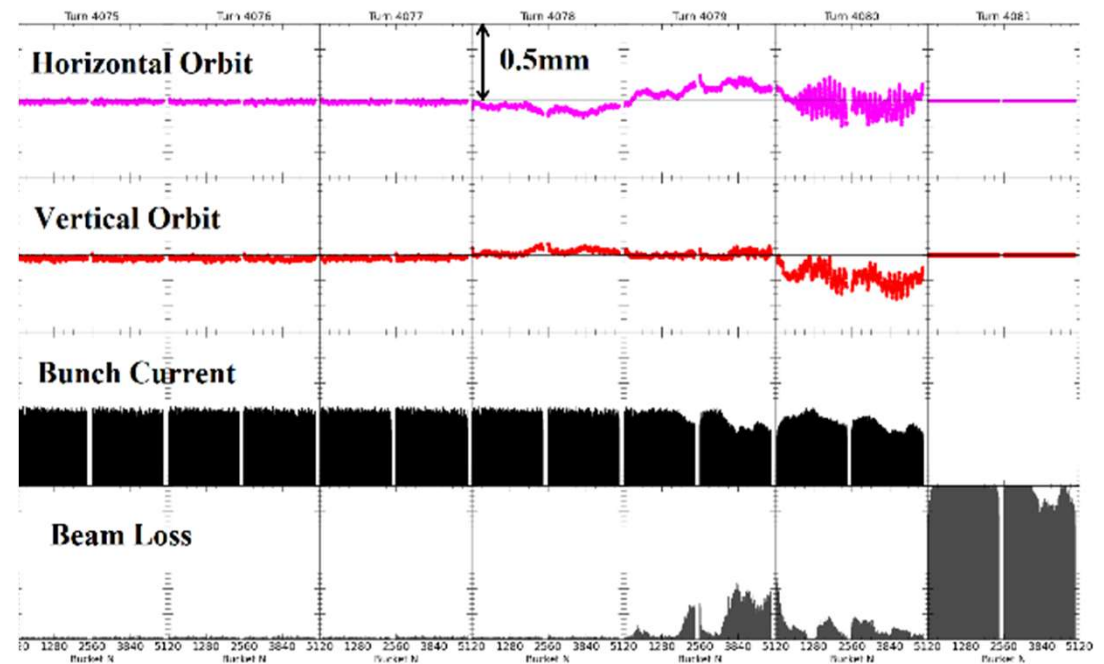
Beam loss that occurs suddenly within 1 turn (10 μ s) without precursory phenomena. = Sudden Beam Loss (SBL)

Beam signal measured by
Bunch Oscillation Recorder(BOR) & Bunch Current Monitor(BCM)

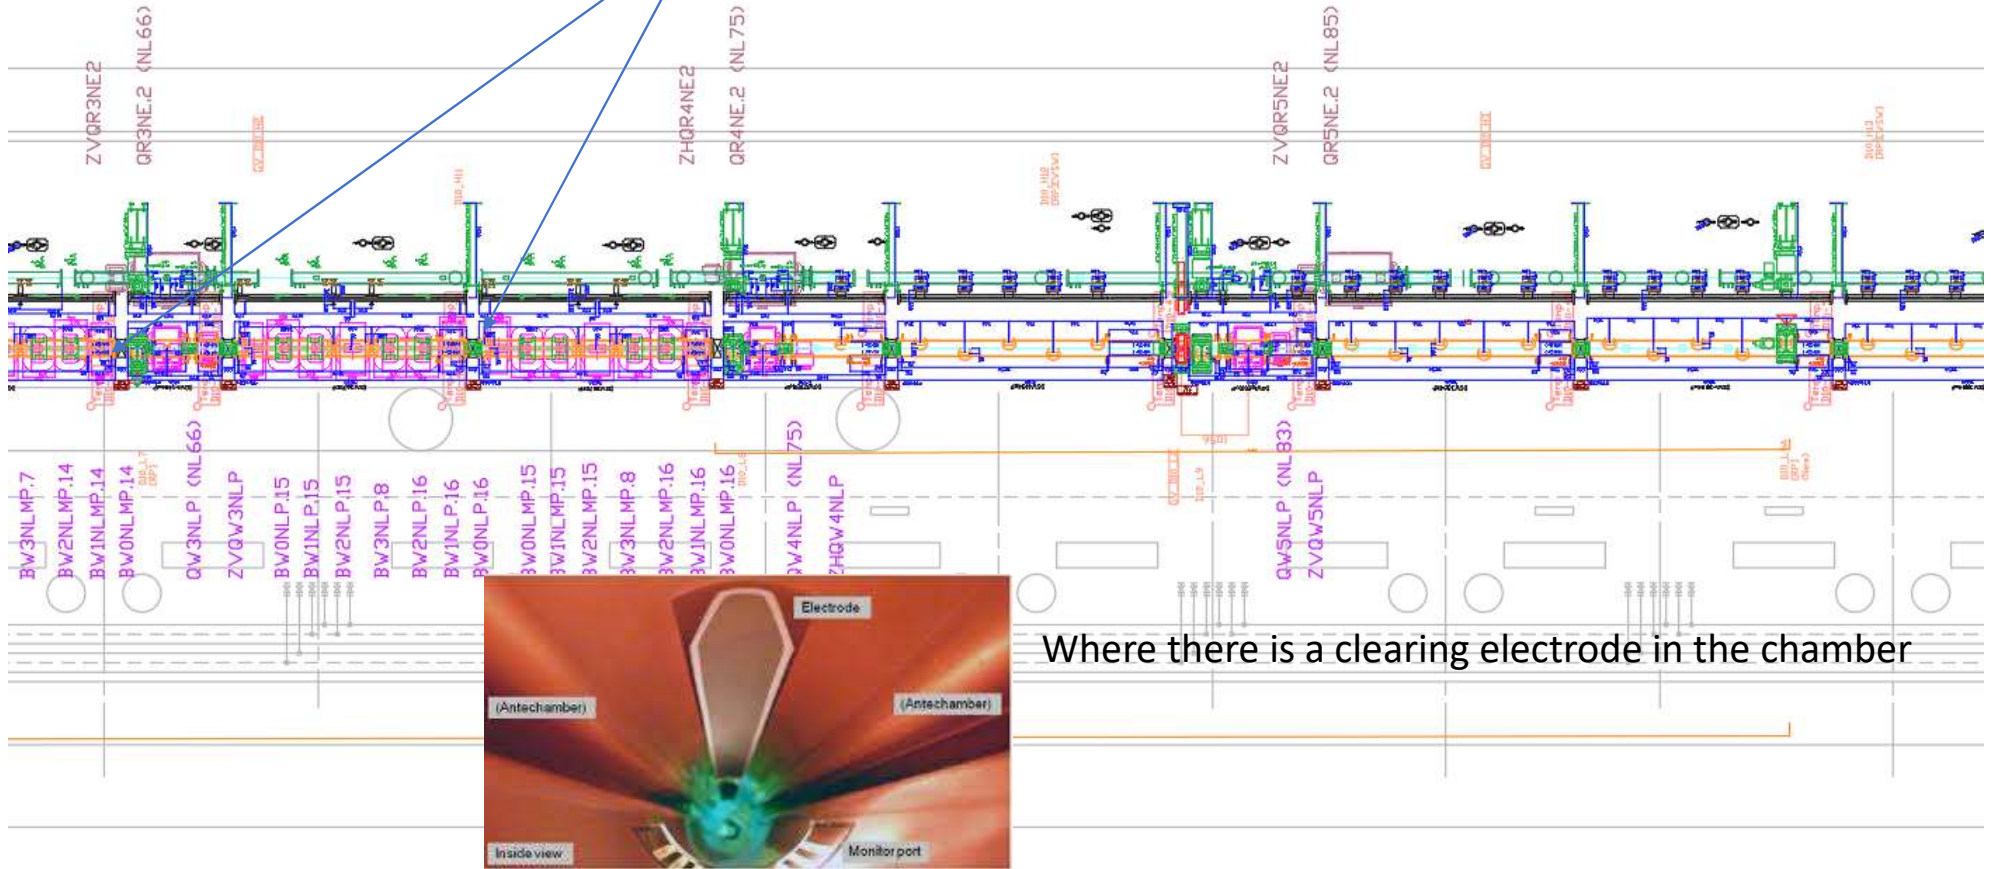
Detailed location of knocker installation D10

- ✓ **Beam pipe with clearing electrode in D10 Nikko Wiggler section** : Electrodes are formed by spraying alumina and tungsten onto copper beam pipes (electrodes are on top of the beam) .

BWONNLP.16 and BWONLMP.14

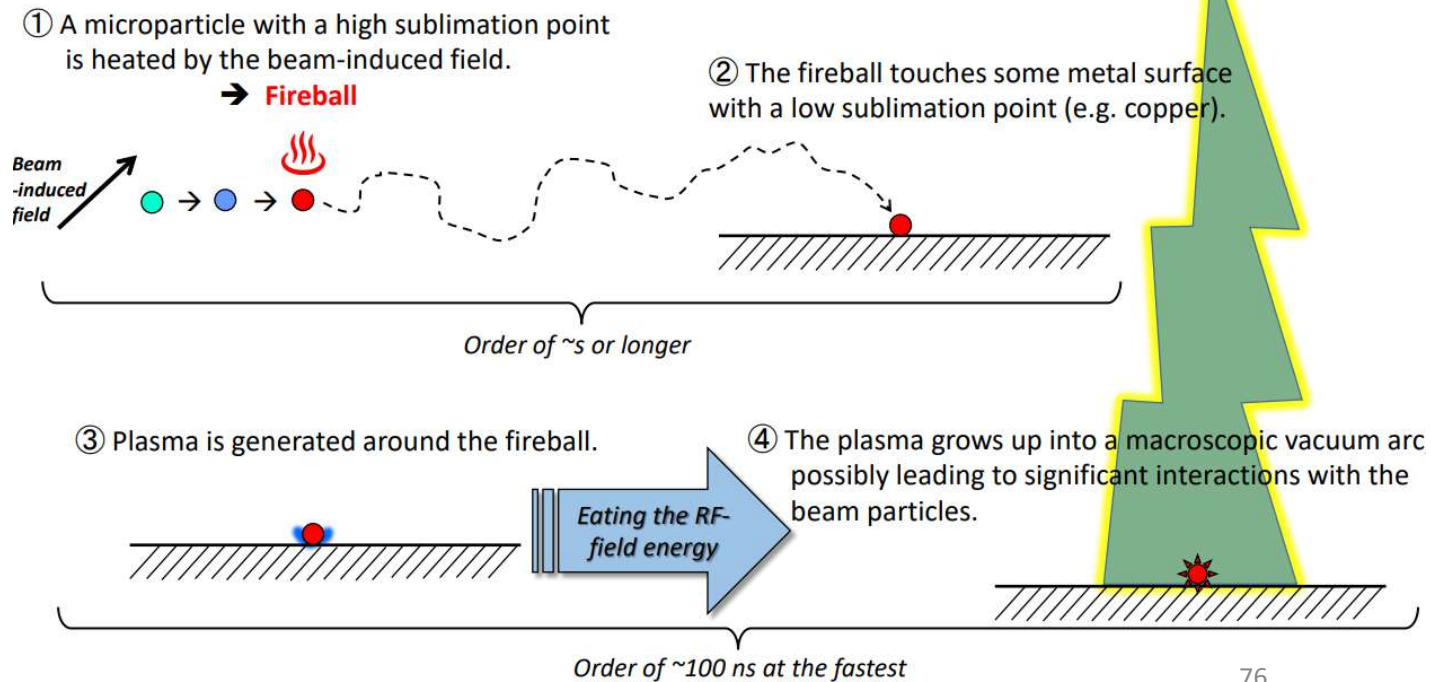
Physical process of the “Fireball” hypothesis, leading to fast beam loss

- Fireball : Measured @ RF cavity
 - The vacuum chamber is made of copper with low sublimation point and collimator head is made of tungsten or tantalum with high sublimation point.
- The situation has the potential for a fireball to be formed.
- This fireball hypothesis could explain SBL ($\sim\mu\text{s}$) due to the fast plasma evolution ($\sim 100\text{ ns}$ at the fastest).
