# AN OVERVIEW OF THE RELIABILITY AND FAULT TRENDS OF THE SYNCHROTRON RADIATION SOURCE

C.L. Hodgkinson, STFC, Daresbury Laboratory, Warrington, UK

The Synchrotron Radiation Source (SRS) at Daresbury Laboratory is a 2GeV 2<sup>nd</sup> generation synchrotron radiation source. The SRS has been an operating light source for 27 years and is scheduled for closure in December 2008.

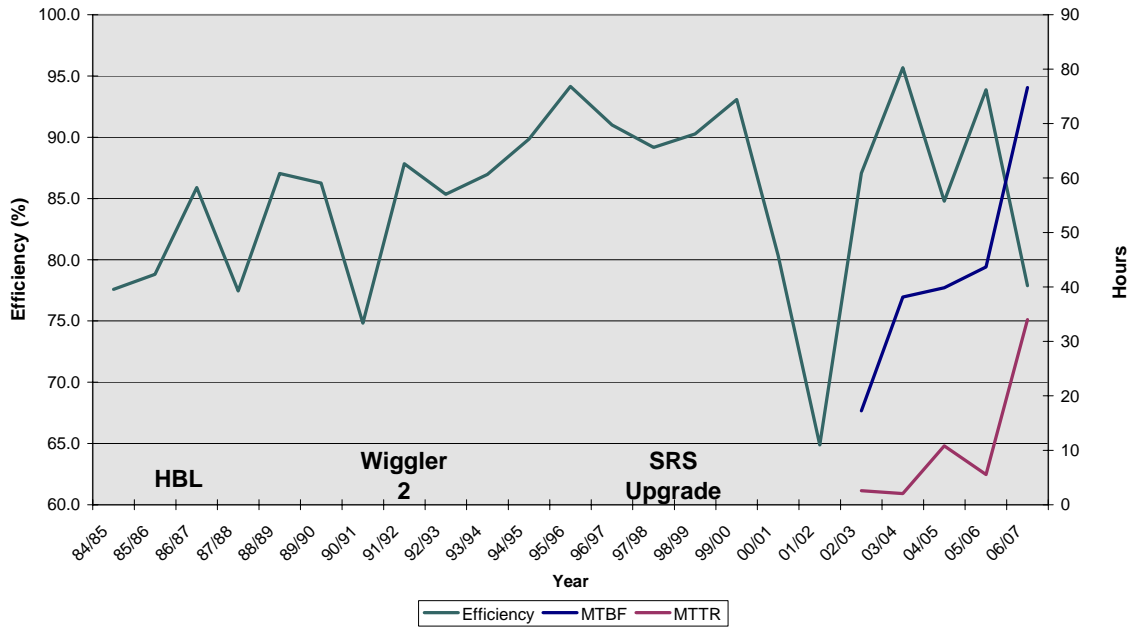
Figure 1: SRS Reliability Data

The efficiency data on the chart from 1984 shows refill compensated efficiency, which is raw efficiency (delivered hours / scheduled hours) with a one hour allowance for each scheduled refill.

Mean Time Between Failure (MTBF) and Mean Time To Repair (MTTR) were only introduced to the published data in 2003.

Figure 1 shows SRS Reliability data from April 1984 to March 2007.

During the first 3 years of accelerator operation, operational efficiency, although monitored was not recorded. Much of the activity being carried out involved collaboration between the university user groups and accelerator physicists at Daresbury to develop experimental techniques. Following initial commissioning of the SRS, the accelerator underwent a number of upgrades to improve the source for users, the installation of the superconducting wavelength shifters, the High Brightness Lattice (HBL) and installation of an Undulator. This resulted in a rather erratic efficiency profile until 1993, as new systems were commissioned and teething problems eliminated the accelerator source then entered, a relatively stable period of operation with no major developments planned.

Throughout the 1990's, the efficiency of the SRS continued to improve, as experienced operations teams became familiar with established systems. Efficiency stabilised in excess of 90% for a number of years and was only marginally effected by the SRS Upgrade, this was an exceptional achievement given the disturbance to the accelerator lattice.

However, in 2001/2002, the efficiency of the SRS fell dramatically, this was due to a water to vacuum leak, caused by a failed vessel absorber. The failure of the absorber occurred during a shutdown and was due to a heat leak between the SC wavelength shifter cryostat and its vessel, this resulted in standing water inside the absorber being frozen, which subsequently ruptured the absorber. A four month unplanned shutdown was required to return to operations, as a large sub-sector of the accelerator and two ports needed to be removed and reinstalled following vacuum processing.

Following this incident, efficiencies rose again. However, this was disruptive year due to two planned shutdowns, to replace the Klystron Power Supply Unit (PSU) and also the installation of two new ports and beamlines. During the year there were a number of losses due to RF trips, which occurred immediately before the replacement of the PSU. There was also another vacuum incident this year when a ceramic feedthrough failed on a Residual Gas Analyser (RGA). Fortunately this did not have a major impact on accelerator operations.

The next significant drop in efficiency occurred in 04/05 and was the result of two vacuum incidents, the first was the loss of an RF Cavity Window, this was the first window to break in over 20 years of operation. In order to reduce to effect on the users, the cavity was taken off tune and the SRS operated with three rather than four RF Cavities until a suitable shutdown later in the year. The second incident had a greater effect on SRS efficiency and was the result of a water to vacuum leak from a Quadrupole vessel absorber.

MTBF and MTTR could be used to determine whether the number of faults are increasing on the SRS. Unfortunately the overall annual figures are skewed in years where there has been a major failure, as the MTBF increases (due to non operation) and the MTTR increases considerably due to long repairs. These figures are more useful when individual systems looked at to determine if a system is showing an increasing number of faults as the machine ages and combing the results with the fault statistics.

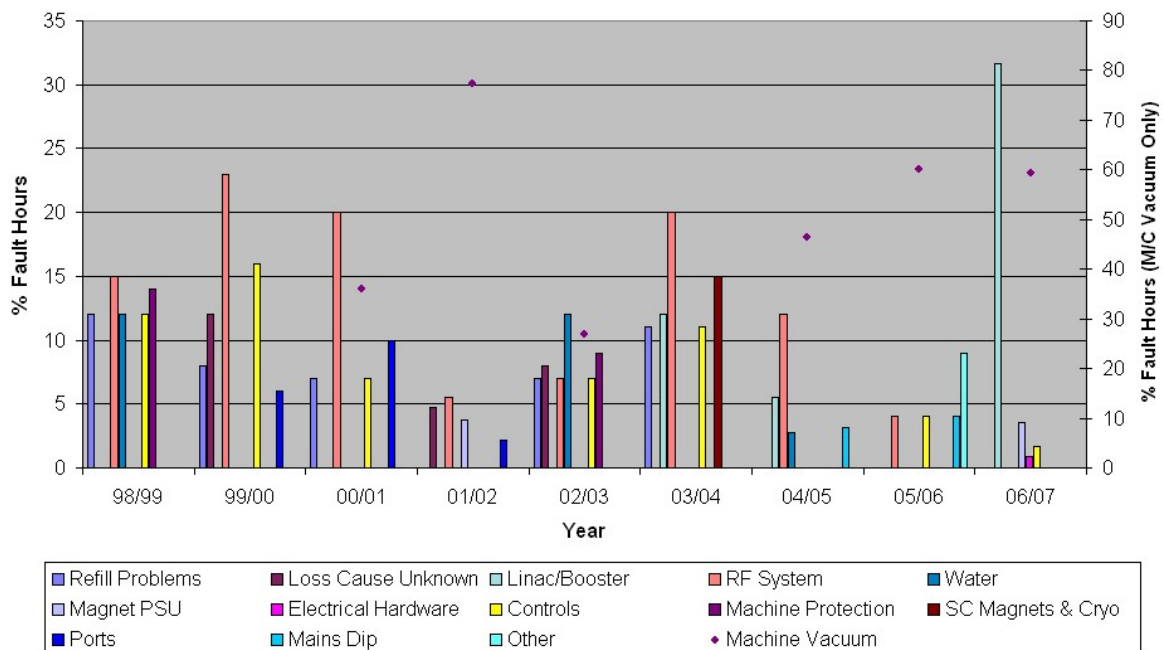
Figure 2: SRS Fault Statistics

The recording of each systems attribution to the fault hours were first published in 1998/99. Figure 2 below shows, for each year since 98/99, the five systems which contributed the most lost user beam time in that particular year.

Analysing the fault statistics, there have been periods of time when a particular system has shown a significant number of fault hours due to start-up issues following the installation of a new or upgraded component in the system. These areas will not be focussed on and the paper will concentrate on profiles and trends which appear or have appeared routinely in the fault statistics.

One of the major issues facing the operations teams during the last few years have been several machine vacuum incidents, which have dominated the fault statistics and skewed the MTBF and MTTR figures. This type of incident is usually an isolated single failure, which is difficult to predict and has significant consequences.

If the vacuum incidents are removed from the statistics, there are a number of systems which have routinely featured highly in the fault statistics, the RF System, Beam Loss Cause Unknown and Controls.

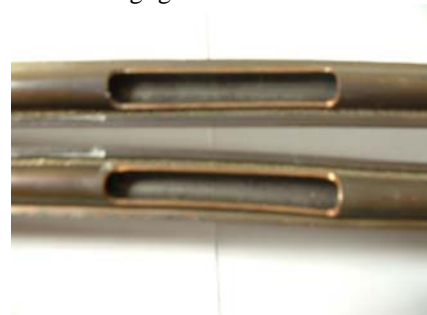
Figure 3: Milled Away Absorber

During the last four to five years of operation, a significant area of concern has been the condition of in vacuum water pipes and whether they have suffered erosion over 26 years of operation, particularly following the failure of an in-vacuum water cooled absorber. In order to assess the risk, sections of 17 year old SRS absorbers removed from the storage ring, Figure 3, were examined and it was confirmed that erosion and change in wall thickness was negligible.

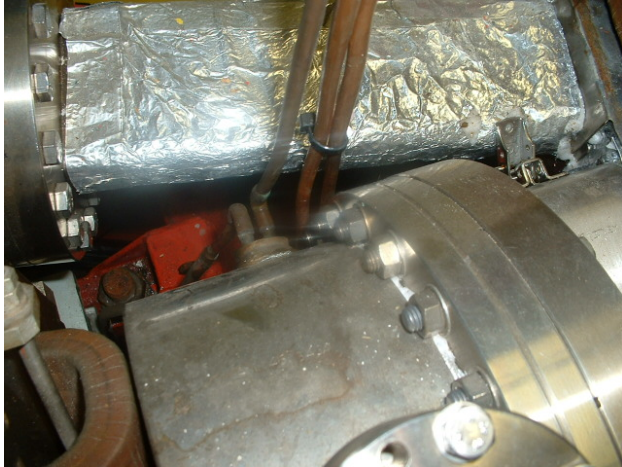
Figure 4: Elbow Water Leak

An area which does not yet feature highly in the statistics, but has been increasing noticeably, are water leaks on pipework external to machine vacuum. The leaks occur on elbow joints - not at the brazed joint, but at the apex of the elbow. The failure mechanism appears to be wear due to the turbulent water flow around the elbow. Mostly these are discovered during shutdowns, as a result they tend not to impact on the operating efficiencies and repairs are quick. If these leaks are not discovered quickly a significant amount of water can be sprayed on to sensitive electrical equipment and accumulate on the floor of the tunnel, increasing local humidity significantly. Fortunately, this type of water has only once resulted in the failure of other equipment, which on that particular occasion was the Injection Septum PSU. The result was 30 hours of lost beam time.

However, external water pipes are now proving to be an issue, with cavitation and erosion causing failures on the apex of the elbow joints. Although, most are relatively straight forward and easy to repair they do cause significant disruption to users, with delays to refills. In a number of cases these elbows are close to ceramic feedthroughs and therefore repair poses a risk to machine vacuum. In unfortunate circumstances these leaks can also lead to failure of sensitive electrical equipment, due to ingress of water and high humidity. Figure 4, shows a typical elbow leak and it's proximity to a ceramic feedthrough.

As a result water leaks are being repaired as and when they occur. One action that has been taken is, over several years of operation cooling water flow rates have gradually been increased, to err on the safe side. The result of this is the possibility of turbulent flow and increased cavitation. Careful setting of appropriate flow rates throughout the cooling system has now been carried out to reduce cavitation to an absolute minimum.

The greatest evidence of systematic failure due to ageing is the failure of copper elbows on cooling circuits. These have a relatively small effect on overall accelerator efficiency, but do have the potential to lead to more serious faults. On an accelerator with a longer period of
