LHC Commissioning

R. Giachino

CERN

WAO 2010

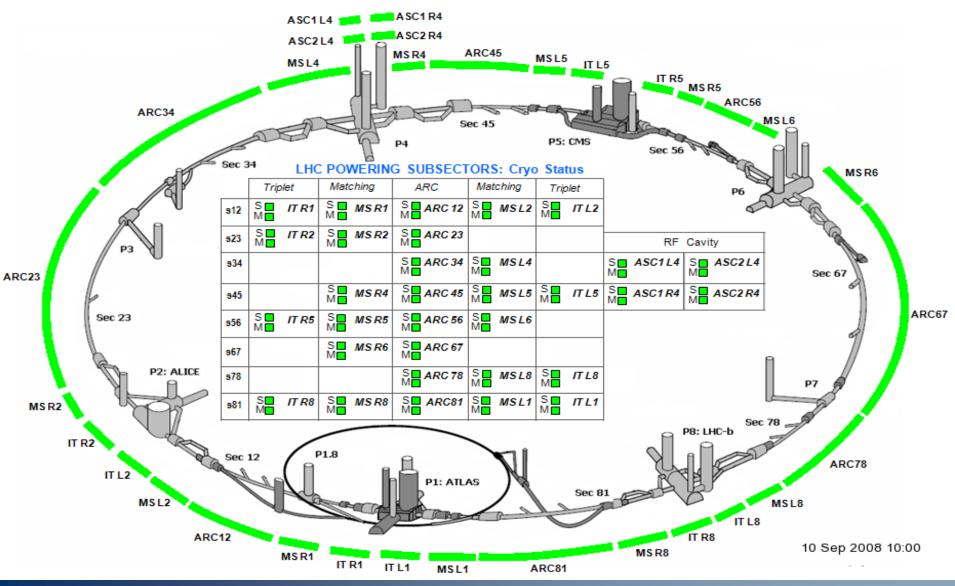
Cryogenic Plant

"Cryo Maintain" – Allowing Circulating Beams 90.4% Available

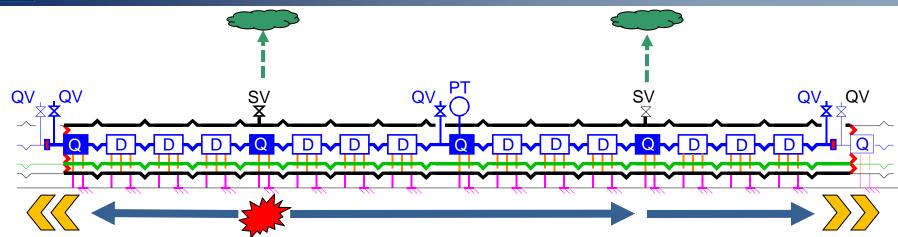
Vacuum Chamber

Dipole bus bar

Pressure wave

- Cold-mass
- Vacuum vessel
 - Cold support post
 - Warm Jack
 - \sim Compensator/Bellows
 - Vacuum barrier

- 1. Pressure Wave propagates inside insulation Vacuum enclosure
- 2. Rapid Pressure Rise
 - Self actuating relief valves could not handle pressure
 - Design: 2Kg He/s Incident: ~20 kg He/s
- 3. Forces on the vacuum barriers (every second cell) Design: 1.5 bar Incident: ~8 bar
 - Several Quadrupoles Displaced by ~50 cm
 - Cryogenic line connections damaged
 - Vacuum to atmospheric pressure

- Electrical Fault at 5.2 TeV in dipole bus bar, between quadrupole and dipole Post-Analysis: R = 220 n Ω , nominal = 0.35n Ω
- Electrical Arc developed and punctured helium enclosure Post-Analysis: 400 MJ dissipated in cold-mass and arcing
- Helium Release into the insulating vacuum
 Post-Analysis: Pressure wave caused most damage

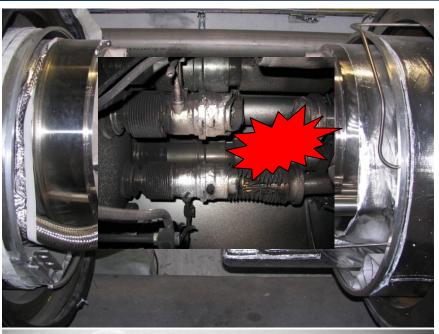
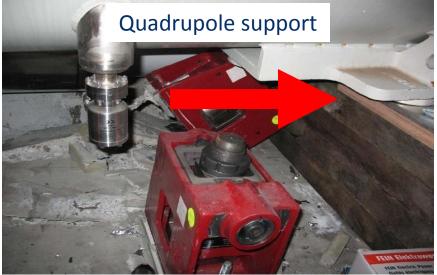
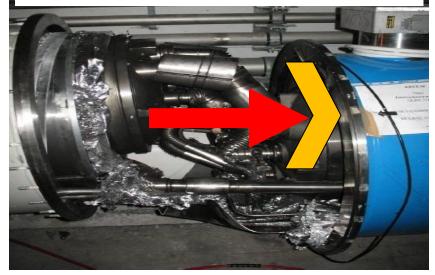
Collateral Damage

Quadrupole-dipole interconnection

Main Damage Area: 700m

- 39 dipoles and 14 quadrupoles effected
- moved to surface:
- 37 replaced and 16 repaired

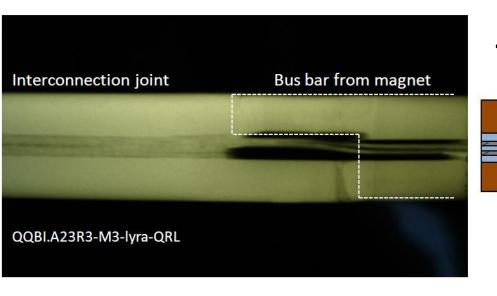
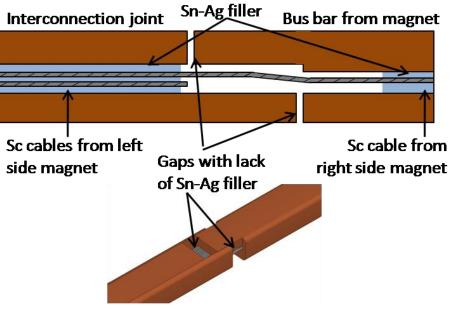
Observed Interconnections

Defective interconnetion-bus bar transition γ -ray picture (left) and scheme (right)

The electrical incident revealed quality issues of the bus-bar joints.

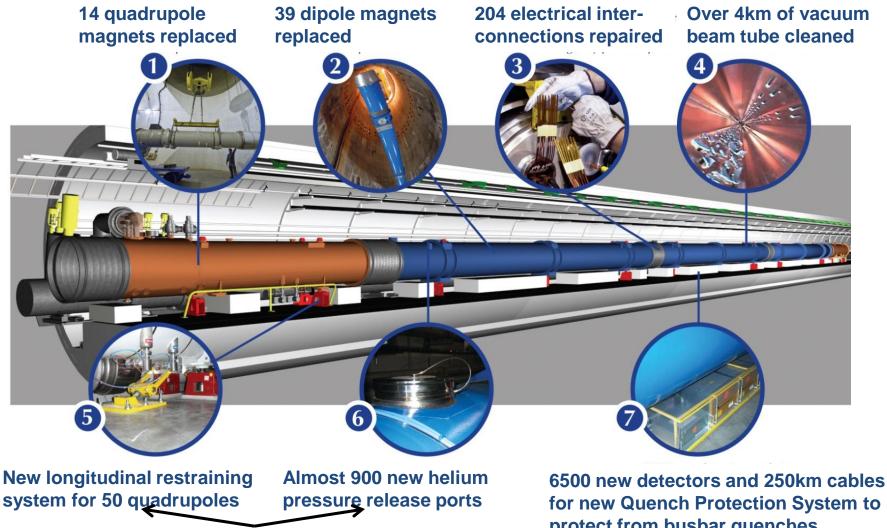
LHC repair and consolidation

Collateral damage mitigation

for new Quench Protection System to protect from busbar quenches

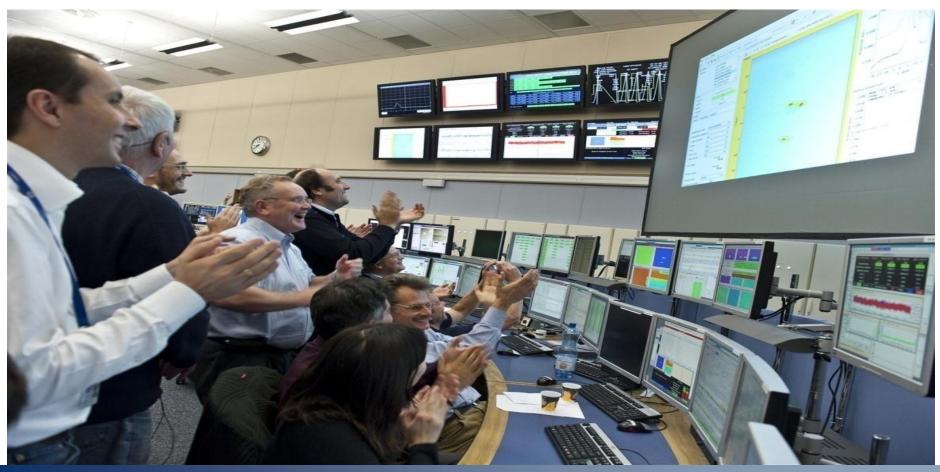
20th November – Circulating beams again!

20 th November	Day 0	Both Beams Circulating after 6 hours
23 rd November	Day 3	First pilot collisions at 450 GeV
29 th November	Day 9	Beams ramped to 1.18 TeV
6 th December	Day 16	Stable Collisions at 450 GeV for experiments
8 th December	Day 18	First collisions at 1.18 TeV

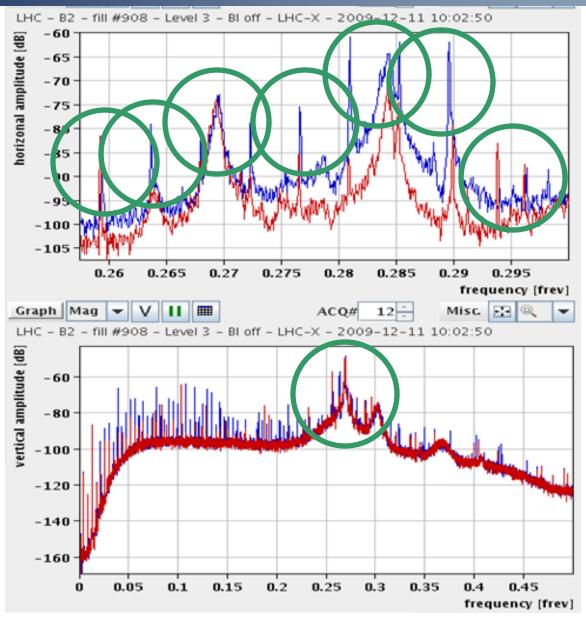
Food for thought – Tune Spectra
