A Fire at KEK LINAC and Its Recovery

Kazuro Furukawa

for KEK e⁻/e⁺ Injector LINAC

Fire at Injector Linac Building

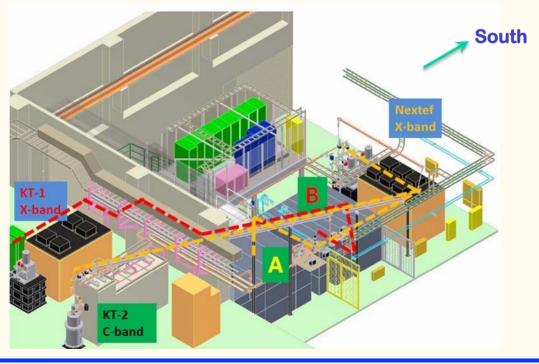
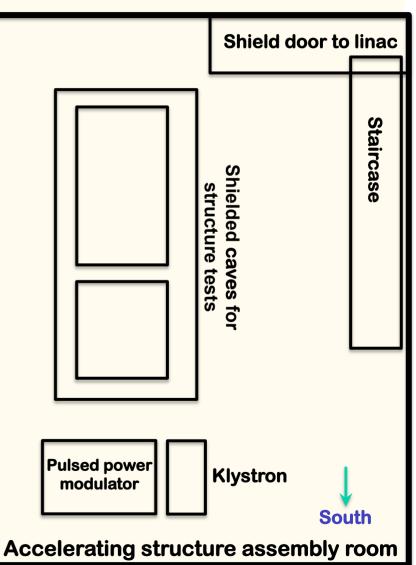
Accelerating Structure Test Facility in the Assembly Hall

Adjacent to the south of the injector building

- ***** X-band, C-band, S-band developments
- Nextef : research collaboration with CERN and US labs. (for 13 years)
 - **¤** 150 MW high-power pulsed power modulator
- On the 2nd day of a planned 3-month work
- Planned to be used for S-band from FY2020

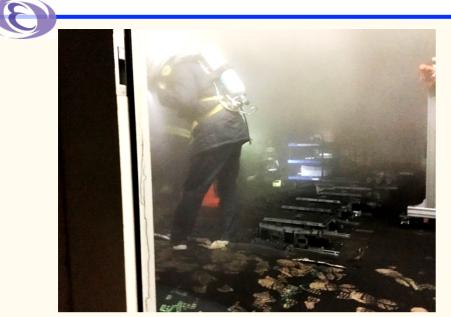
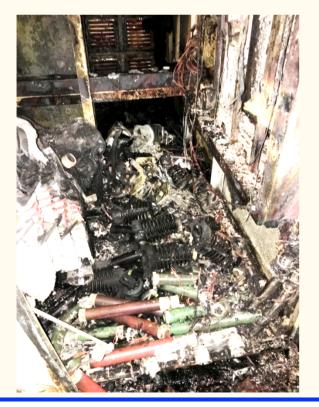
Fireman in the smoke and carbon soot

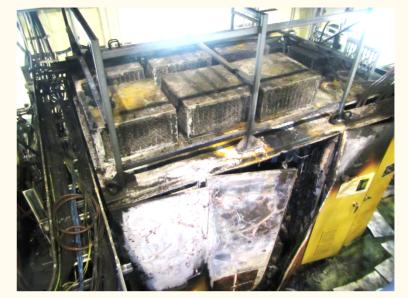
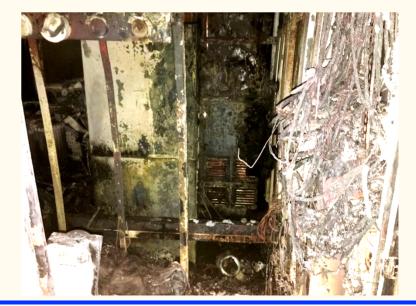
A fire started in a microwave high-power modulator

- \asymp X-band microwave: 11.424 GHz, 10 100 MW, 1 μ s, 50 Hz
- An aged capacitor in the pulse-forming network (PFN) burst, discharged, ignited

Modulator burnt

- A capacitor with plastic container in the pulse forming network of high-power modulator punctured, discharged, and fired
- The modulator was restarted after the initial interlock without detailed investigations

- Usage of metal (or ceramic) container capacitors
- Conservative (long-life) capacitor design with lower gradient
- Routine inspection of characteristics of capacitors
- Rigid interlock handling
- Improve the sensors and video cameras
- Documentations especially with power board connections
- Tight communication between main injector operation and test-stand experiments

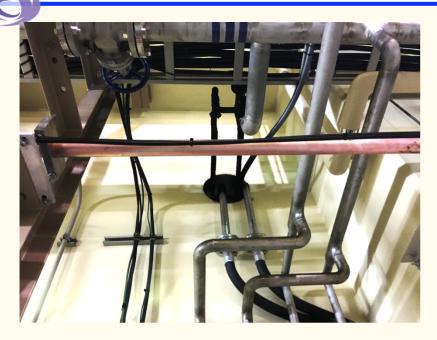
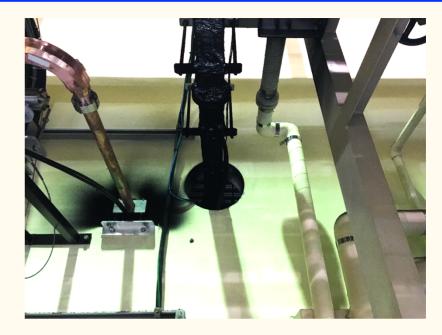
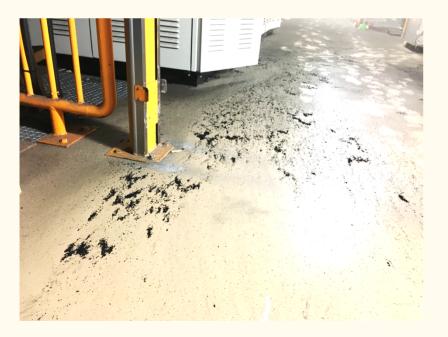
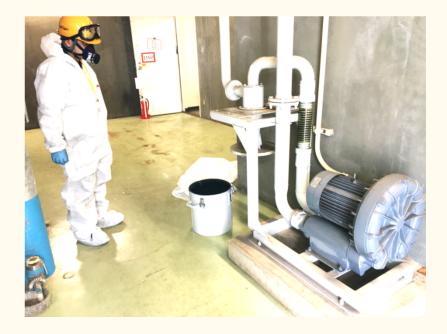
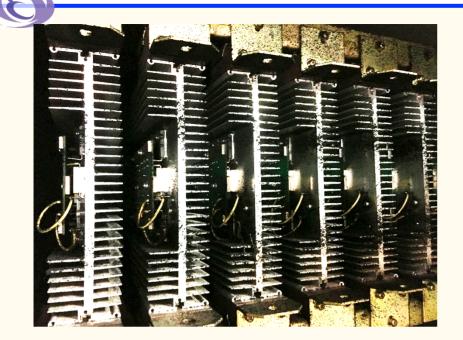
- No injury (could not enter the hall because of smoke)
- Self-extinguished when firemen entered with oxygen
- No direct fire damage to the main injector linac...
- Large amount of carbon soot sneaked into the injector
 - Discharge might prevent high-voltage operation of high-power pulsed modulators
 - Short-circuit might prevent high-precision operation of the instrumentation

Carbon soot sneaked through holes between rooms

Carbon soot in the equipment

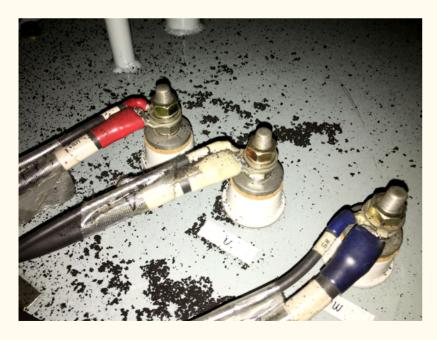
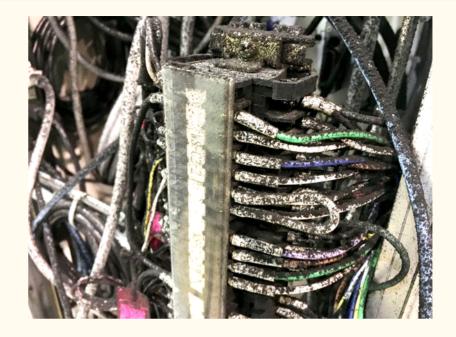
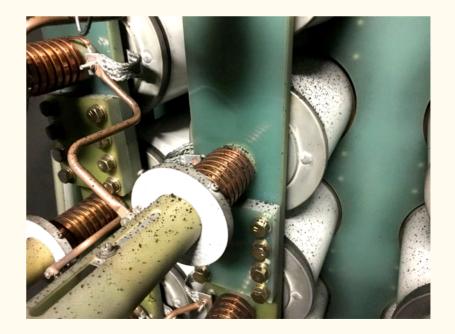
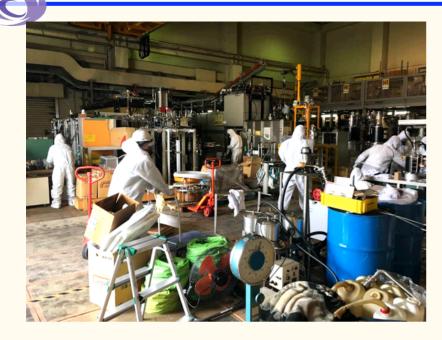
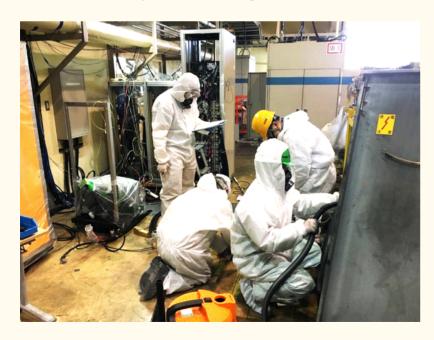
Cleanup one by one

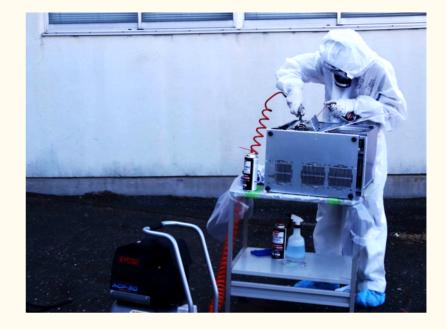
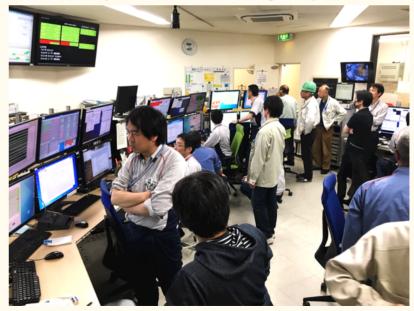
Low-power & high-power tests

Apr.18: Low power test started.

Apr.22, 23: High power test was performed successfully.

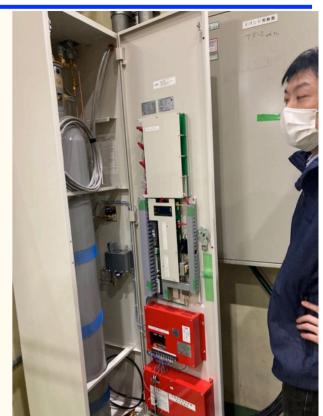
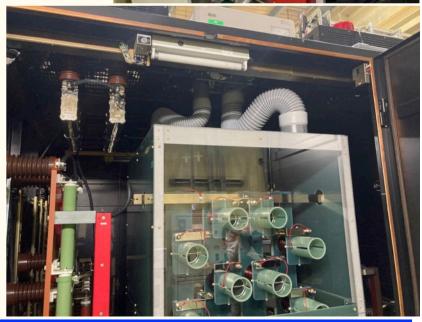
Auto-extinguisher and Cameras

- We experienced punctures before
- We learnt that several other institute experience such fire incidents
 - At least we got information from SLAC and CERN
- An automatic extinguisher was installed in the new Nextef modulator
 - A smoke sensor triggers non-combustible gas into PFN box
- Hundred of video cameras were installed to observe interlocked devices in main LINAC

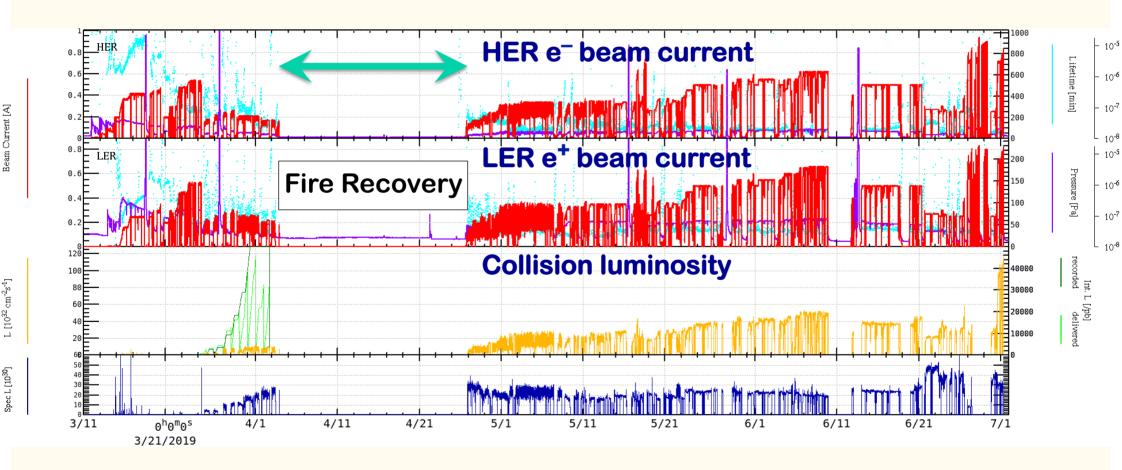
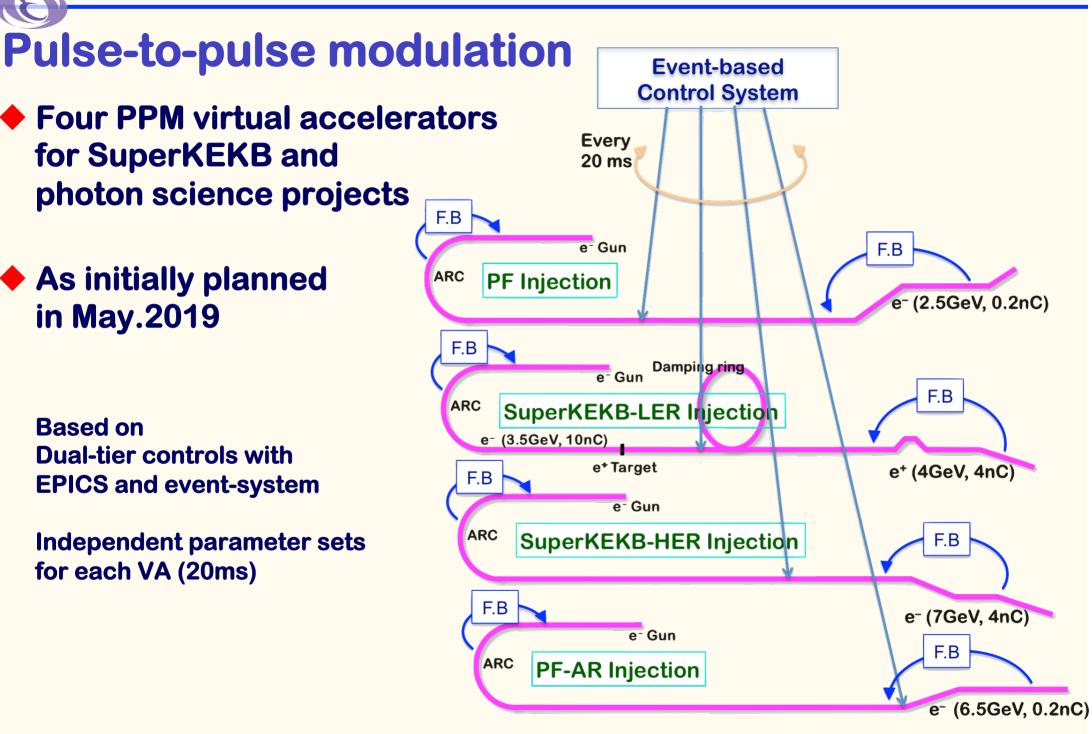
Impact on SuperKEKB Operation

Beam suspension for 3 weeks

- i at the first stage of phase 3 operation
- i at the middle of luminosity development

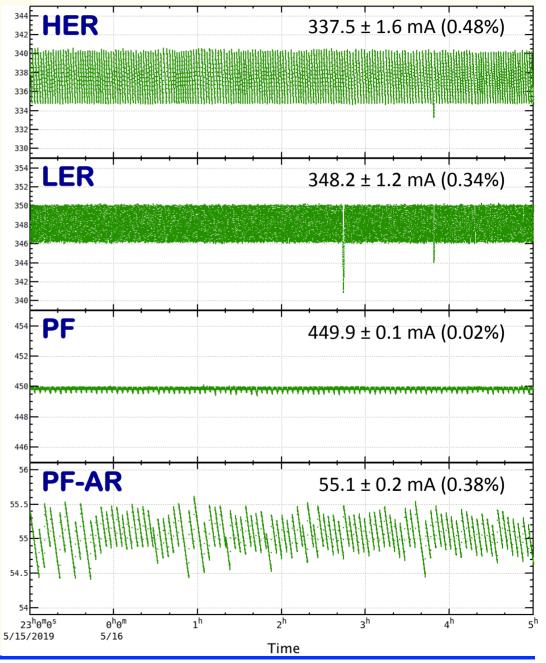
Simultaneous 4 + 1 Ring Top-up Injection

Realized for the first time

- ≍ SuperKEKB HER 7 GeV e-
- □ SuperKEKB DR and LER 4 GeV e+
- ¤ PF-AR 5.0 / 6.5 GeV e-
- 4 beams are modulated at 20 ms PPM
- More than 200 pulsed devices were constructed for SuperKEKB, as well as beam and RF monitors
- Injection noise (background) were well studied from the 2nd week of May

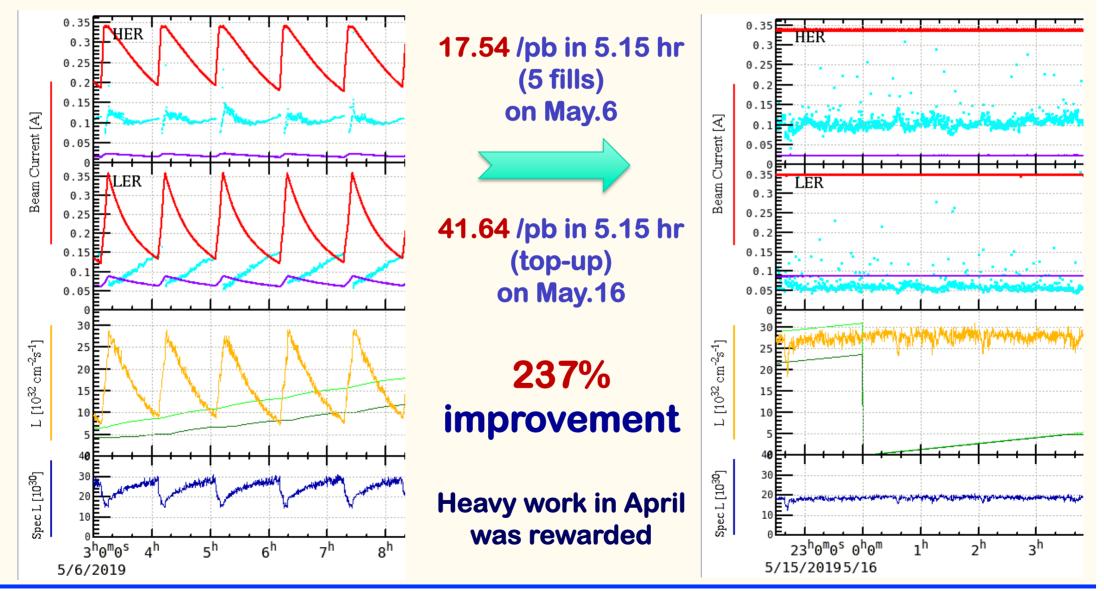
Simultaneous Top-up Injections Integrated luminosity improvement (example)
