SuperKEKB status

2025/09/29 B2GM
Ryuichi Ueki
on behalf of SuperKEKB

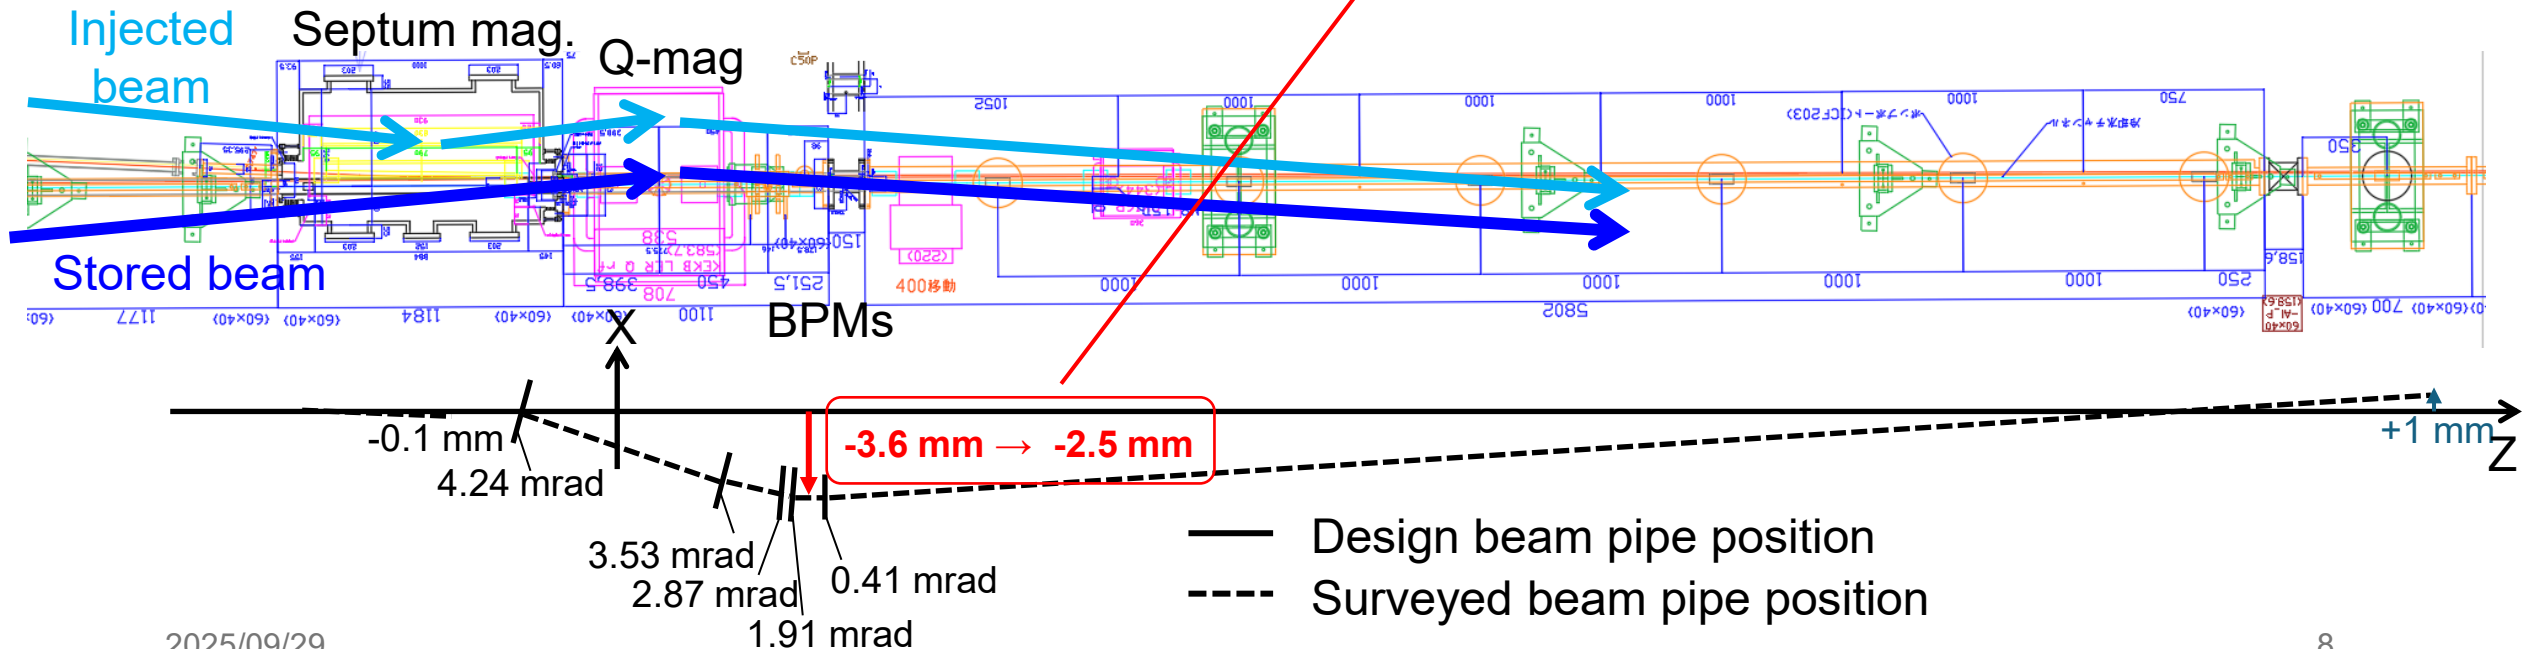
- LER beam pipe position survey was carried out.
- We found out beam pipes were tilted and deformed.

Improvement of physical aperture is expected.

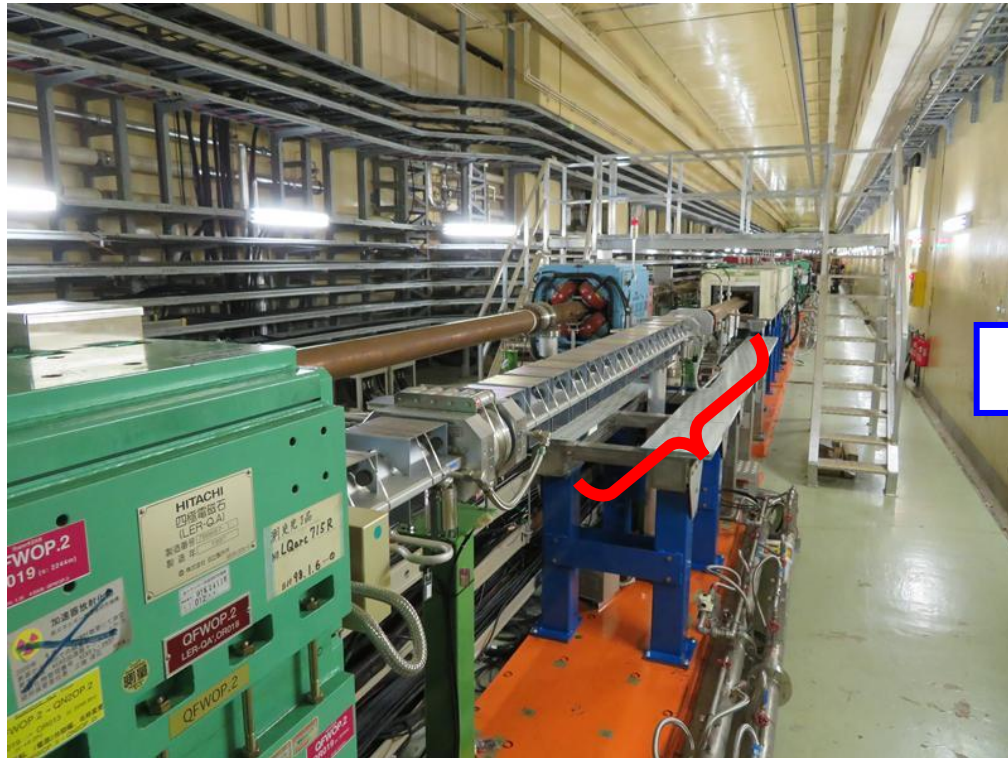
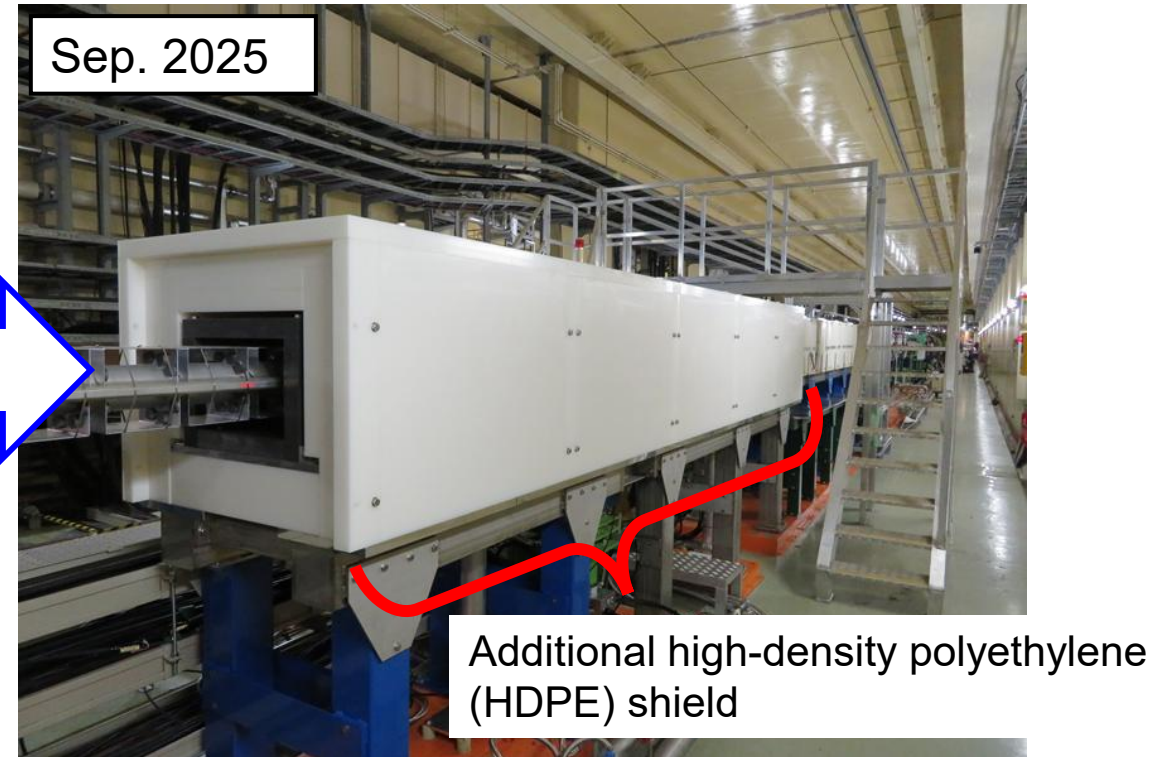
2. Shield extension at downstream of D5V1 collimator

- Radiation shielding at downstream of NLC was extended from 5 m to 10 m.

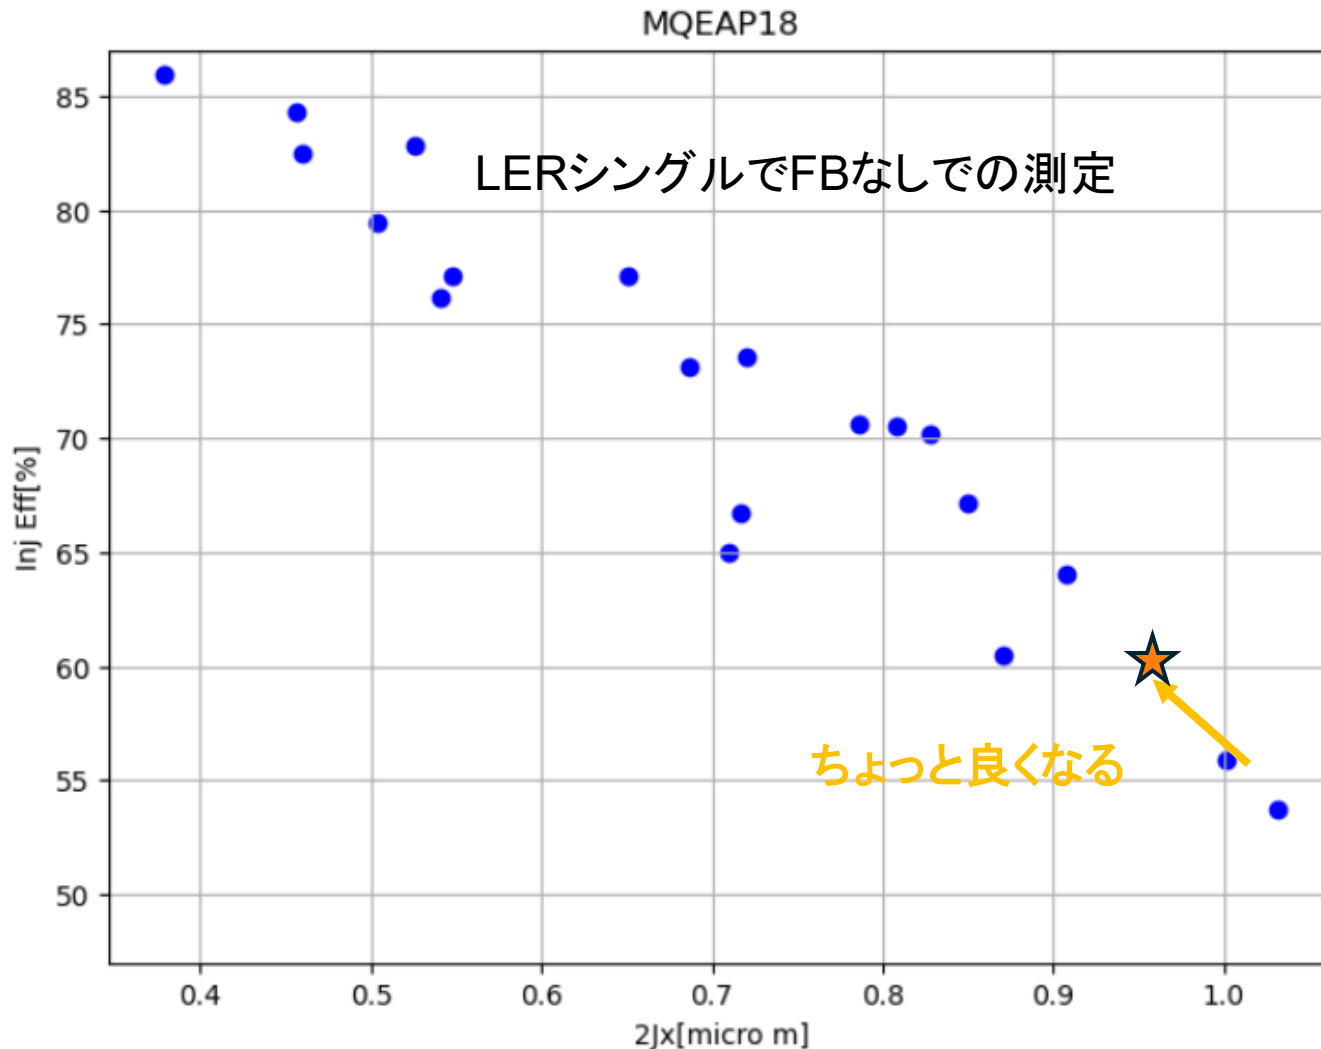
By*1mmでの2Jxの改善具合の推定

- LERシングルなら
By*1mm でも
2Aに到達可能！（かも？）

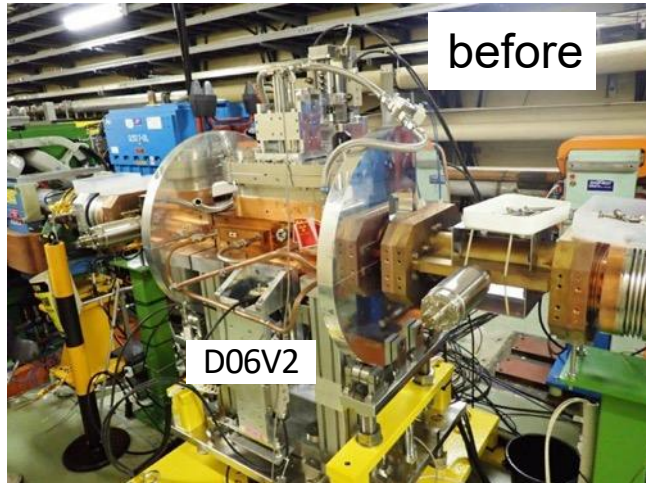
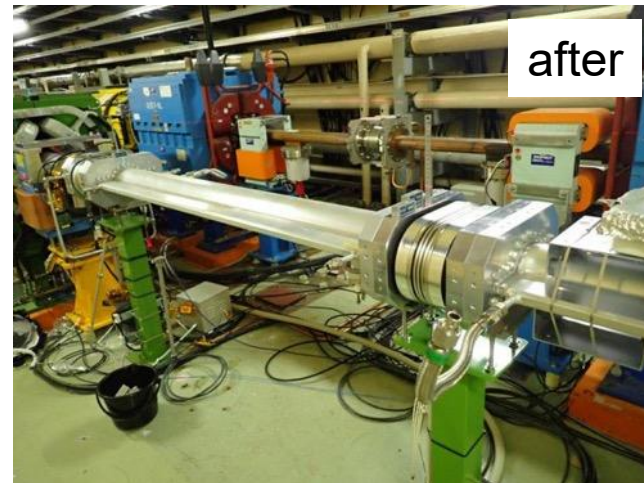
Location of D06V2

- The D06V2 collimator was relocated to D03V4 as a countermeasure against SBLs to reduce losses at the IR and D02V1 regions.

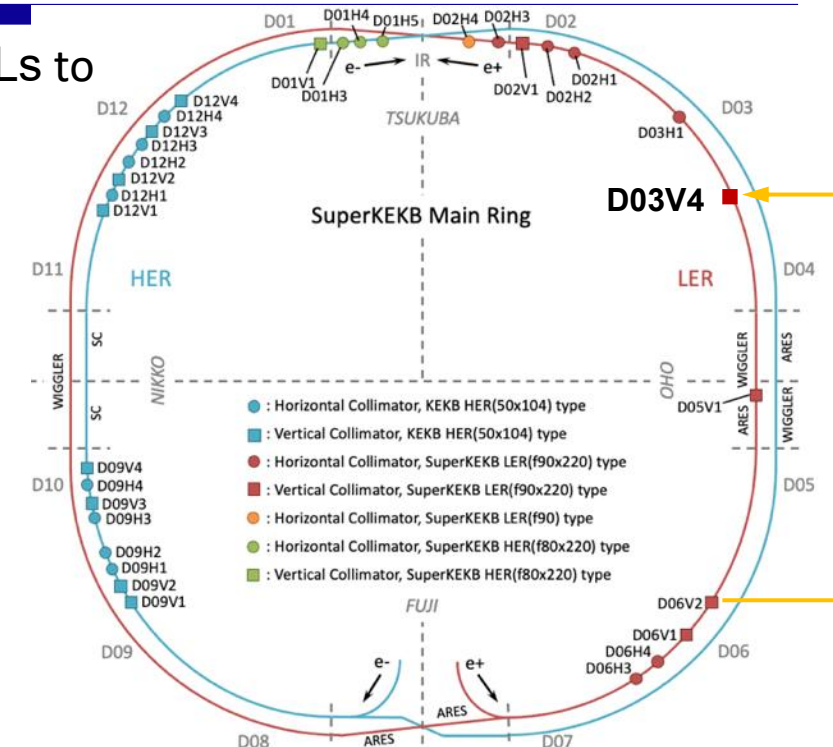
Name	Tip Material (): longitudinal length in mm	Tip Condition
D06V1	Ti (10)	Healthy
D05V1	Top: Ti (10) Bottom: Ta (10)	Healthy
D03V4	Hybrid: Ta (3) + C (7)	Healthy
D02V1	Ta (10)	Healthy

- Damaged jaws in D02V1 and D05V1 were replaced with new ones.
- The top jaw removed from D05V1 was replaced, although its flat area at the tip appeared undamaged and still usable.
- We installed a Ti jaw on the top side of D05V1 to test its durability and evaluate its background reduction performance.

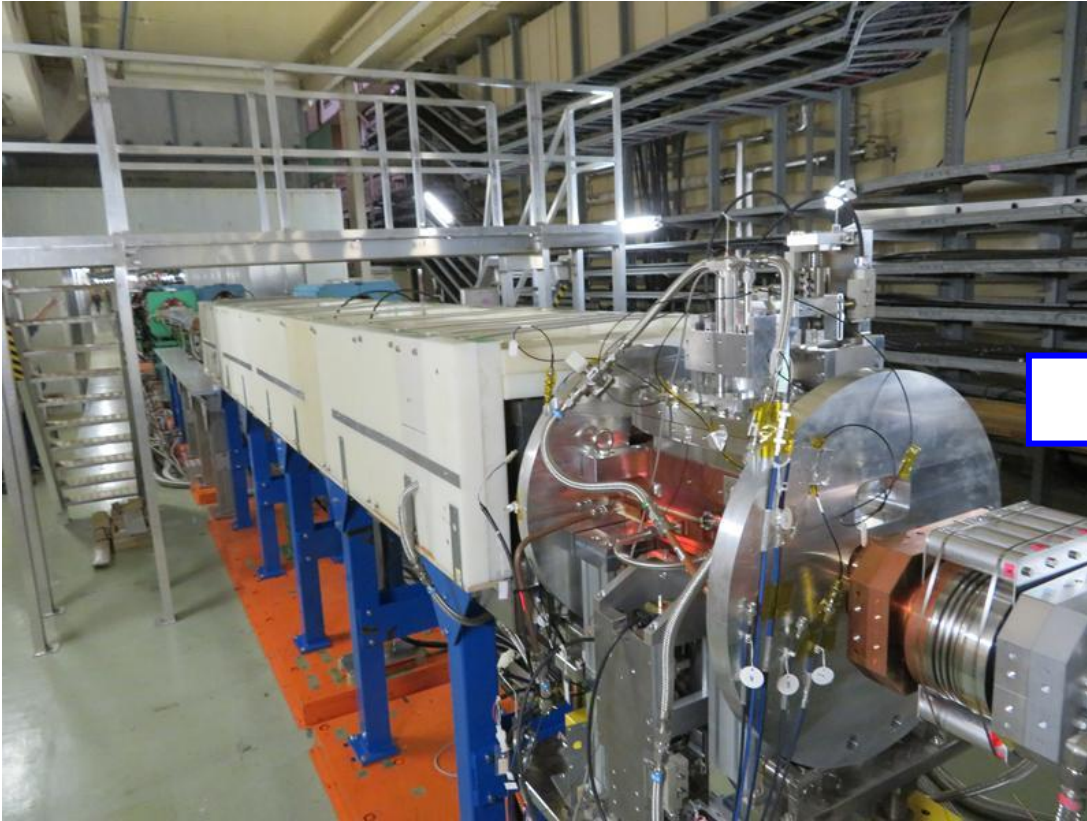
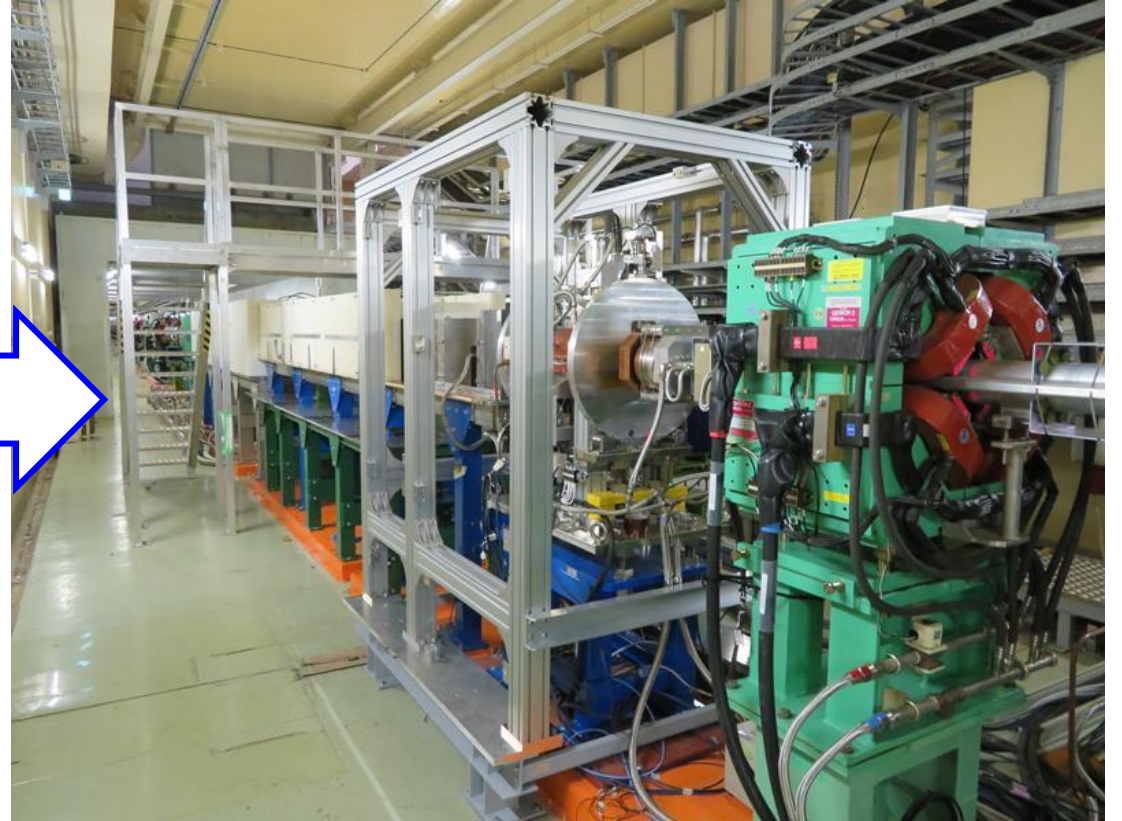
Radiation shielding reinforcement at NLC

Frame for installing the shielding around D05V1 (NLC) has been completed.

On the beam line,
* 10m-long beam line shield
- Lead (50mm thickness)
- HDPE (100~200mm thickness)
* Shield room around D5V1
- HDPE (100~200mm thickness)

Currently, additional concrete shield is being
constructed at the boundary between the
tunnel and the laboratory.

And, the high-density polyethylene (HDPE)
shield is also constructed on the cable tray.

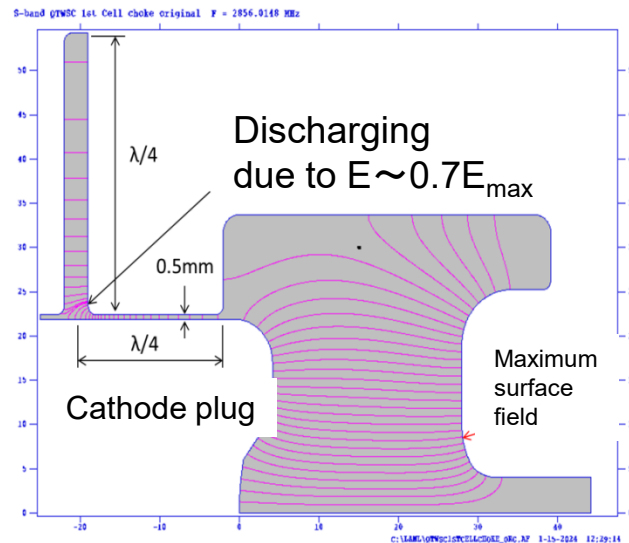
Old RF-Gun cathode cell
with choke structure
for cathode thermal cleaning

- Laser window lifetime
- Dischargetment at choke structure
- Dark current
- Energy slope due to lower voltage
- Focusing magnet

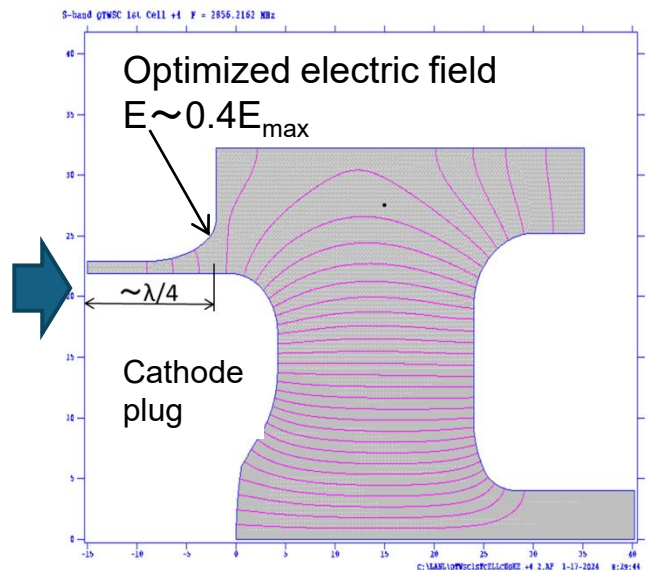
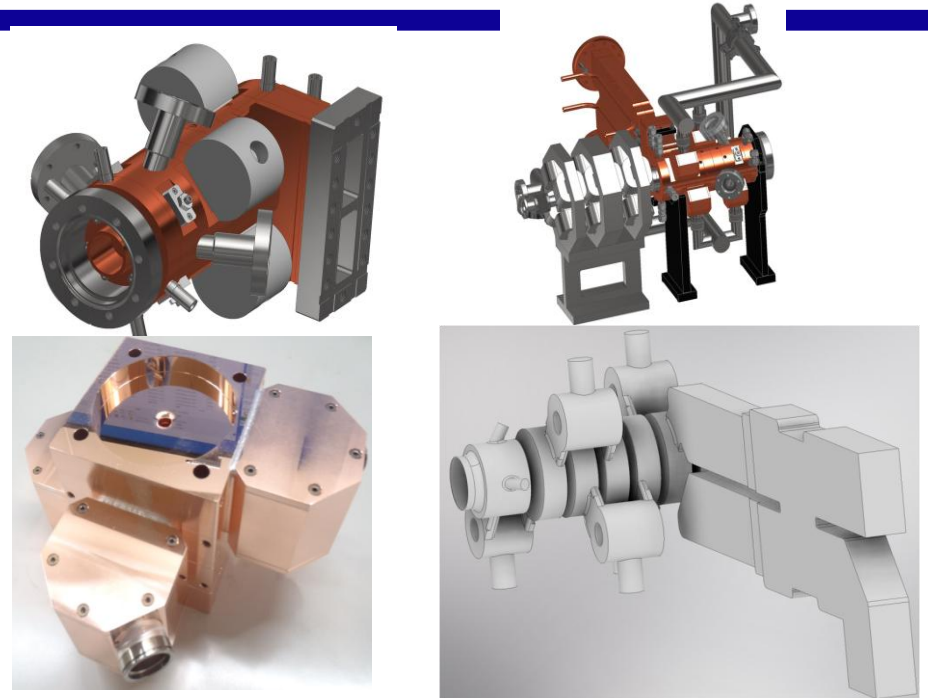
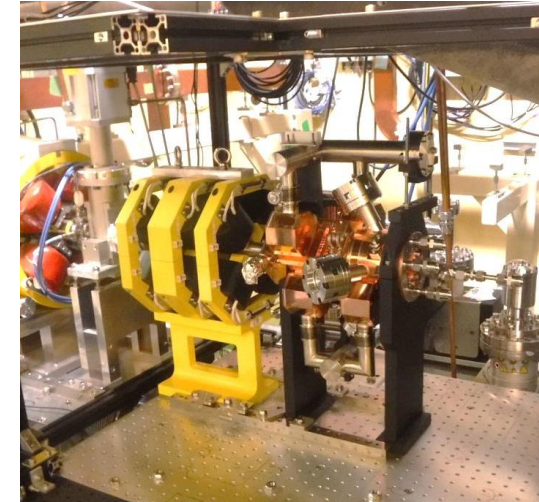
New RF-Gun cathode cell
optimized surface field

- The current RF gun cathode cell includes a choke structure for thermal cleaning of the cathode.
- The updated cathode cell is designed with:
 - Optimized surface field
 - Additional vacuum pumping
 - A new triplet downstream of the gun
- During brazing, the wrong cavity cell was assembled, resulting in a 10 MHz frequency offset (No tuning required for cathode side cavity chain).
- Tuning of the RF cavity is scheduled this week. RF conditioning will be performed until July.

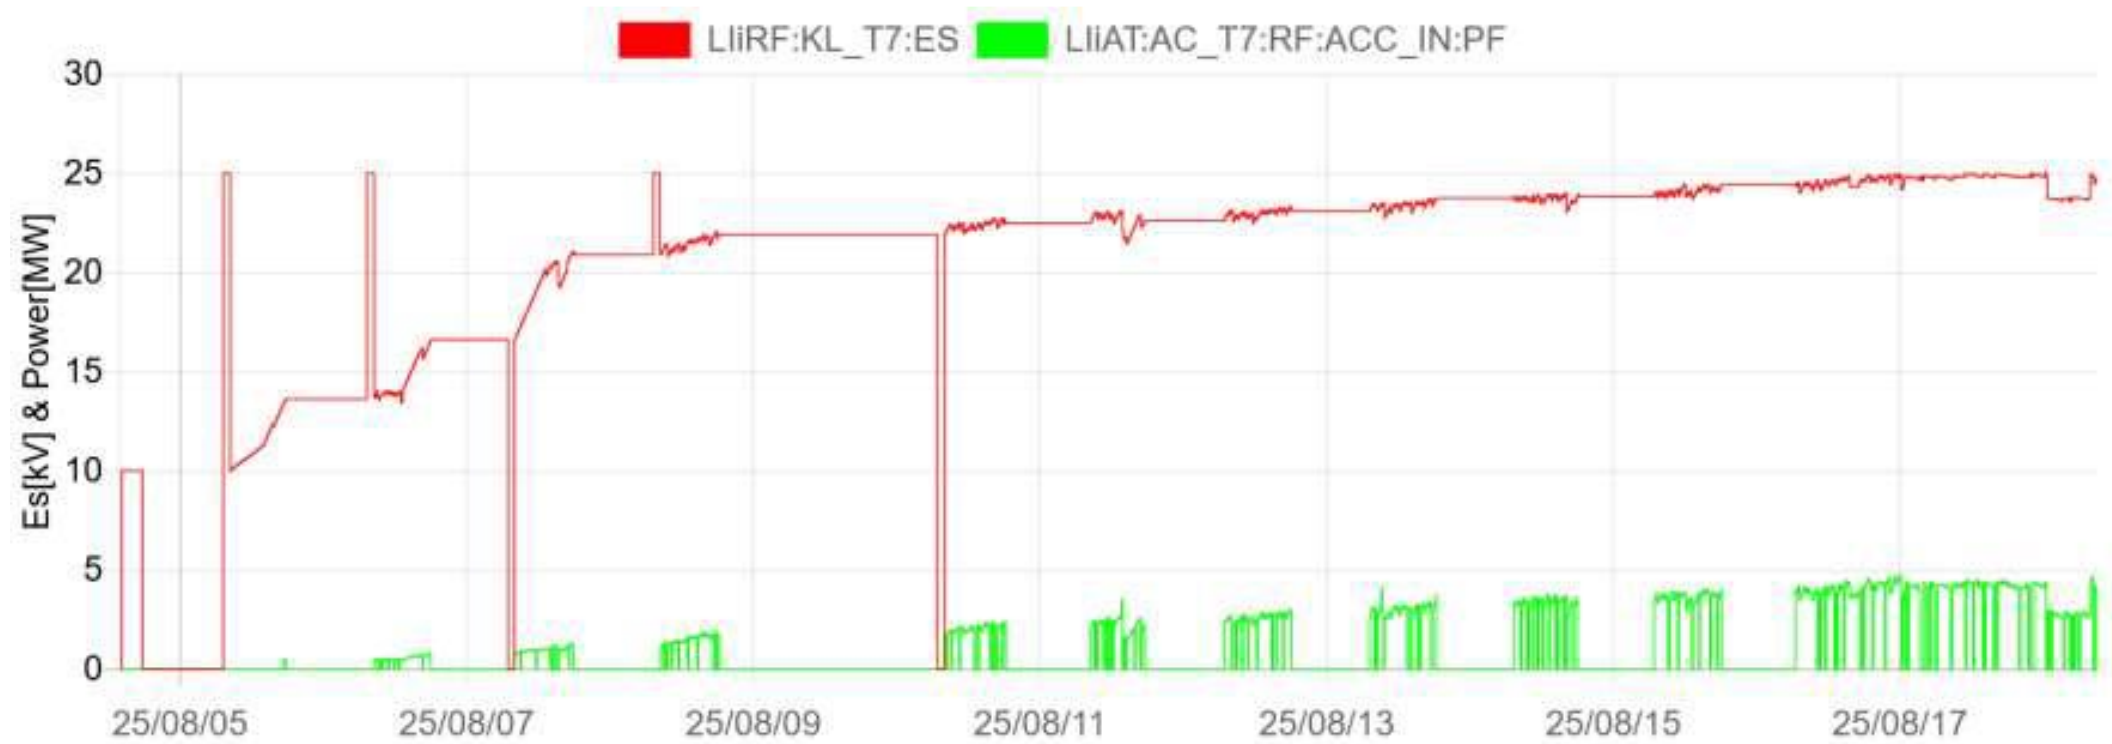
RF conditioning at test bench

RF power was achieved about 5 MW (1 μ s width)

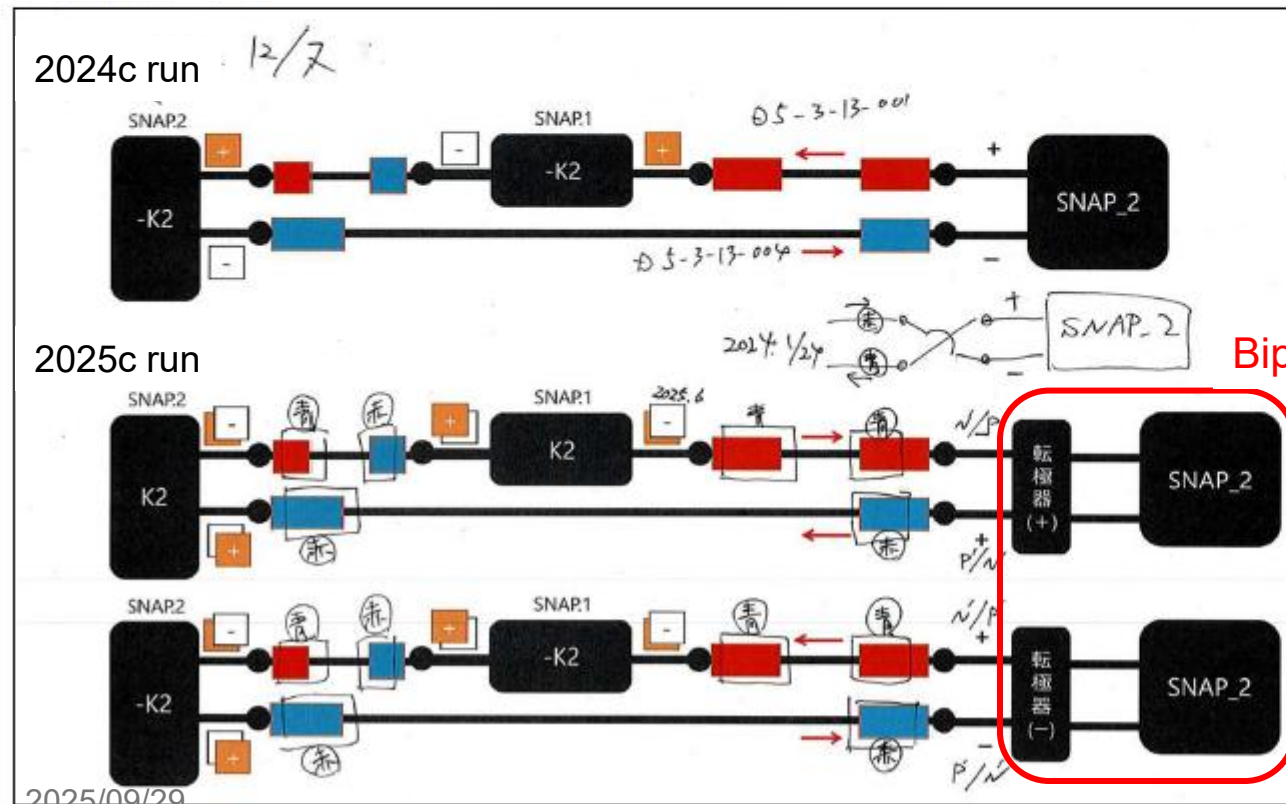
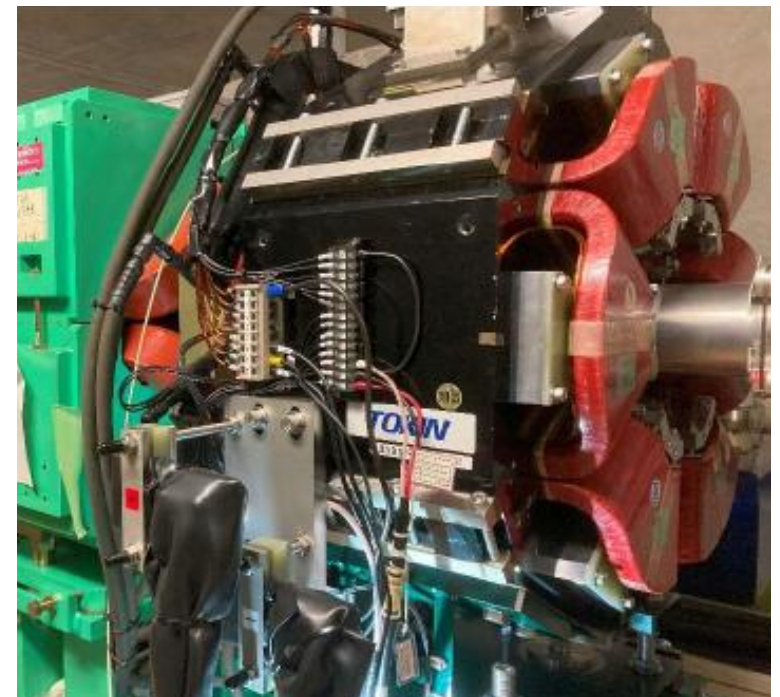
Installation bipolar power supply of Sextupole magnet for NLC

The polarity of the sextupole magnet was reversed by rewiring the power cable. (two or three hours)

Polarity reversal is possible via remote operation of the polarity reverser.
