# SuperKEKB status

BPAC Review in summer 2025

30th June 2025

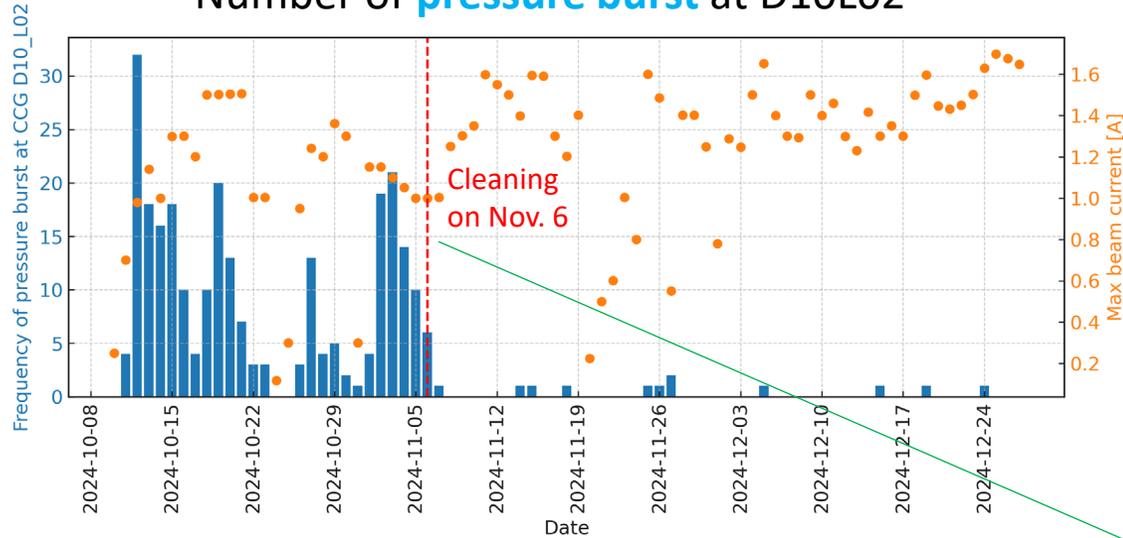
Number of **pressure burst** at D10L02

- Removal of black stains was found to be effective in reducing frequency of pressure burst and SBL event (2025c run)

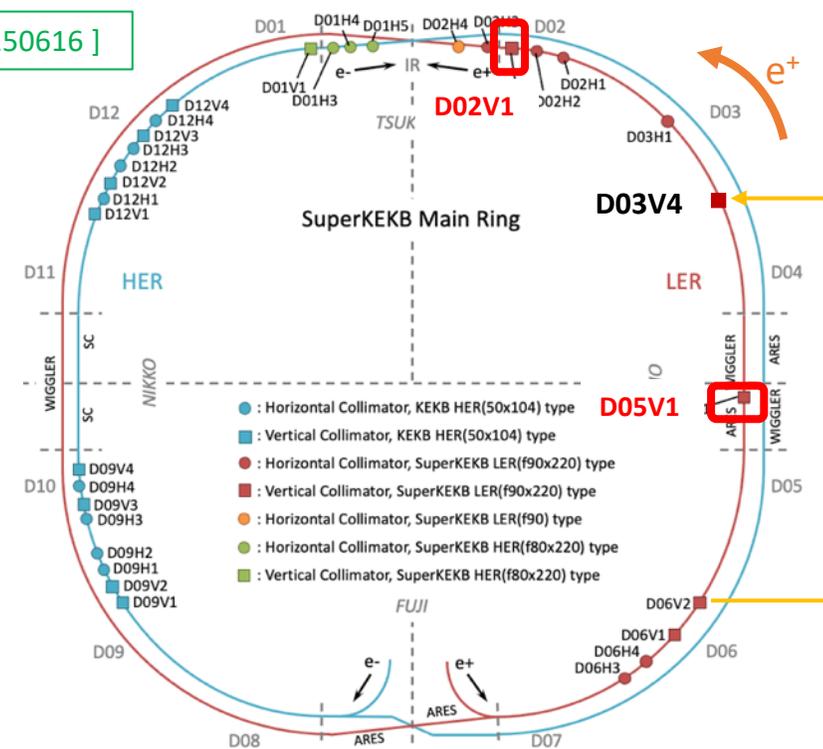
Damaged jaws (D02V1, Ta, 10 mm)

- D02V1 and D05V1 were replaced with new ones.
- D05V1 (NLC) top jaw material was changed to Ti.
  - Top side : Ta (4 mm) -> **Ti (10 mm)**
  - Bottom side : Ta (4 mm) -> Ta (10 mm)
- Durability and background reduction performance of **Ti jaw** will be tested in coming beam operation.

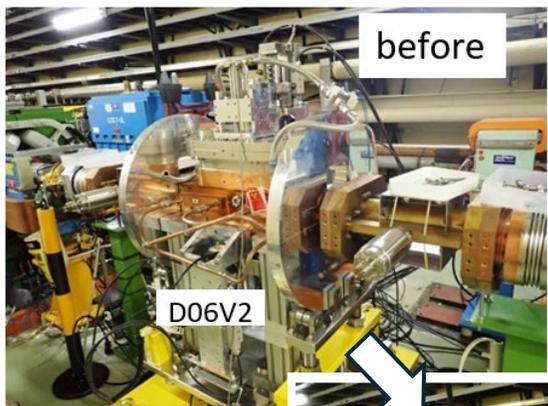
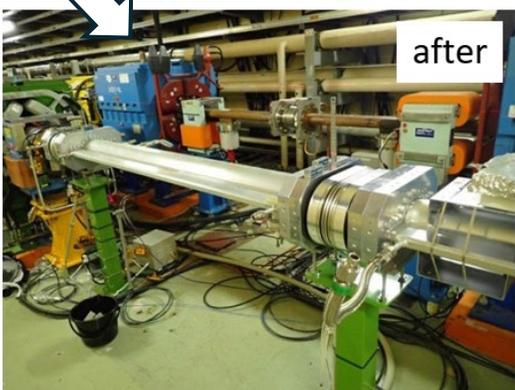
Location of D06V2

- Collimator relocation (LER)
  - D06V2 collimator was relocated to D03V3 as a countermeasure against SBLs
  - Protection for Belle II, QCS, and D02V1 from SBLs occurred downstream of D05V1 (e.g., D04 wiggler section).

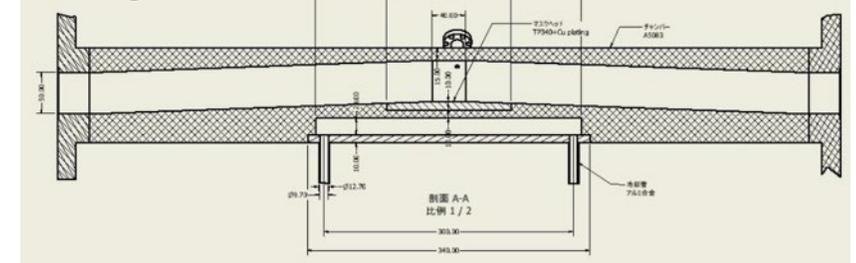
Drawing of HER vertical collimator with water channel

- Abnormal pressure rise was observed near D09V3 in 2024c run.
  - Pressure increased even if the beam current is constant.
  - Pressure depended on bunch current and collimator gap.
- Collimator jaw may be heated by HOMs generated by itself.
  - Or discharge may occur around collimator jaw.
  - The cause of the abnormal pressure rise is still unclear.
- D09V3 collimator will be replaced with water-cooled one.
  - New collimator is expected to be delivered by the end of October and installed in early November.

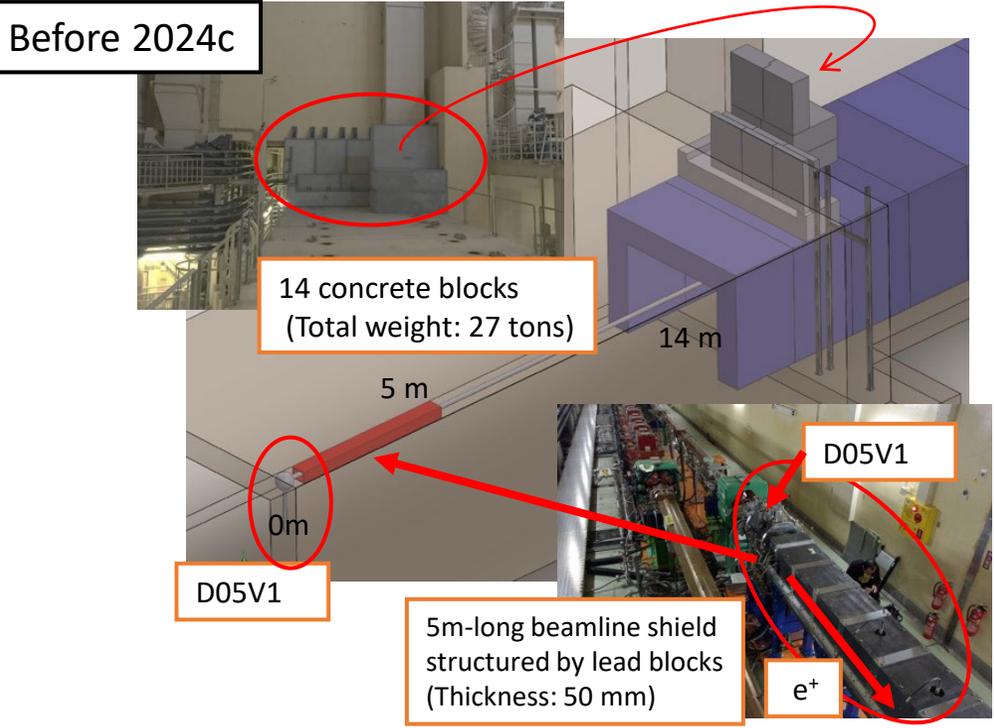
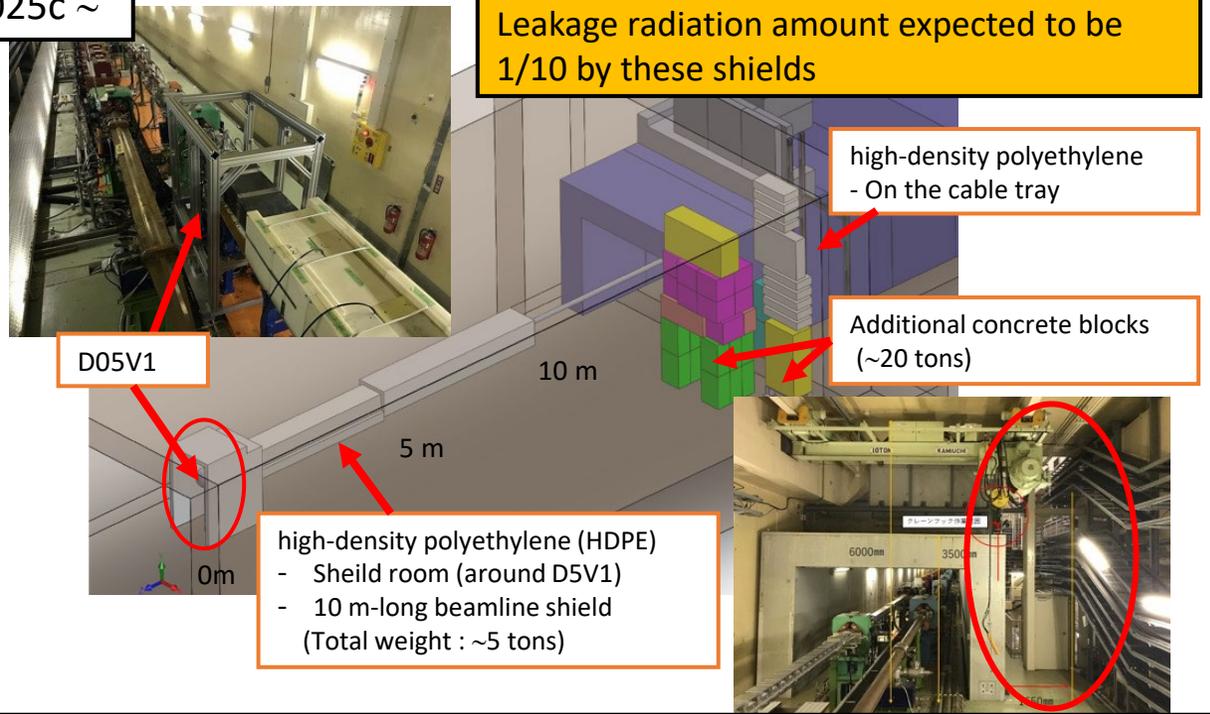
Leakage radiation amount expected to be 1/10 by these shields

- Radiation shields were installed at two locations.
  - A beamline shield covering ~5 m from D05V1
  - A concrete shield added onto the existing shield for the straight section
- The dose limit within the radiation control area was reached, making additional shielding necessary.

- Plan for installation of additional shields before the start of 2025c
  - For the beam line,
    - Shield room around D5V1 (HDPE, thickness: 100-200mm)
    - 10 m-long beamline shield (HDPE, thickness: 150-200mm)
    - Additional lead beamline shield (5-10m section, thickness: 50 mm)
  - For the inside of the accelerator tunnel,
    - Additional concrete shield (max. 4.5 m height, thickness: 0.6-1.2m)
    - Additional shield on the cable tray (HDPE)

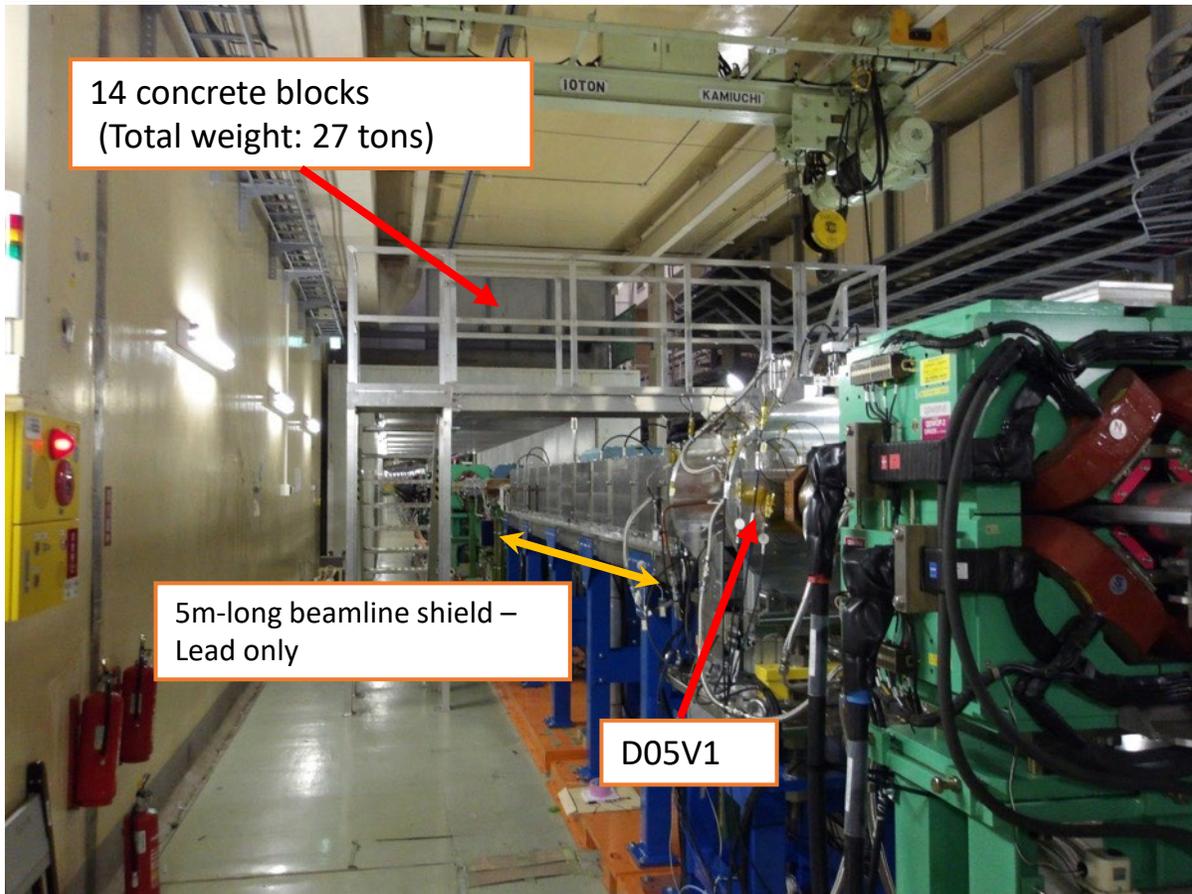
Oct. 2024

- Shield installation progress

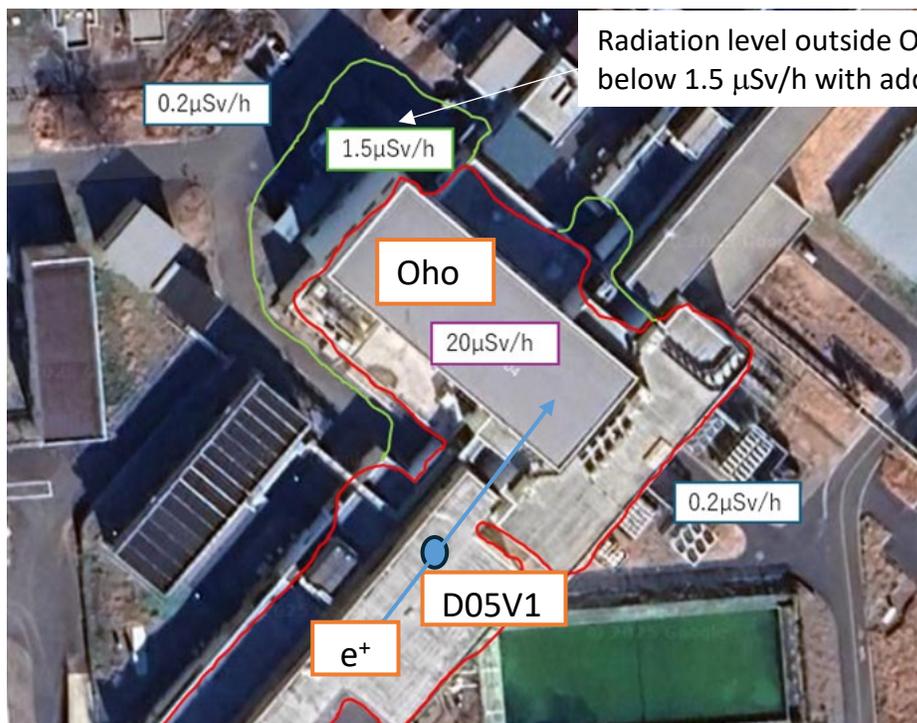
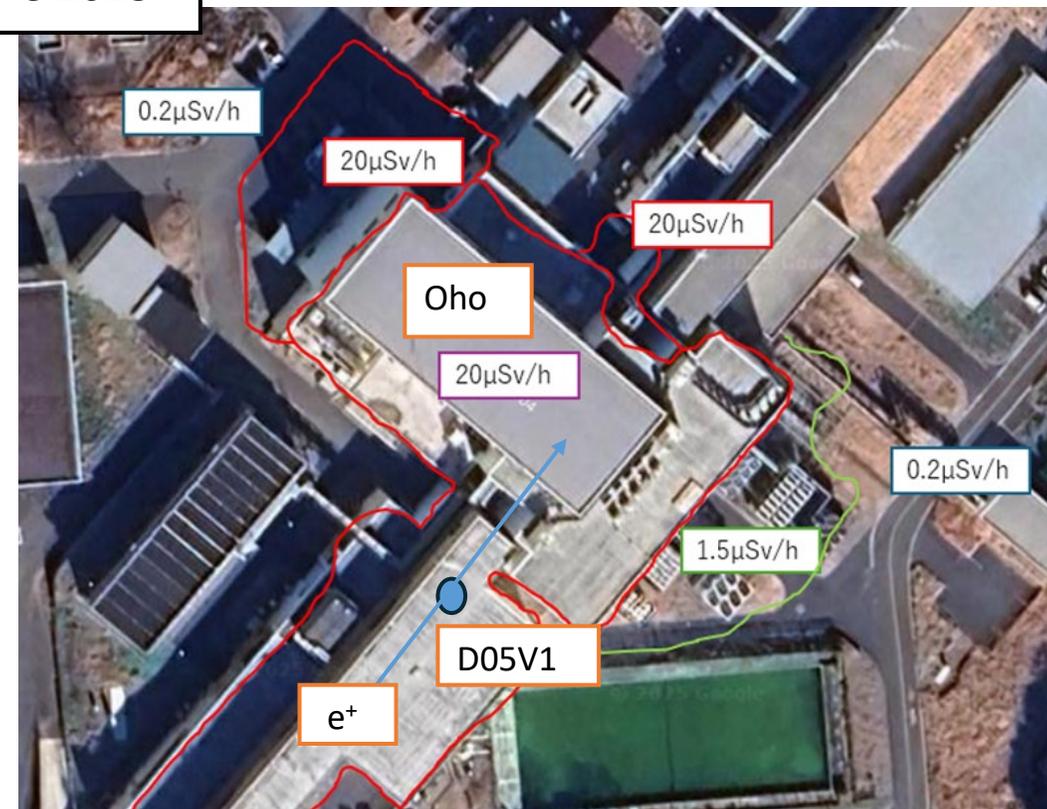
June 2025

Radiation level outside Oho Exp. Hall was maintained below 1.5  $\mu\text{Sv/h}$  with additional concrete shields.

A fence is being constructed to establish the boundary of the radiation control area until September 2025.

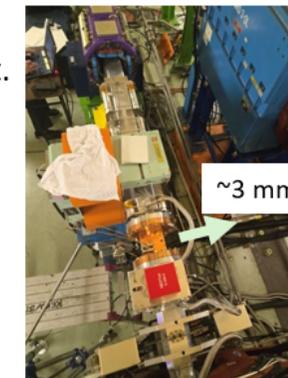
Drive mechanism of D02V1

- Installation of gap sensors for vertical collimators [T. Ishibashi]
  - Measure jaw displacement with higher precision and cross-check with the existing displacement sensors.
