# T24 - 11WNSDvg1.8Cu

Post mortem SEM inspection

A. Toerklep EN/MME  
G. Arnau Izquierdo EN/MME

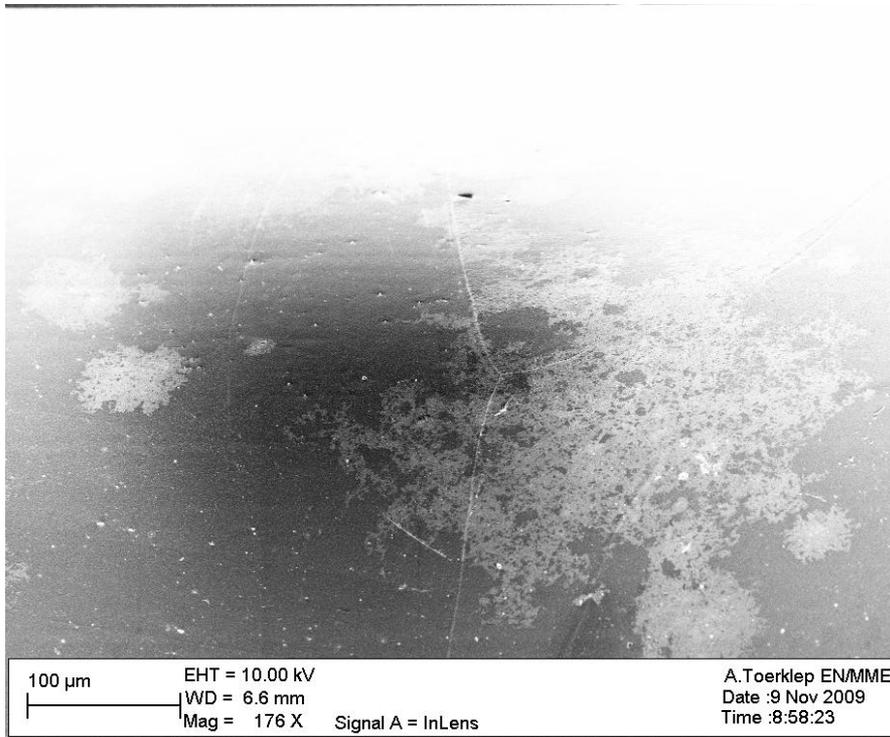
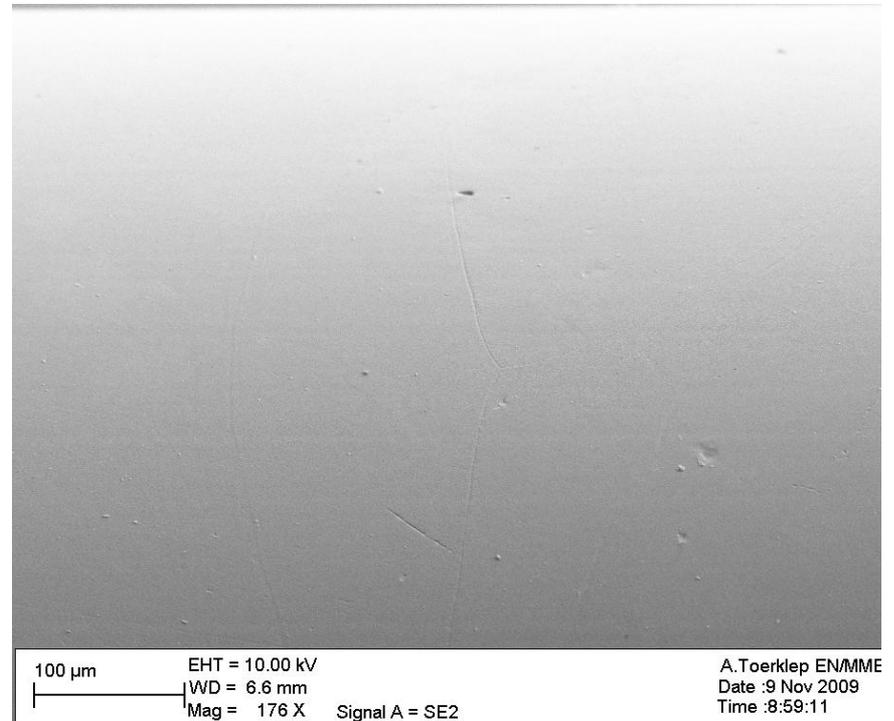
## In-lens detector vs standard Everhart-Thornley detector

- Breakdown regions are randomly distributed on the iris tip.
- Scratches visible on all irises. Not related to breakdown activity.
- Inlens vs SE2 detector – Wormlike features more easily visible with Inlens detector.
- Standard surface show faceting due to vacuum brazing.
- Circular features in couplers – composition Cu, **Al**, C and O.
- Brazing material only found in couplers – Brazing material from coupler to disc.
- Small grainsize in the cavity, close to tuning holes. Due to recrystallisation in heat treatment after tuning.
- EDS analysis in different breakdown areas consist mainly of Cu with traces of C and O.
- Dark halos around breakdown areas has slightly higher content of carbon.

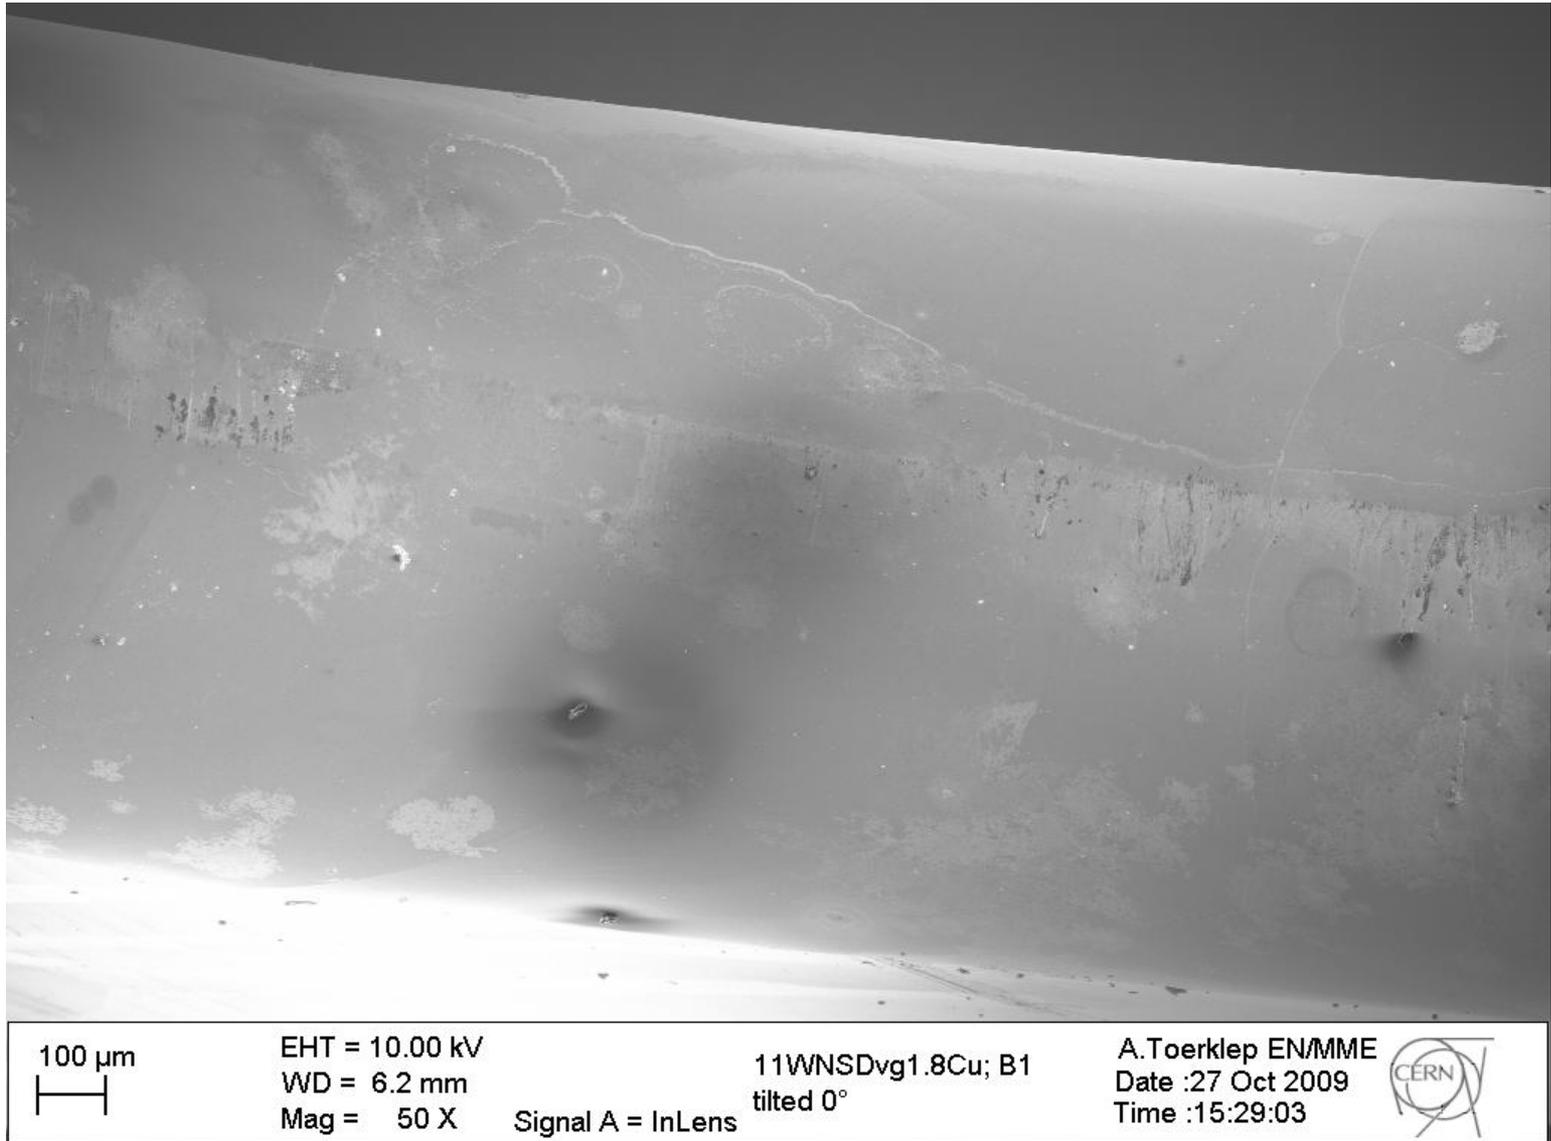
- Breakdown area - Randomly distributed

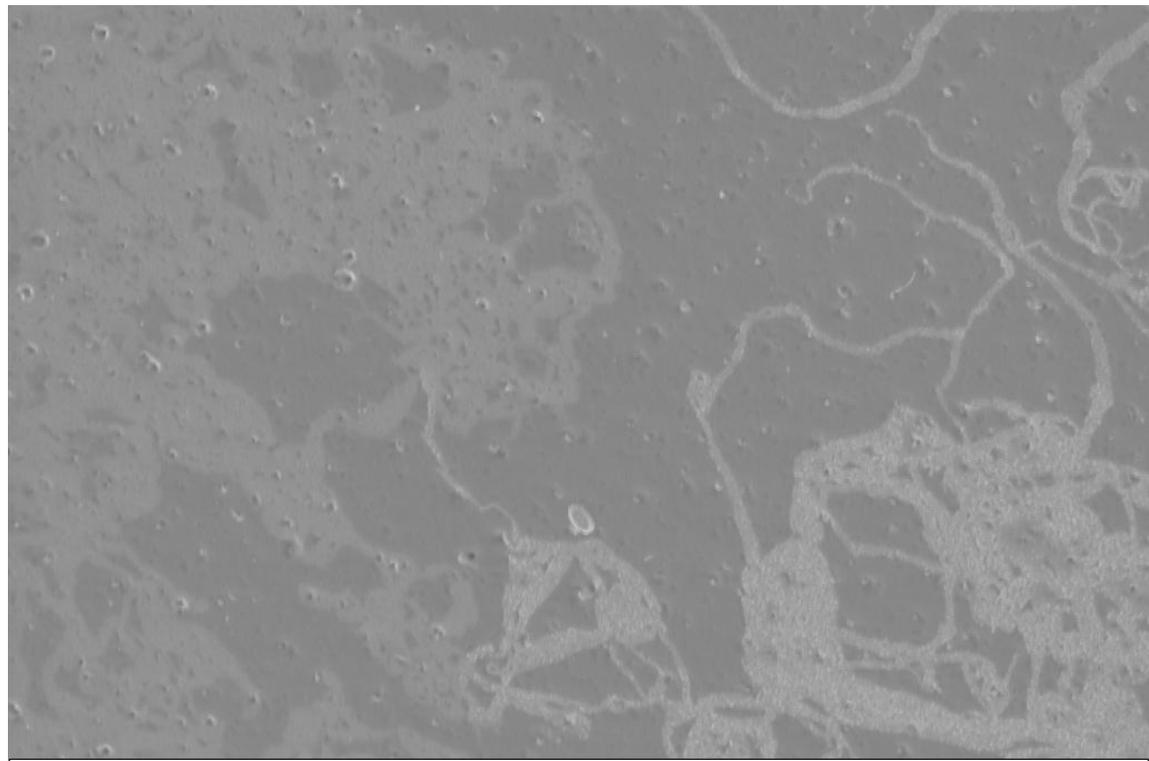
Worm-like features are are:

- Very superficial, as seen from images. The contrast seen may be due reduction of some vey surface oxidation or contamination.
- Due to the RF, it appear in the region of the iris only, not in the other walls of the structure. also because in the middle the are (small) craters.
- More or less noticeable depending on the observation conditions (angle, detector)

Is it a kind of prelude of breakdown or a form of very soft breakdown ?
