# HIGH POWER KLYSTRON STATUS AT THE PHOTON FACTORY INJECTOR LINAC

S.Fukuda, S.Anami, T.Shidara, Y.Saito, H.Homma, K.Nakao, H.Hanaki and J.Tanaka  
 National Laboratory for High Energy Physics  
 Oho-machi, Tsukuba-gun, Ibaraki-ken, 305, Japan

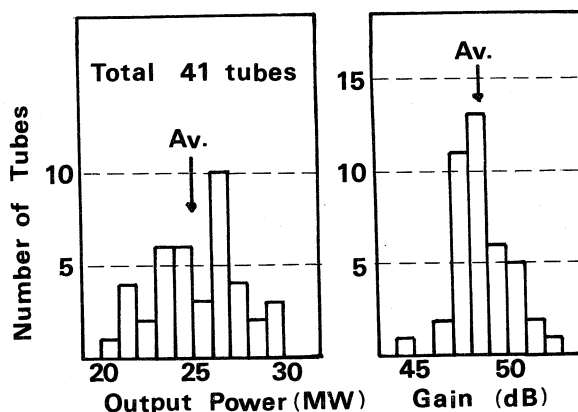
Figure 1. Test results with the permanent magnet.

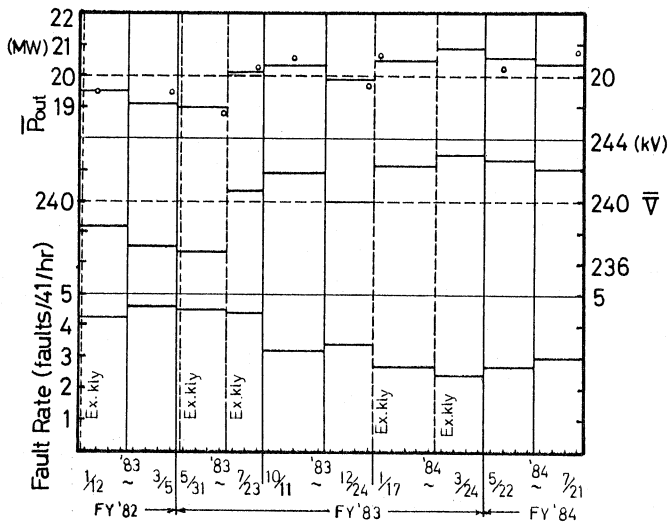
Continuous improvements described next section are making possible to decrease the fault rate year by year. Average fault rate in the beginning of 1983 was 4.8 faults/hours and recently this rate reduces to 2.6 faults/hours (i.e. 1 fault/23min.). Figure 2 shows the recent performance of gallery about the fault

Figure 2. Recent performance about faults rate etc.

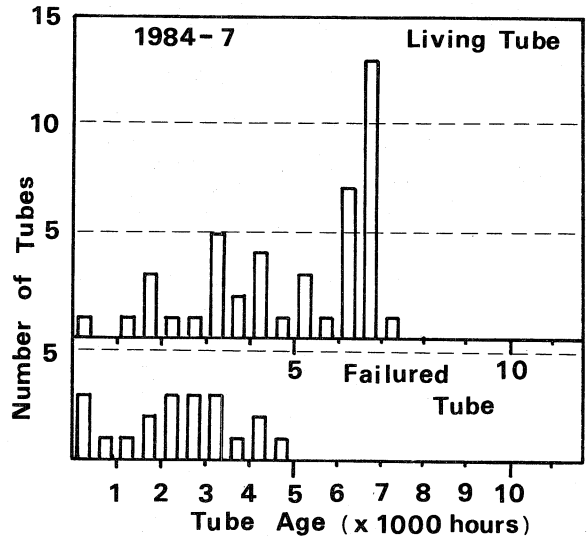
Various age distribution histograms for the high power klystrons are shown in Fig.3.

Figure 3. Age distribution of the failed and living tubes.
