Injector Linac Status

Takuya Natsui

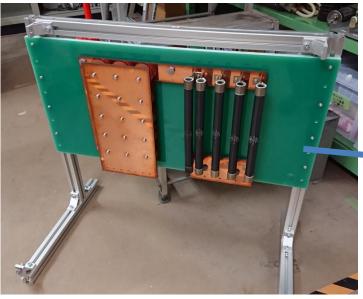
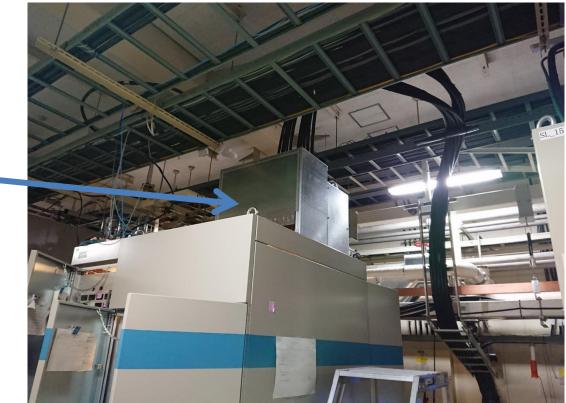
Set RC circuit to the FC modulator

RC circuit

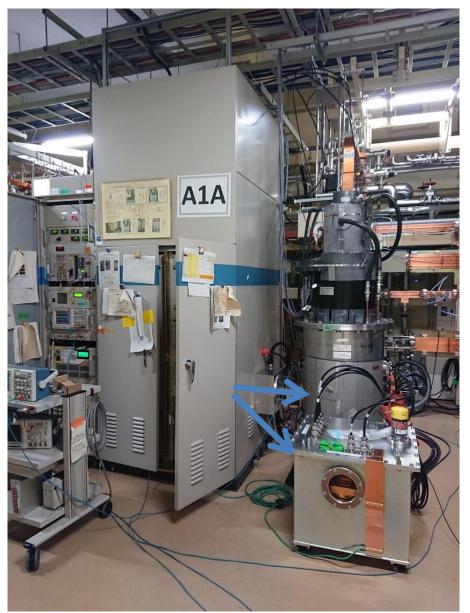
Thermionic gun modulator had been removed. Currently, one modulator feed HV pulse to two devices which is klystron and gun.

We use klystron modulator with parallel connection. It is abnormal usage.

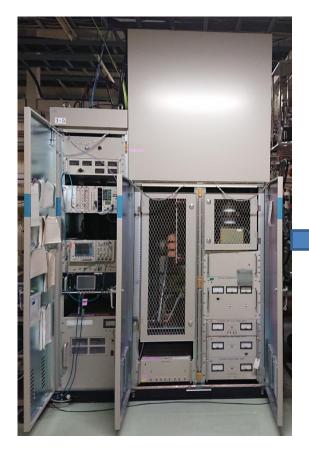
Modulator feed pulse HV.
