# SuperKEKB Status Report

20th annual BPAC Full Review meeting

10<sup>th</sup> February 2026

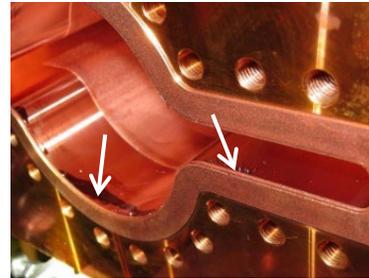
## 1. Beam pipe cleaning (HER/LER)

- Vacuum sealant (VACSEAL) removal as countermeasure against SBL
- At IR (HER/LER), LER wiggler sections (LER D04, D10, D11)

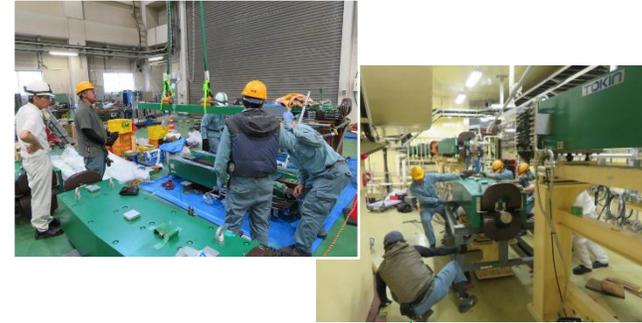
Magnet pole replacement (BTp)

⇒ Improvement of injected beam quality and injection efficiency  
Increasing injected bunch charge
- Magnet pole replacement of positron BT line (BTp)**
  - Emittance growth mitigation by improving the magnetic field.

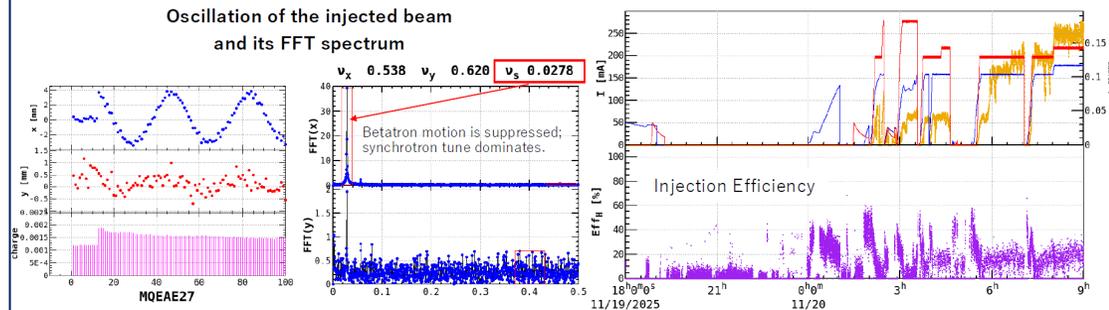
## Synchrotron Injection in HER

- Extensive machine tuning, including linac and collimator optimization.
- Successful beam injection for the  $\beta^* = 1$  mm optics after dedicated machine tuning.
- Attempted collision operation during the morning shift on Nov. 20.
- Unfortunately, the injection efficiency was low particularly at higher injection rates.
- We decided to return to betatron injection considering the low injection efficiency and uncontrollable beam backgrounds.

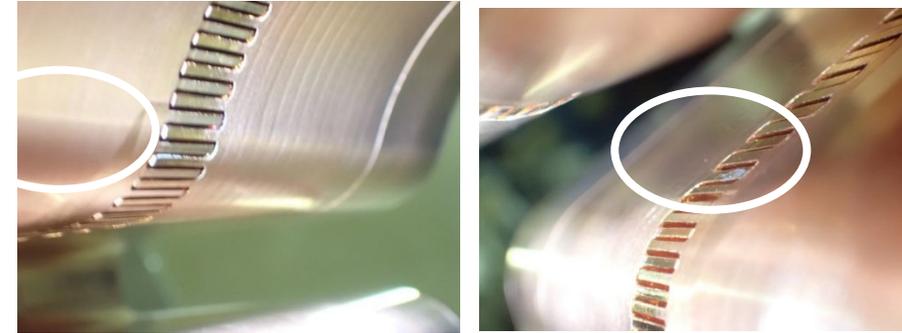
Inside the bellows near D10\_L21  
Some contamination was found, but it was not VACSEAL.

- Countermeasures against SBLs
  - Pressure bursts were observed at the D11 and D04 wiggler sections.
    - For both locations, internal inspections of the beam pipes and removal of VACSEAL had already been carried out before the 2025c run.
  - The bellows chambers were replaced with spares at both D11\_L21 and D04\_L03.
  - At D11\_L21, small contamination (not VACSEAL) was found in the bellows chamber.
  - At D04\_L03, no abnormality was observed.
- Countermeasures against the injection kicker accidental firing
  - The frequency of kicker accidental firing has been significantly reduced by optimizing the thyatron parameters before 2025c.

- The bellows chambers were replaced with spares at both D11\_L21 and D04\_L03.
- At D11\_L21, small contamination (not VACSEAL) was found in the bellows chamber.
- At D04\_L03, no abnormality was observed.

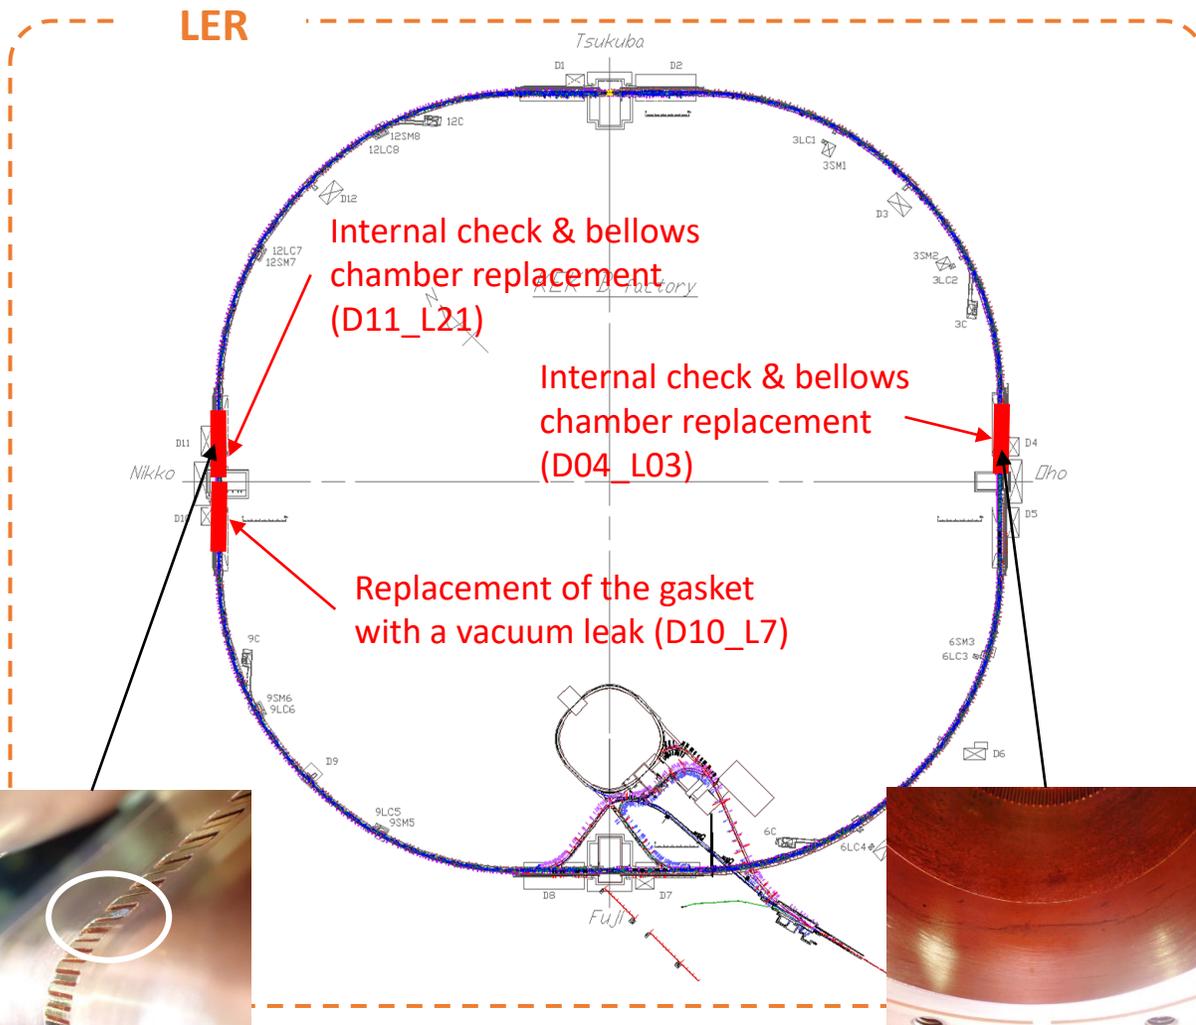
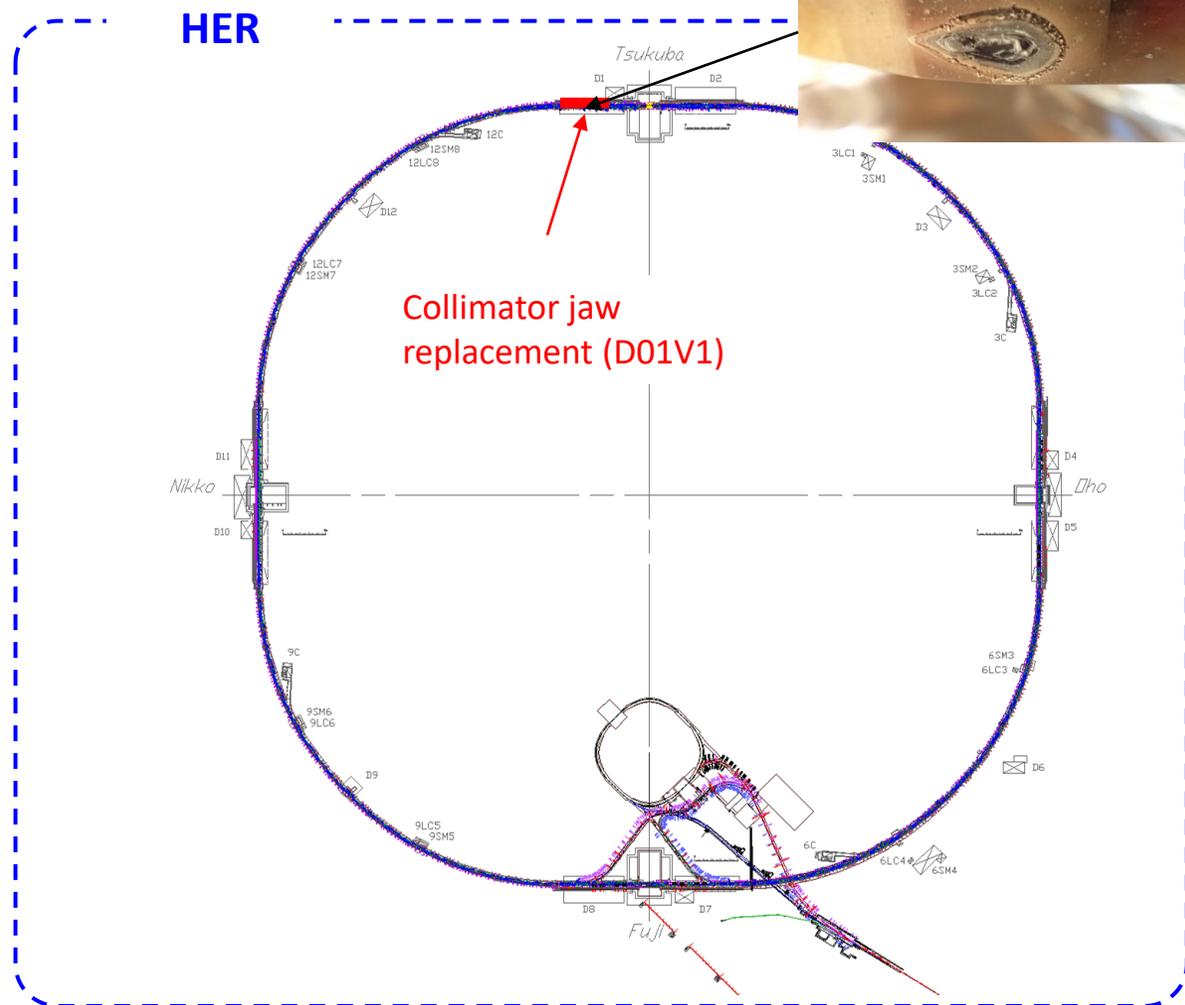
# Vacuum work during winter shutdown

— : vented section for vacuum work

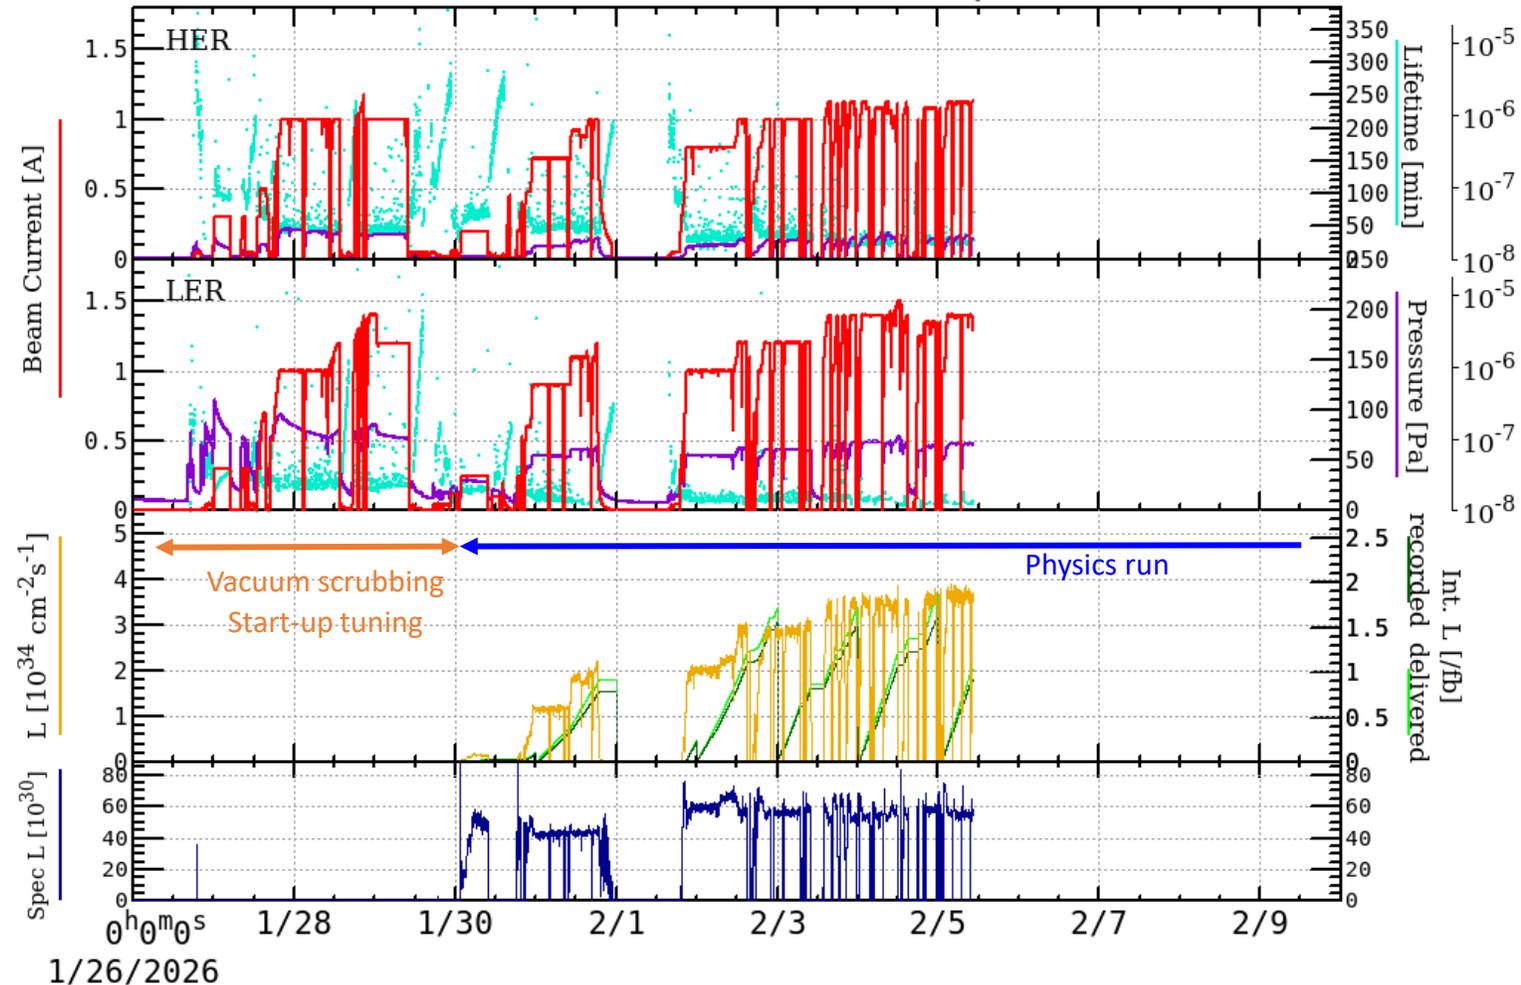
Peak L 3.910 [ $10^{34}/\text{cm}^2/\text{s}$ ]@ 2026-02-04 11:49 HER  $I_{\text{peak}}$ : 1175.5 [mA]  $\beta_{x/y}^*$ : 60./ 1.00 [mm]  $n_p$ : 2346  
Int. L/day 0.915 / 1.039 [fb] LER  $I_{\text{peak}}$ : 1500.3 [mA]  $\beta_{x/y}^*$ : 60./ 1.00 [mm]  $n_p$ : 2346

- 2026a run resumed on Jan. 26.
  - Vacuum scrubbing and start-up tuning, including injection tuning, were conducted until Jan. 30.
  - The physics run started on Jan. 30.
- As of Feb. 4, the peak luminosity has reached  $3.9 \times 10^{34} \text{ cm}^{-2}\text{s}^{-1}$ .

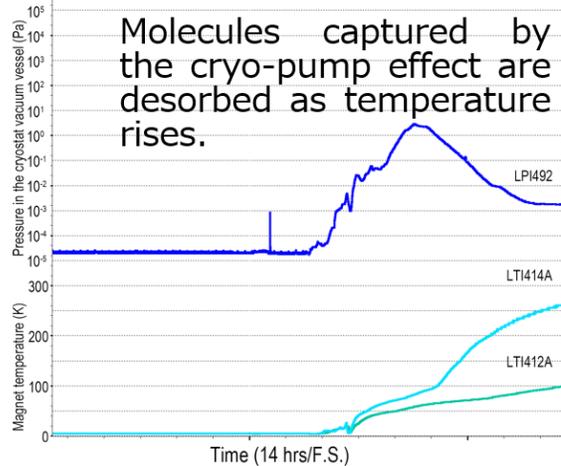
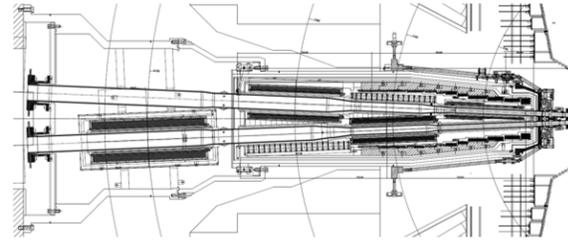
Pressure change in the cryostat vacuum vessel

- Typically, as a reference case, the measured pressure result of the vacuum vessel when the magnet cryostat was warmed in Dec. 2024 is shown here.
- As the temperature rises, molecules captured on the surface of the helium vessel inside the vacuum vessel due to the cryo-pump effect desorb, causing the pressure to increase.

Measured in 2024 as reference

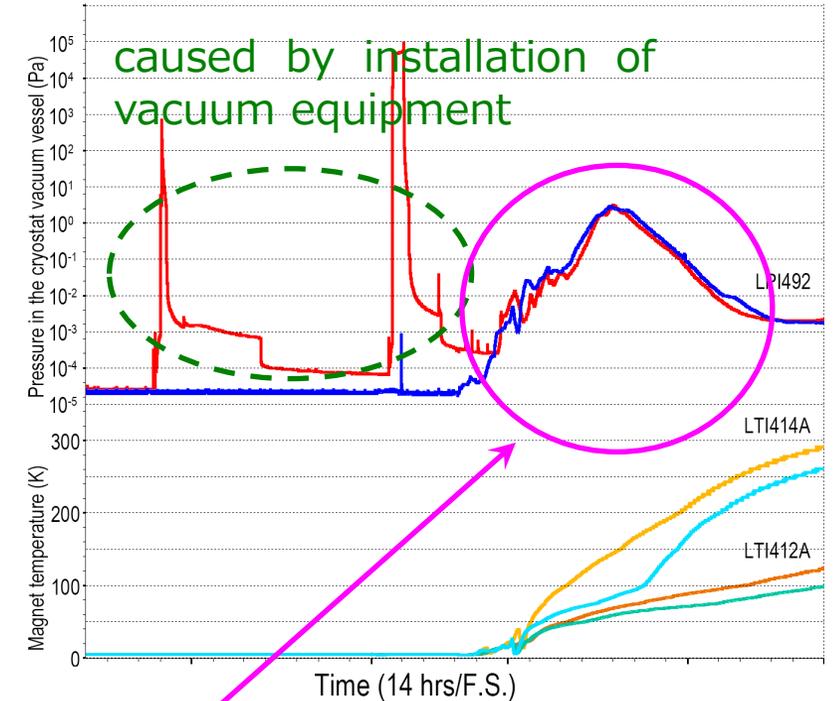
Magnet temperature at different measurement points

No difference was observed between the measured results in 2025 and the reference data from 2024. Thus, no increase in matter captured by cryo-pump effect was detected.

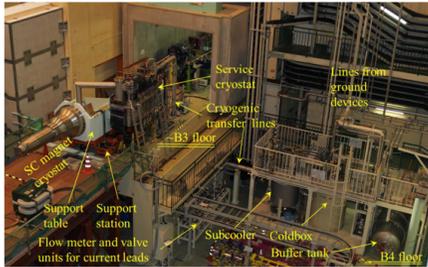
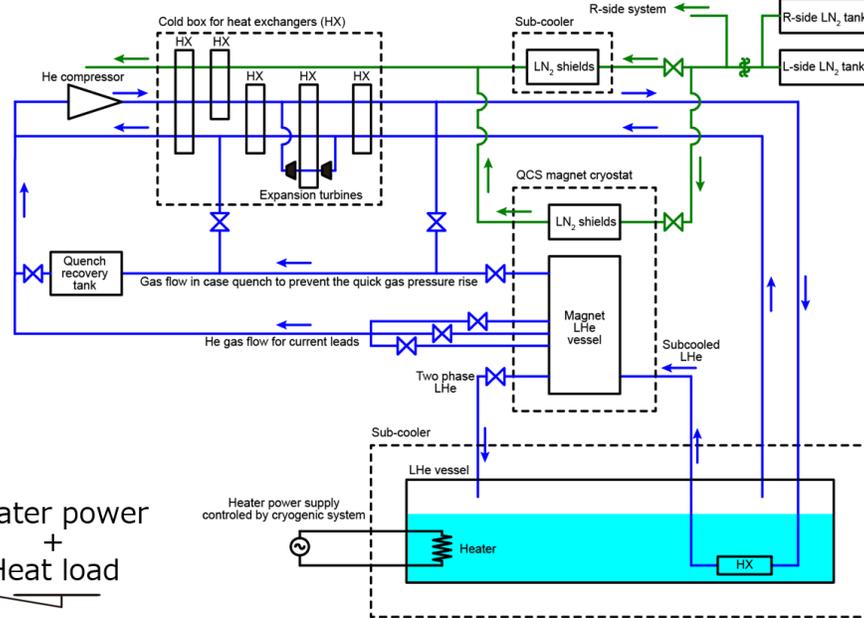
## What is the liquid helium level control: our cryogenic system overview

- For a finite and constant liquefaction capacity, heater control system is used to balance variable heat loads.

$$\text{Liquefaction capacity} = \text{Heater power} + \text{Heat load}$$

- Failure to keep the liquid level means either reduced liquefaction capacity or increased heat load.

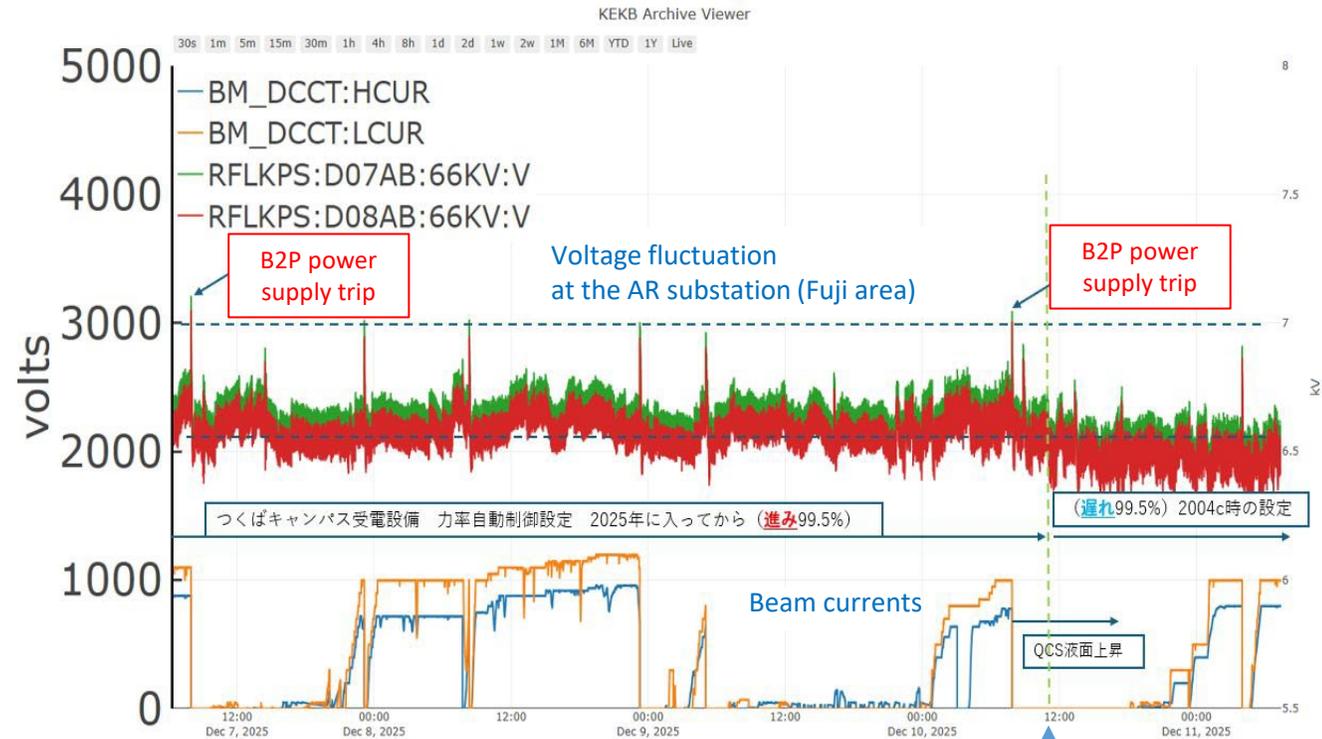
- The KEK Plant and Facilities Department investigated the issue, identified the cause, and addressed it during the 2025c run.
- Cause
  - Modification of the settings for the power factor correction capacitors in the 6.6 kV line at the AR substation (Fuji area) to save electricity.
  - The modification was carried out before the 2025c run.
- Countermeasure
  - The settings were restored to their original configuration during the 2025c run.
  - Efforts were also made on the RF side to reduce power consumption in the Fuji area.

AR substation setting restored to the 2024c configuration

- The KEK Plant and Facilities Department investigated the issue, identified the cause, and addressed it during the 2025c run.
  - Cause;
    - Modification of the settings for the power factor correction capacitors in the 6.6 kV line at the AR substation (Fuji area) to save electricity.
    - The modification was carried out before the 2025c run.
  - The settings were restored to their original configuration during the 2025c run.
    - Closer coordination with the Plant and Facility Department is required.

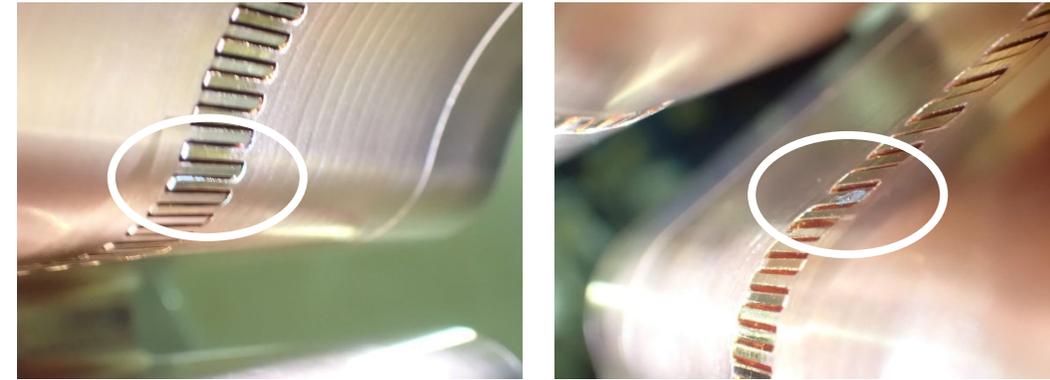
Inside the bellows near D10\_L21  
Some contamination was found, but it was not VACSEAL.
