SuperKEKB Status Report

20th annual BPAC Full Review meeting
10th February 2026

Kyo Shibata (KEK Accel. Lab.)
On behalf of the SuperKEKB

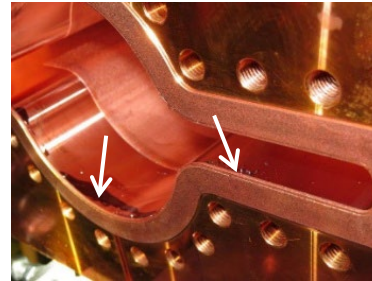
Beam pipe cleaning

- Vacuum sealant (VACSEAL) removal as countermeasure against SBL
- At IR (HER/LER), LER wiggler sections (LER D04, D10, D11)

⇒ Improvement of accelerator stability

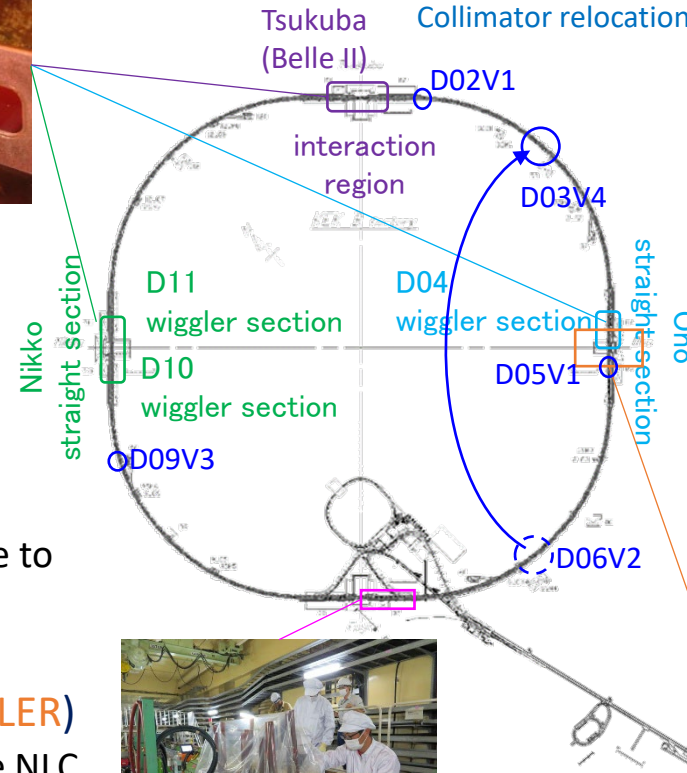
Collimator relocation (LER D06V2 → D03V4)

- Collimator relocation from D06V2 to D03V4 (LER)
- Damaged jaw replacement at D02V1, D05V1 (LER)
- New water-cooled D09V3 collimator (HER)

⇒ Protection of Belle II from SBL (D03V4)

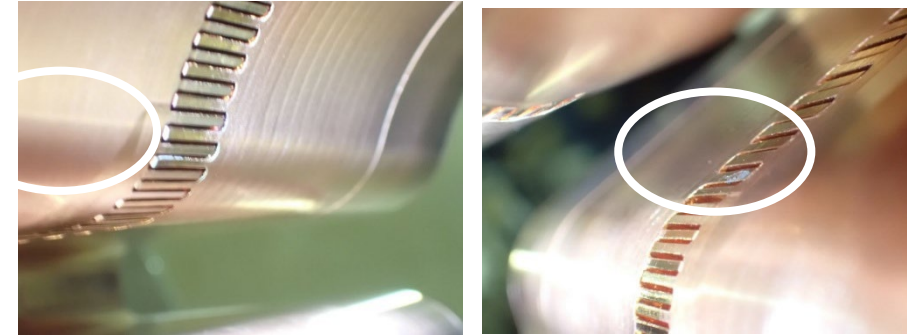
Inside the bellows near D10_L21
Some contamination was found, but it was not VACSEAL.

- Pressure bursts were observed at the D11 and D04 wiggler sections.
 - For both locations, internal inspections of the beam pipes and removal of VACSEAL had already been carried out before the 2025c run.
- The bellows chambers were replaced with spares at both D11_L21 and D04_L03.
- At D11_L21, small contamination (not VACSEAL) was found in the bellows chamber.
- At D04_L03, no abnormality was observed.

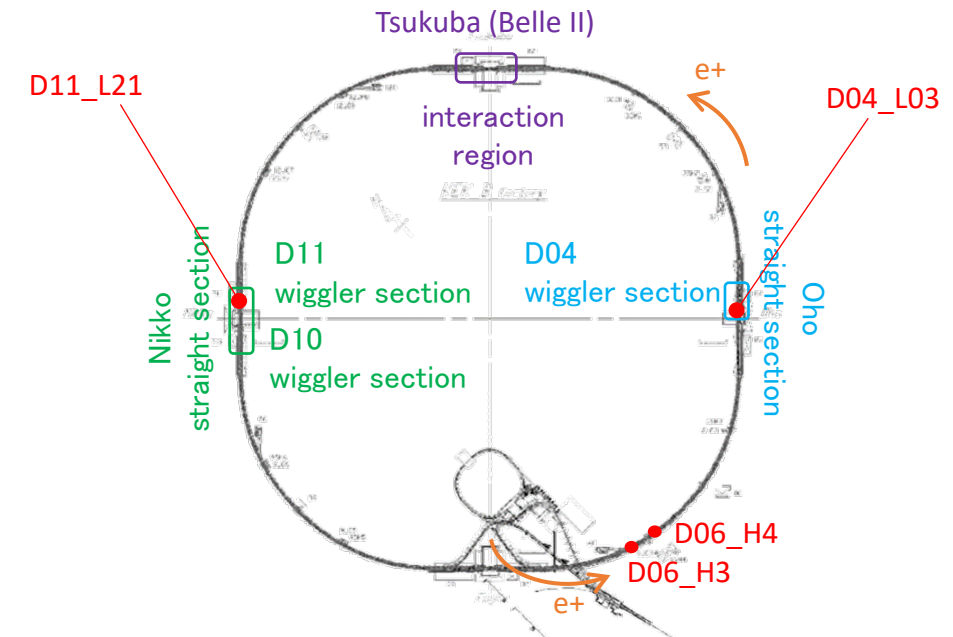
Vacuum work during winter shutdown

— : vented section for vacuum work

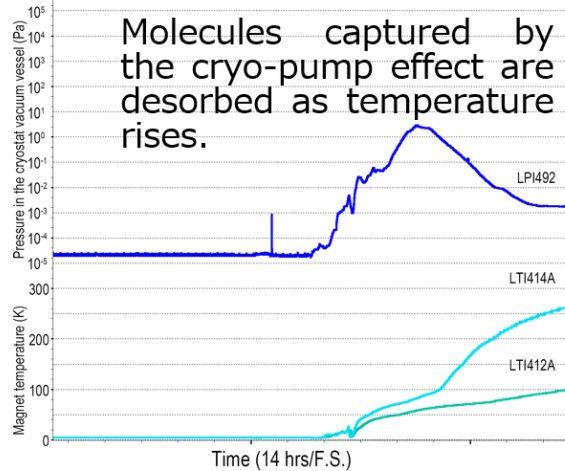
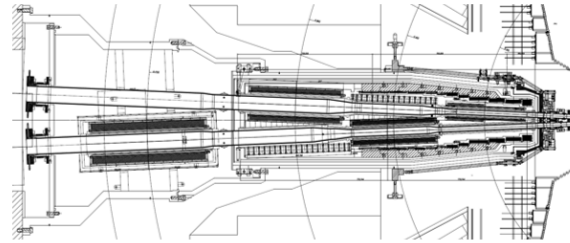
Pressure change in the cryostat vacuum vessel

- Typically, as a reference case, the measured pressure result of the vacuum vessel when the magnet cryostat was warmed in Dec. 2024 is shown here.
- As the temperature rises, molecules captured on the surface of the helium vessel inside the vacuum vessel due to the cryo-pump effect desorb, causing the pressure to increase.

Measured in 2024 as reference

No difference was observed between the measured results in 2025 and the reference data from 2024. Thus, no increase in matter captured by cryo-pump effect was detected.

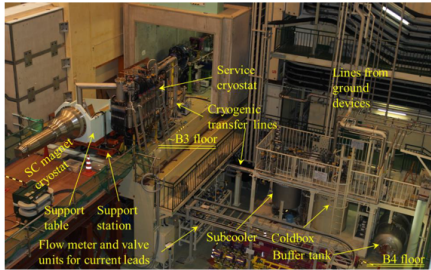
What is the liquid helium level control: our cryogenic system overview

- For a finite and constant liquefaction capacity, heater control system is used to balance variable heat loads.

$$\text{Liquefaction capacity} = \text{Heater power} + \text{Heat load}$$

- Failure to keep the liquid level means either reduced liquefaction capacity or increased heat load.

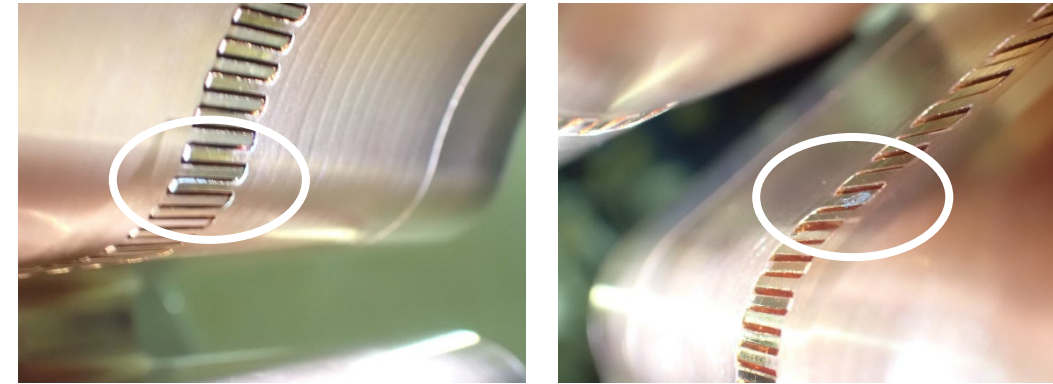
Inside the bellows near D10_L21
Some contamination was found, but it was not VACSEAL.

- The bellows chambers were replaced with spares at both D11_L21 and D04_L03.
- At D11_L21, small contamination (not VACSEAL) was found in the bellows chamber.
- At D04_L03, no abnormality was observed.
