A Fire at KEK LINAC and Its Recovery

Kazuro Furukawa

for KEK e^-/e^+ Injector LINAC

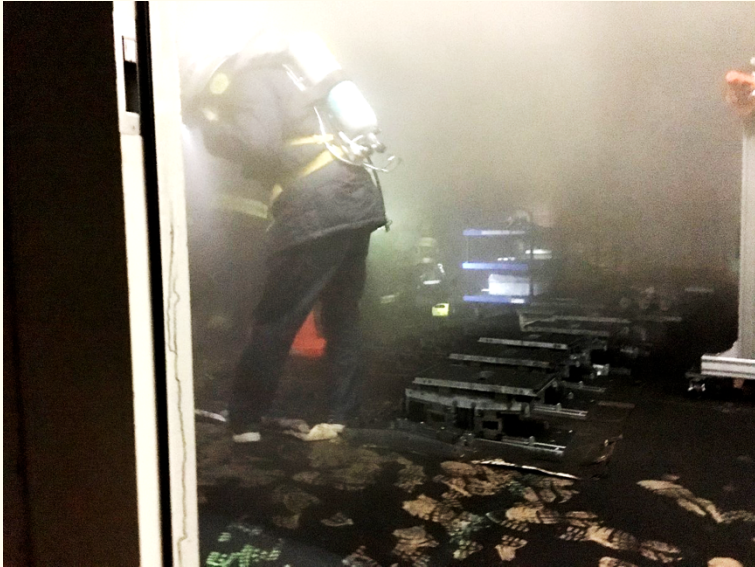
Fireman in the smoke and carbon soot

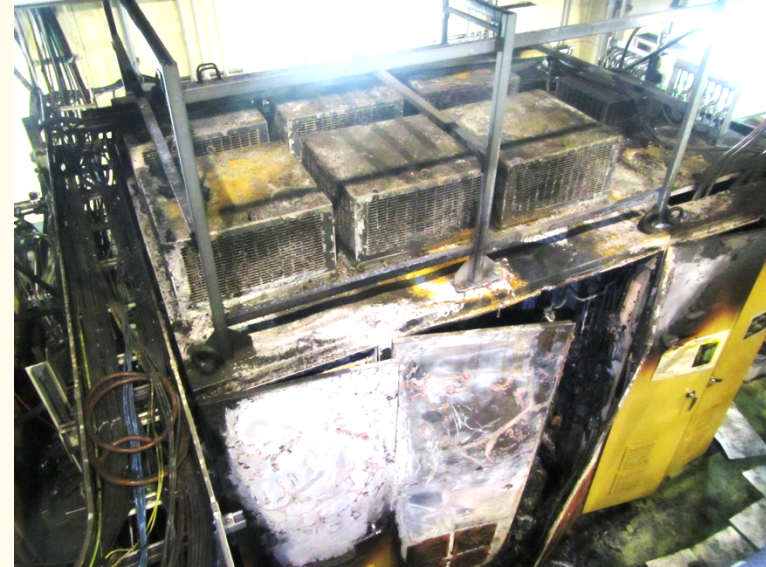
Modulator burnt

- ◆ **A fire started in a microwave high-power modulator**
 - ✧ X-band microwave: 11.424 GHz, 10 - 100 MW, 1 μ s, 50 Hz
 - ❖ An aged capacitor in the pulse-forming network (PFN) burst, discharged, ignited

- ❖ A capacitor with plastic container in the pulse forming network of high-power modulator punctured, discharged, and fired
- ❖ The modulator was restarted after the initial interlock without detailed investigations

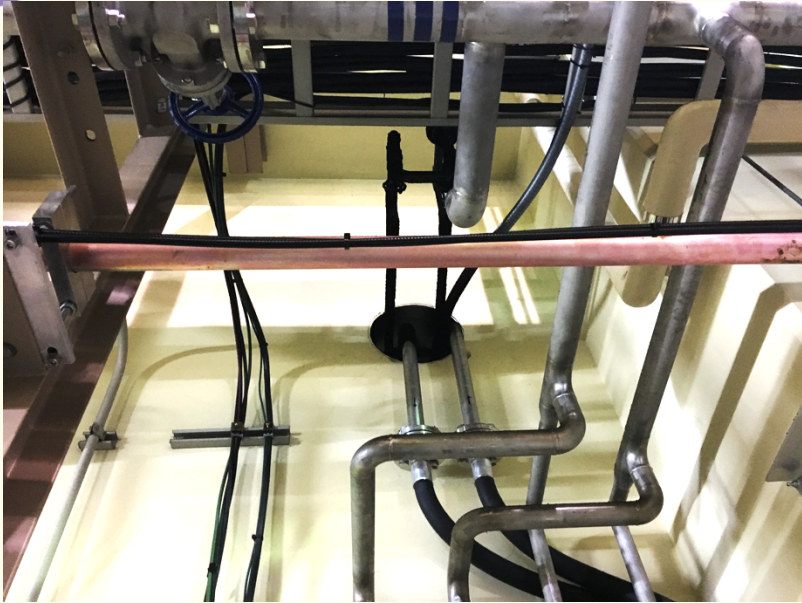
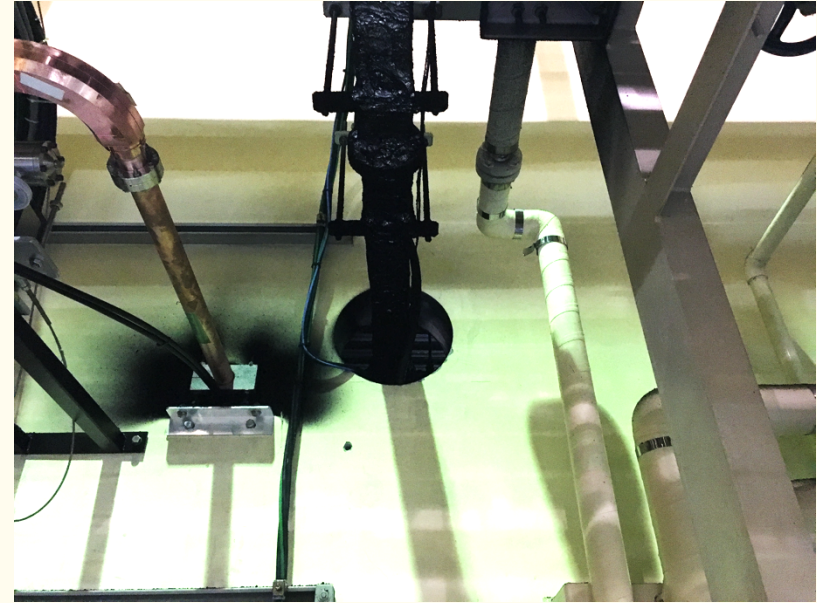
❖ Carbon soot sneaked through holes between rooms

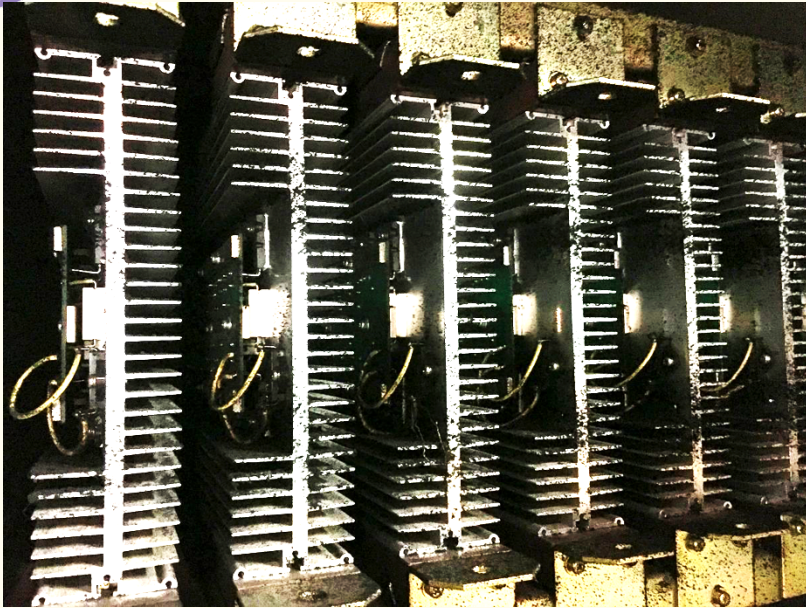
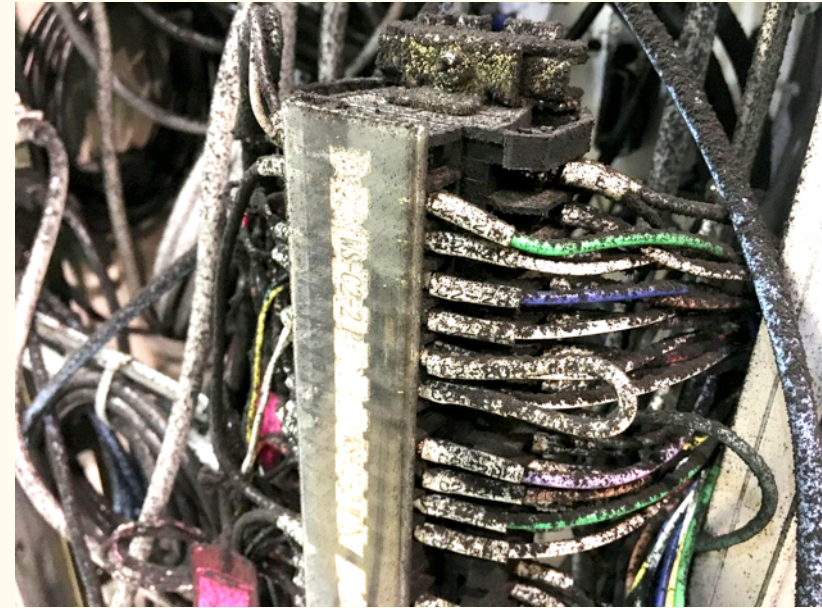
❖ Carbon soot in the equipment

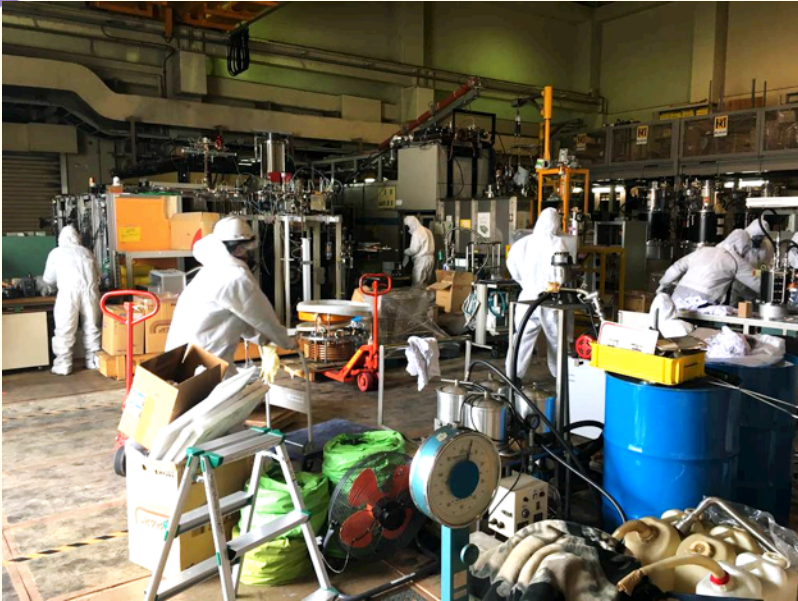
❖ Cleanup one by one

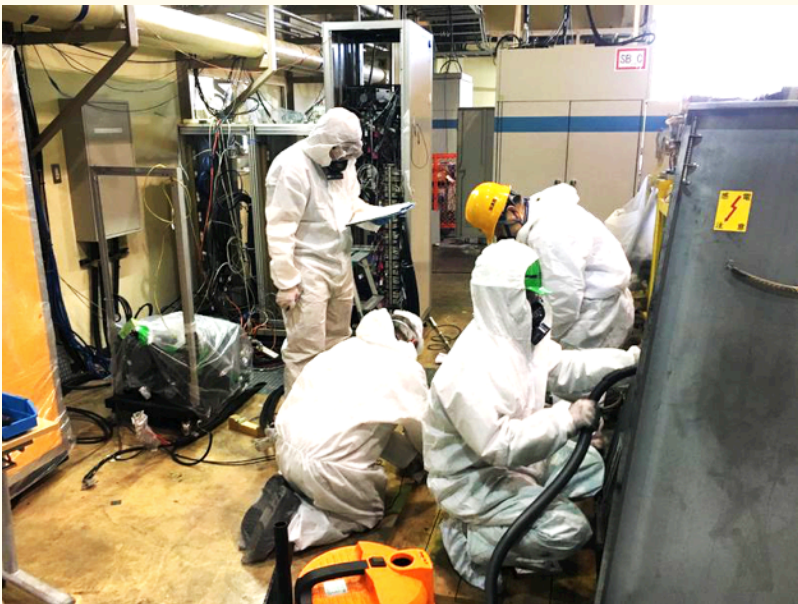
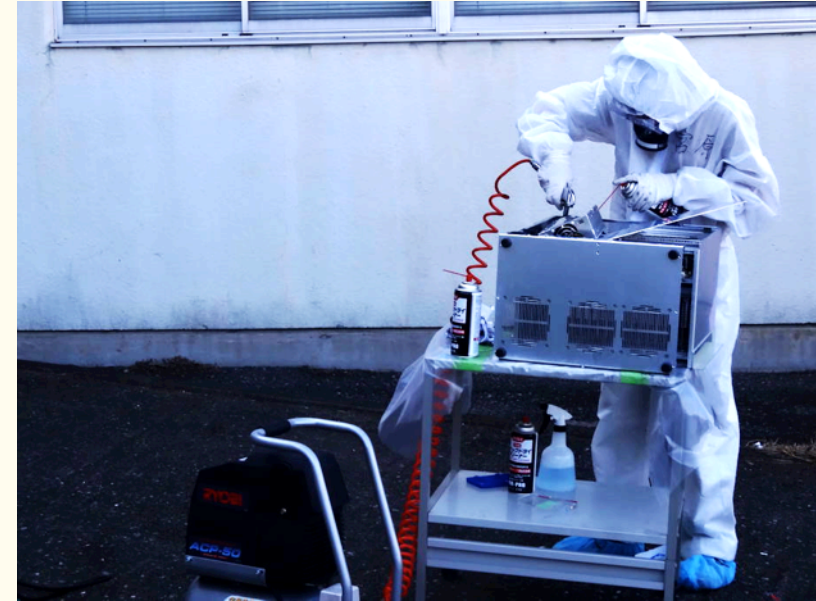
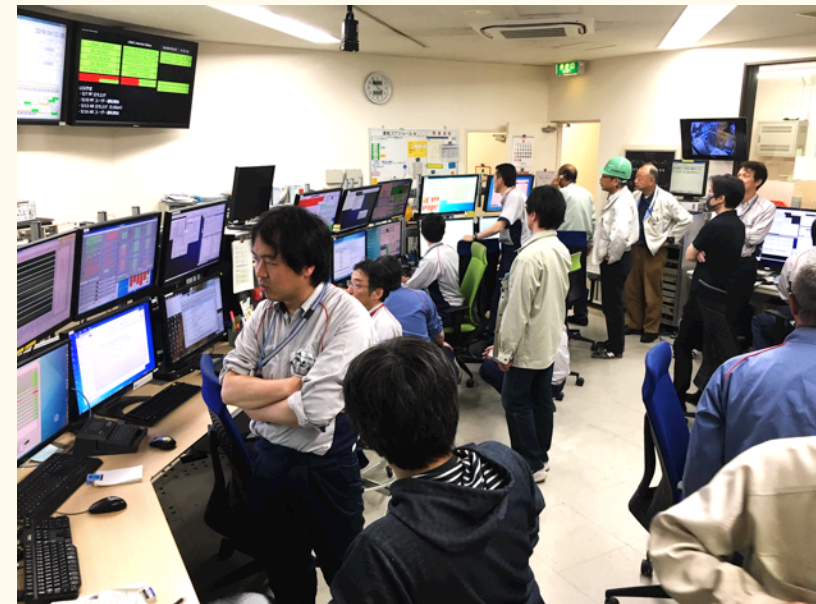
❖ Low-power & high-power tests

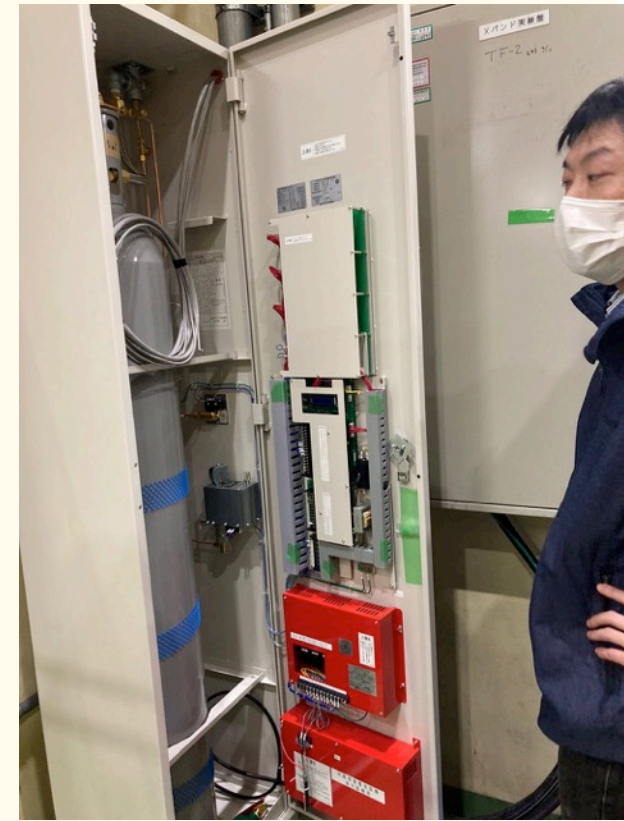
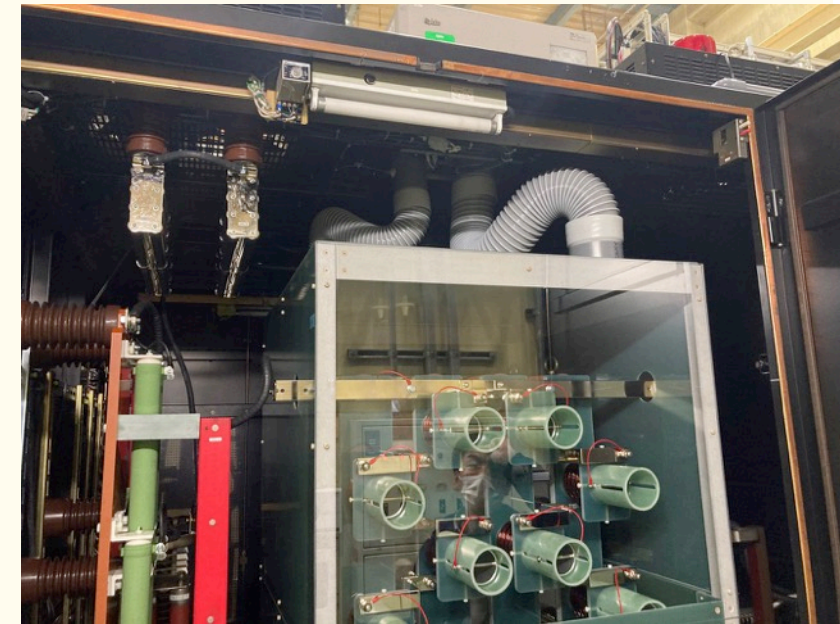
Auto-extinguisher and Cameras

- ◆ We experienced punctures before
- ◆ We learnt that several other institute experience such fire incidents
 - ❖ At least we got information from SLAC and CERN
- ◆ An automatic extinguisher was installed in the new Nextef modulator
 - ❖ A smoke sensor triggers non-combustible gas into PFN box
- ◆ Hundred of video cameras were installed to observe interlocked devices in main LINAC
